re: Bulk Fibre Analysis

Sampled by : Client
Laboratory No. : 6840
Order No. : -
Location/Description : Textured Ceiling Sample

Re: Stability for Subdivision No 137 and 139 Victory Rd, Laingholm.

STABILITY AND FOUNDATION BEARING STRENGTH LOT 101, 102, D.P. 19099
137 VICTORY ROAD, LAINGHOLM.

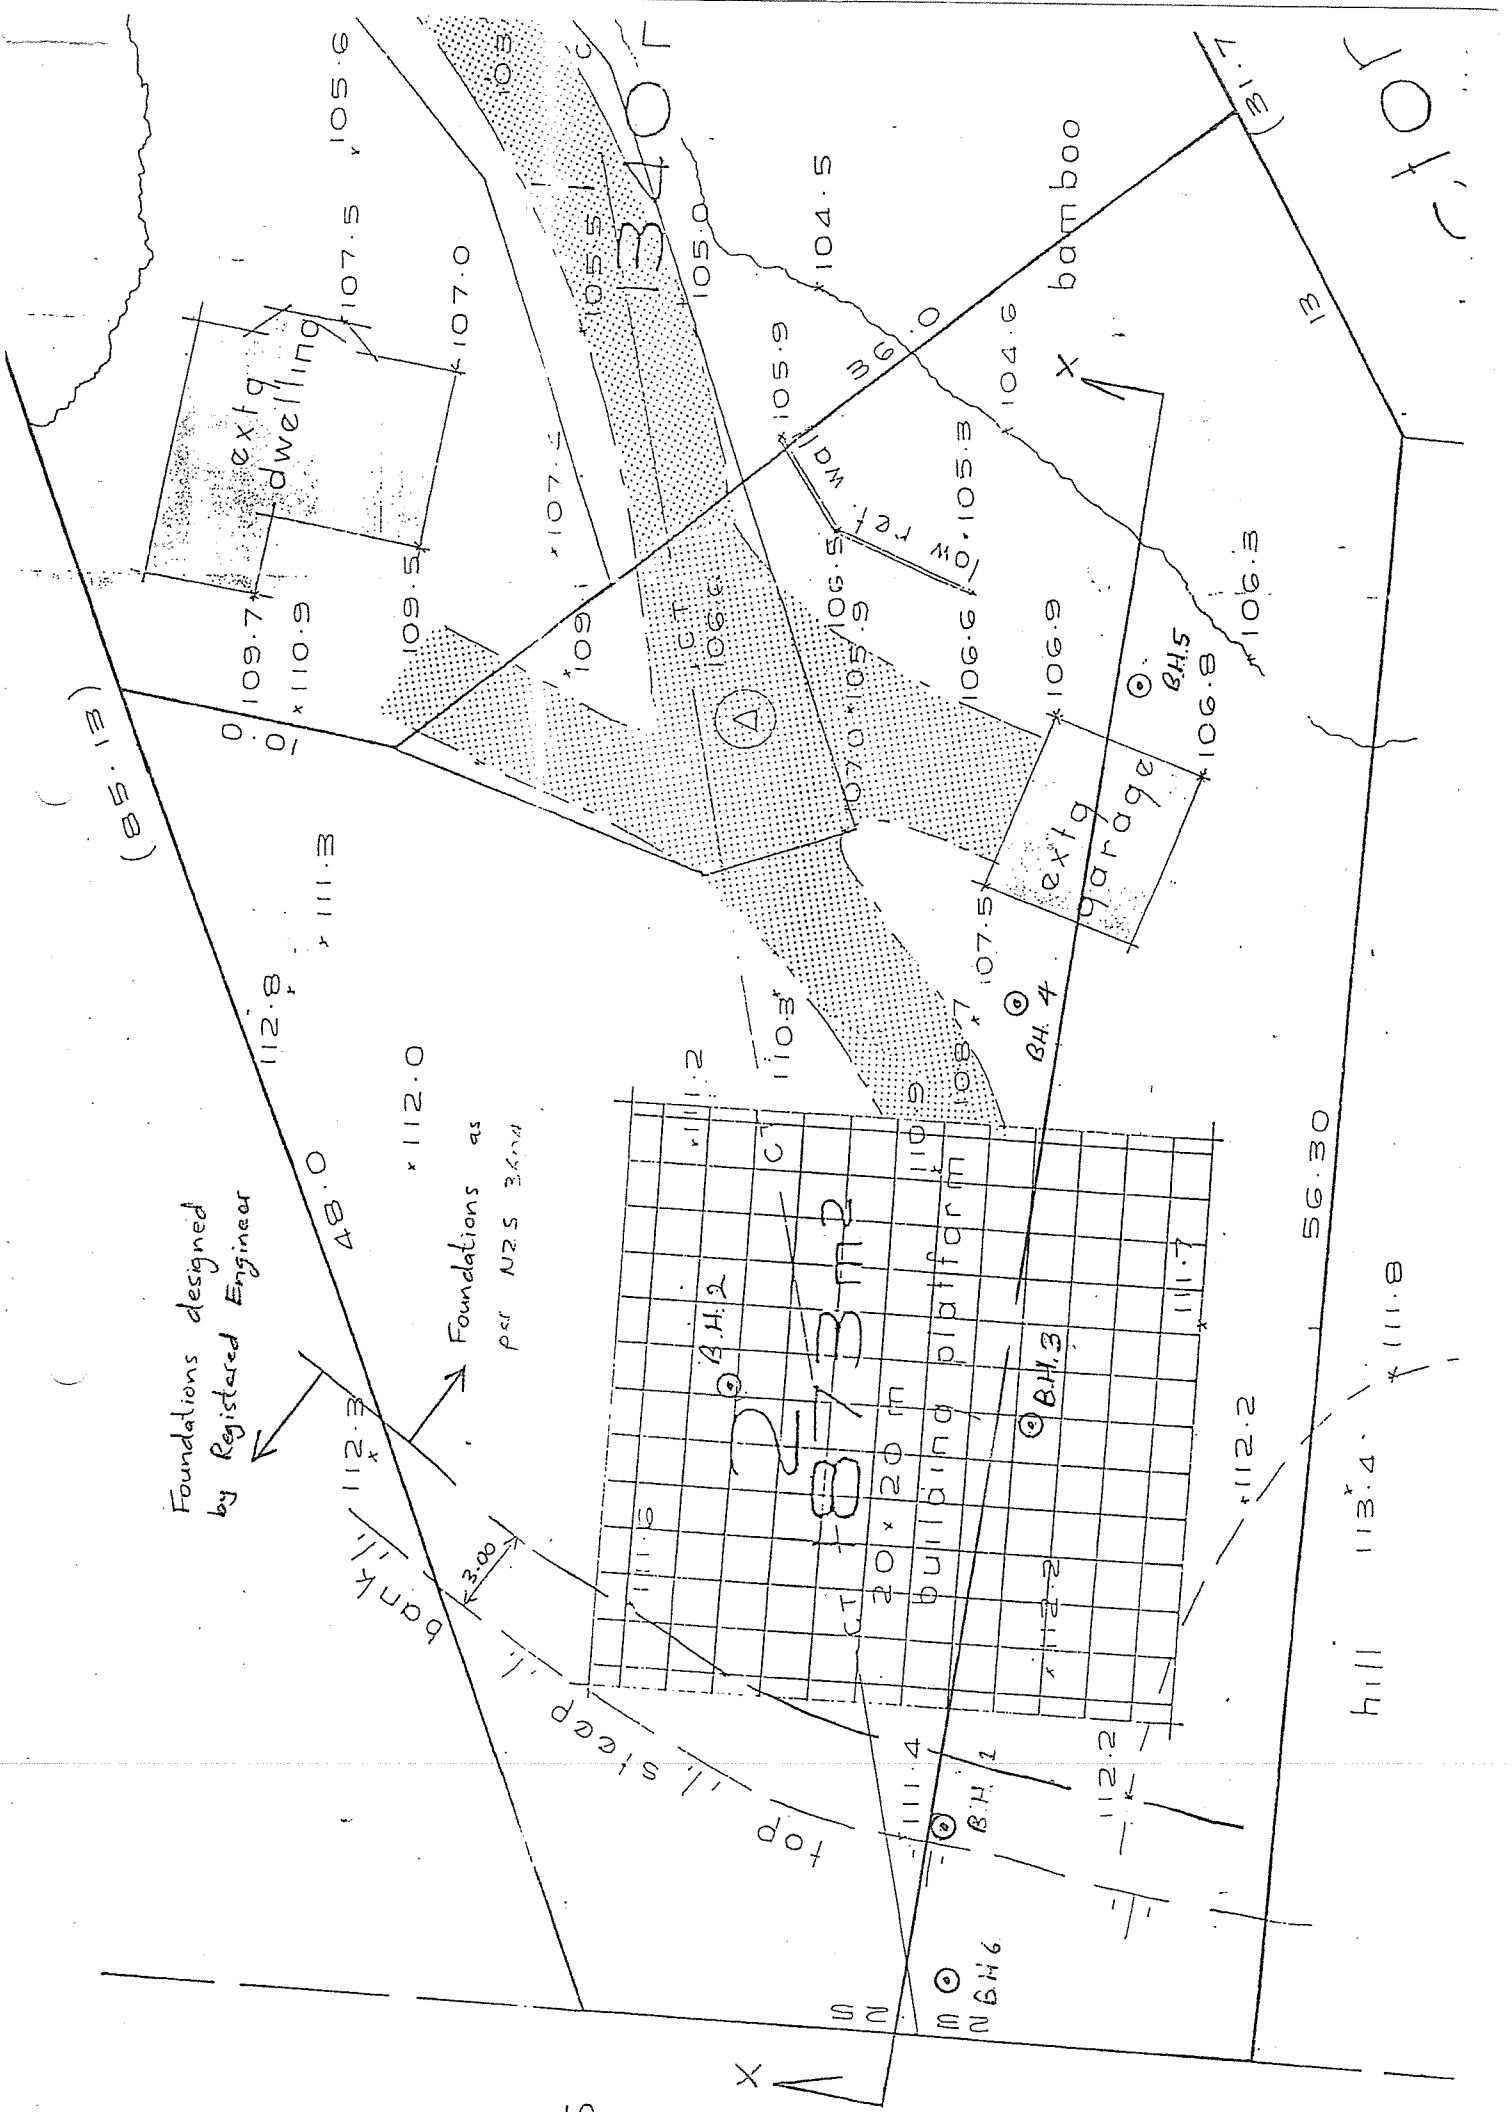
Foundations beyond a 3 metre offset from the top of the Eastern batter can be designed in accordance with NZS 3604:1990. Foundations within 3 metres of the top of this slope shall be designed by a Registered Engineer familiar with this report, and allow for possible creep movement within the upper 600mm on the slope.

Foundations designed
by Registered Engineer

Foundations as
per N25 3/2011
