Guardian Housing Services Ltd

Job Ref: 4118

20th February 2020

RE: SAFE AND SANITARY REPORT ON THE SMALL DWELLING UNIT LOCATED AT 321a HUIA ROAD.

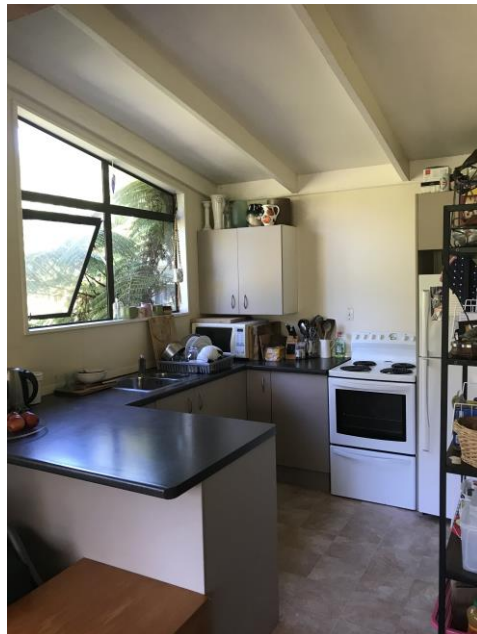
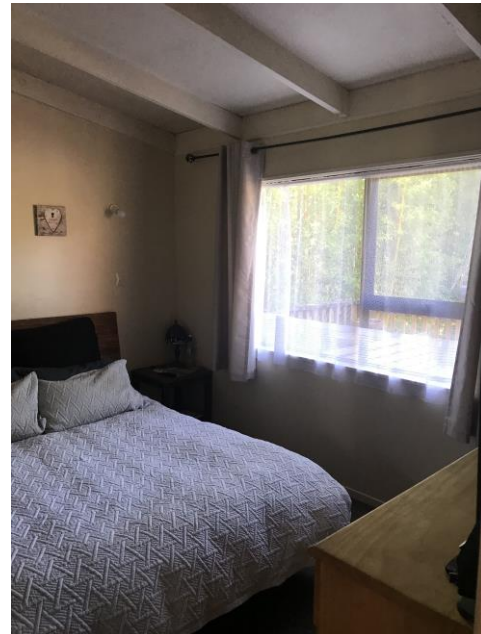
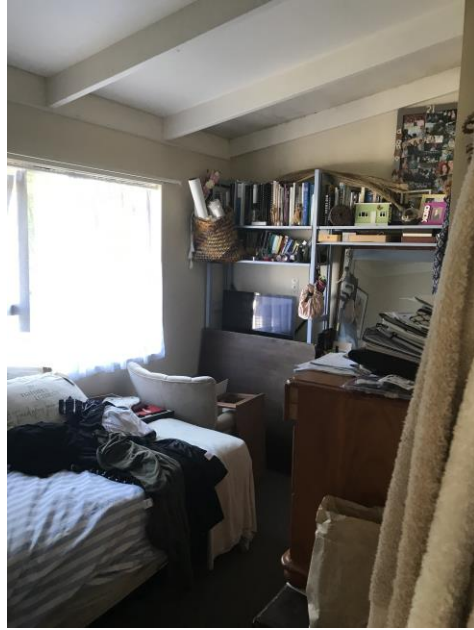
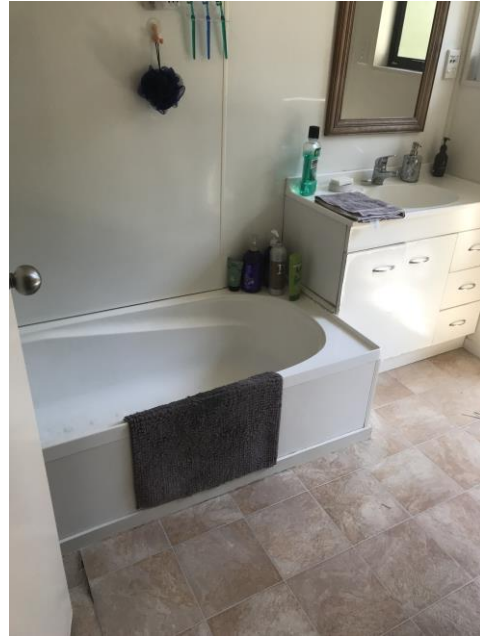
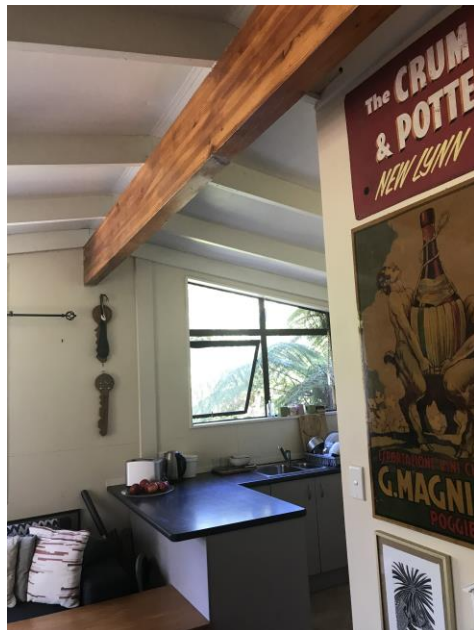
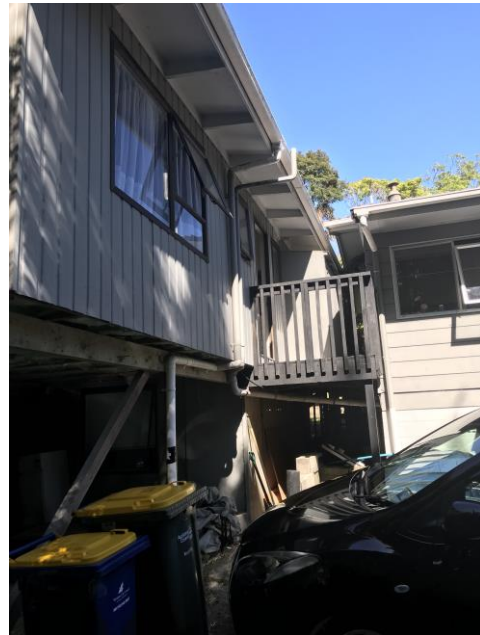
- 3.6 The living areas (bedrooms and lounge) are all provided with windows for natural light and ventilation. The original plans show a door unit located at the front of what was labelled as the rumpus area, now a lounge however there was no deck shown. Currently a deck is located out from the lounge. We note that the deck appears to be of more recent construction, this was explained as being replacement as a section of the deck was badly damaged by a large tree which fell on the deck.
