Moisture Inspection

115 Laingholm Drive, Laingholm,
Auckland, New Zealand

Moisture inspections undertaken on the 1st and 4th of September

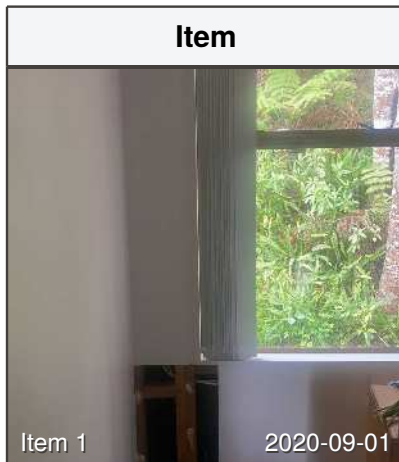
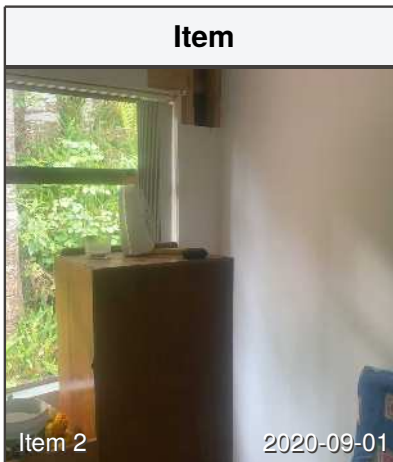
Timbers relatively dry as per readings.

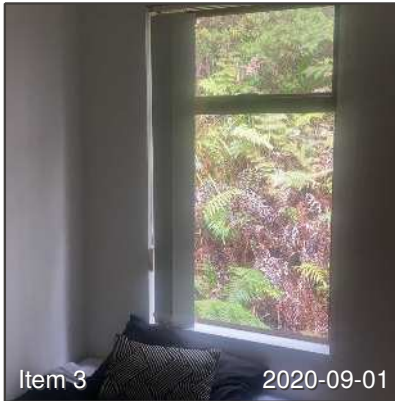
Bedroom 2 Ceiling:

Ceiling timber is dry readings taken were 14.2% and 15.8%

This has been replaced and is new dry plasterboard

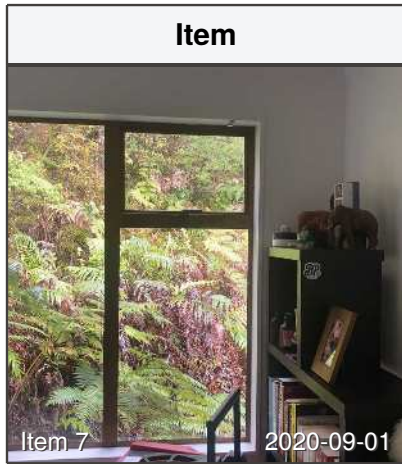
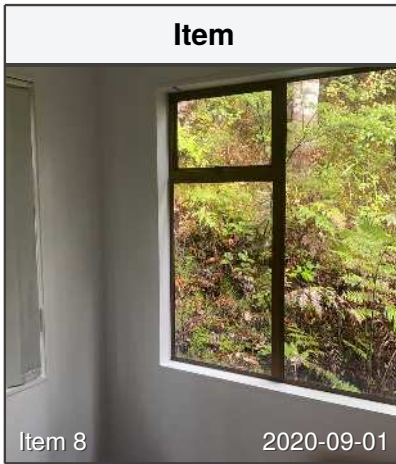
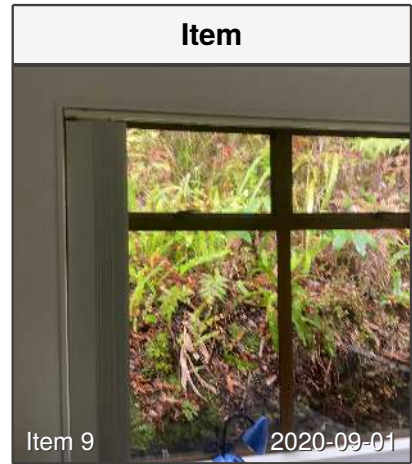
The average dry standard in this house is approximately 100 out of 300 in scan mode. The reading of 112 (recorded) was the highest reading observed when scanning numerous areas. Average 90. We will class this area as dry.

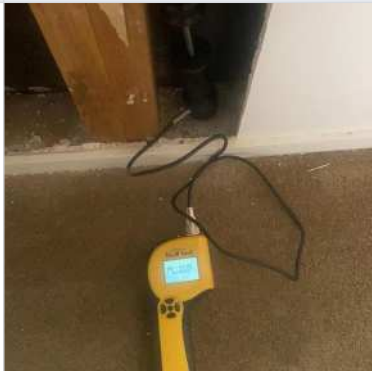
Point 1: Outside Wall

1: Wood Sill Plate
Delmhorst Wood 60%
 Dry Standard: 18%

#	Time	Meter	Moisture Content	Surface Temperature	Notes & Photos
1	Sep 1, 3:18 PM	Delmhorst Wood 60%	19.8%

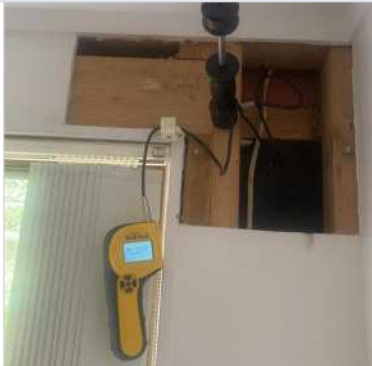
Point 2: Outside Wall

2: Framing
Delmhorst Wood 60%
 Dry Standard: 18%

#	Time	Meter	Moisture Content	Surface Temperature	Notes & Photos
1	Sep 1, 3:21 PM	Delmhorst Wood 60%	14.2%

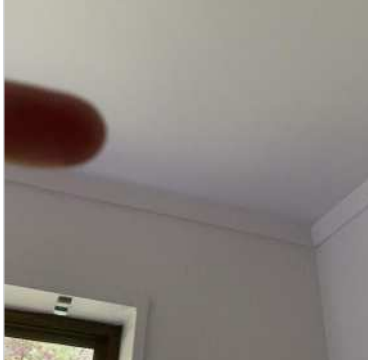
Point 1: Outside Wall

#	Time	Meter	Moisture Content	Surface Temperature	Notes & Photos
1	Sep 1, 4:39 PM	Delmhorst Scan 300	300

#	Time	Meter	Moisture Content	Surface Temperature	Notes & Photos
2	Sep 4, 1:19 PM	Delmhorst Scan 300	112		<p>Highest reading recorded. Average approx 90. This area is deemed dry</p>
