Job Ref: J525/WJD
1 March 2006

**Re: Section 121-123 'Safe & Sanitary' Report on Unauthorised Additions to Upper Floor of the Existing Dwelling at 23 Laingfield Terrace, Laingholm.
Legal Description: Lot 24 DP 90998.
Land Area: 2304m².
Current Owner/s: John William Palmer & Corrine Mary Palmer.**

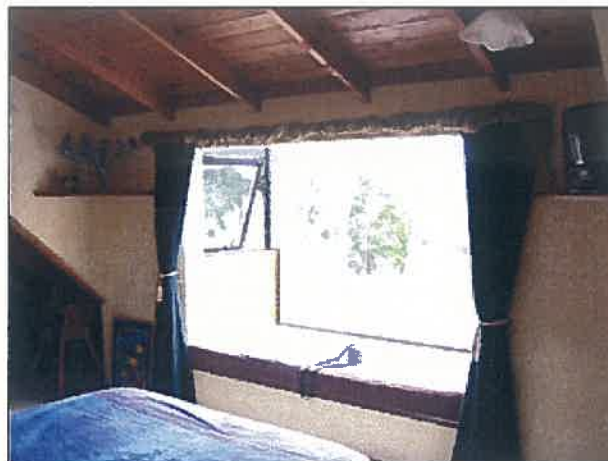
Internal view of bay window.

- 7.2 The bay window addition to the dwelling is mainly comprised of glazed aluminium joinery with some lower timber framing. The exterior area which is not glazed is clad with weatherboards to match the existing exterior cladding to the original dwelling. The junctions of the bay window with the original dormer window are acceptable flashed/sealed and there was no evidence of external water penetration at these points.

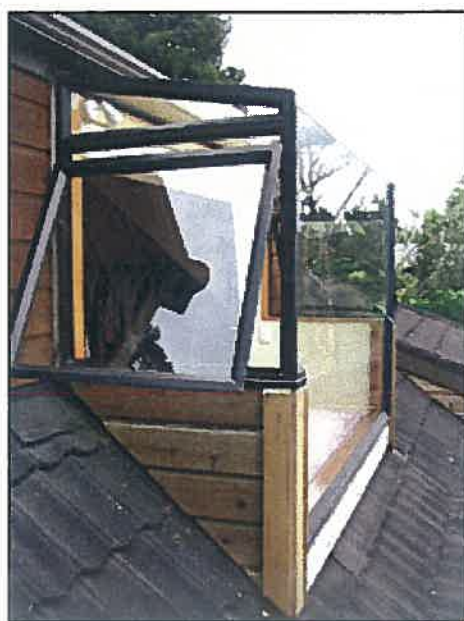
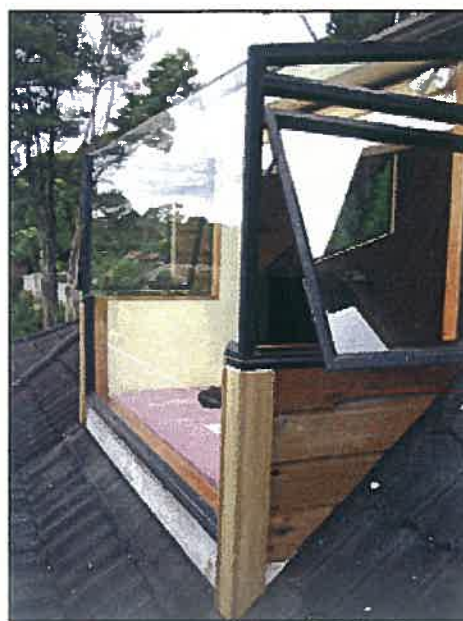
- 7.3 The outer face of the bay window is set in line with existing external wall to the kitchen and dining room located below bedroom 1. The existing 150x50mm roof rafters have been trimmed to a suitable timber lintel located at the head of the new opening created for the bay window.

- 7.4 All exposed timber would appear to have been treated to the correct Hazard Class and all members appear free from any signs of serious insect or fungal attack and all metal connectors in place are free from any signs of serious corrosion or deterioration.

Views of Bay Window.

- 7.5 We are satisfied on reasonable grounds that the bay window and means of support to its framing is sound and is of sufficient structural strength to cope with the relatively small loads imposed on the structure.
- 7.6 The original external envelope of the dwelling remains basically unchanged by the construction of the bay window addition which has not compromised the weathertightness of the exterior envelope as a whole.
- 7.7 The bay window addition appears to have been carried out in an acceptable manner with no visible signs of weakness, with no adverse impact on the structural integrity of the original dwelling, and the exterior envelope remain acceptable weathertight. Therefore, we can confirm that in our professional opinion the works as a whole can be considered sound from a construction and/or structural point of view.

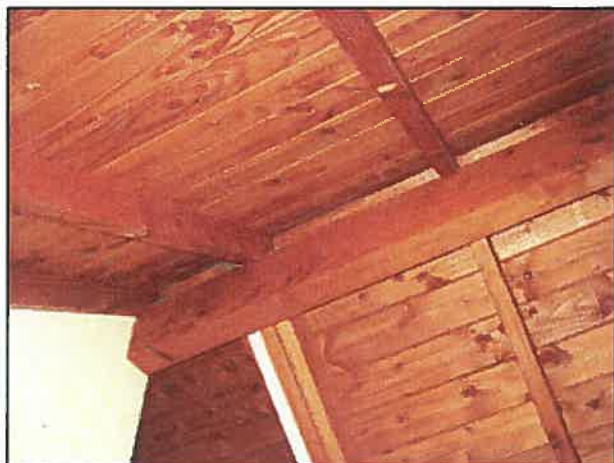
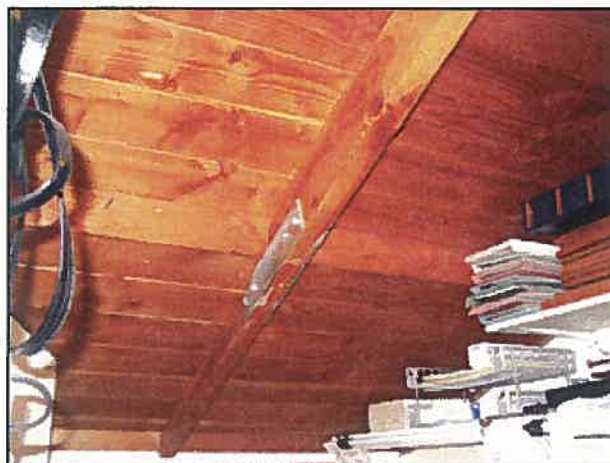
Internal views of rear roof plane framing.

- 8.2 The framing to the raised roof plane is essentially unchanged from the original form of raftered construction. The inner ends of the rafters are supported on the original ridge beam and are acceptably secured. The outer ends are supported on a new area of external wall framing which is located directly above the lower exterior load bearing wall.

- 8.3 The exterior area of the new area of wall is clad with weatherboards to match the existing exterior cladding to the original dwelling while internally it is clad with plasterboard. All necessary insulation has been installed to the exterior envelope of the structure.

- 8.4 We are satisfied on reasonable grounds that the framing of the raised roof plane and means of support to this framing is sound and is of sufficient structural strength to cope with the relatively small loads imposed on the structure.

- 8.5 The raising of the rear roof plane appears to have been carried out in an acceptable manner with no visible signs of weakness, with no adverse impact on the structural integrity of the original dwelling, and the exterior envelope remain acceptable weathertight. Therefore, we can confirm that in our professional opinion the works as a whole can be considered sound from a construction and/or structural point of view.

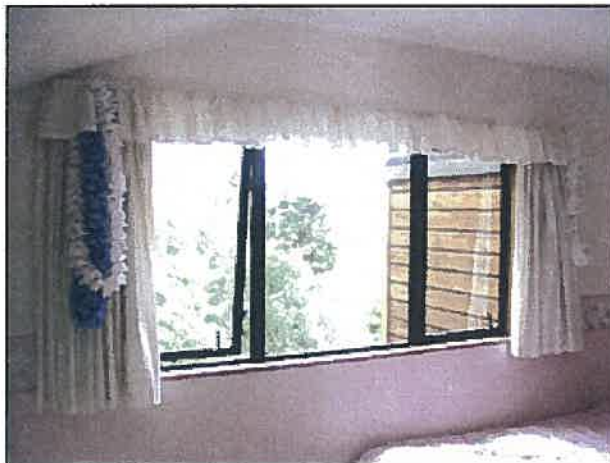
- 9.2 The framing to the relocated side wall is essentially unchanged from the original form of construction and is 100x50mm timber studs at 600mm centres with 100x50mm top and bottom plates. A window located in the new area of wall has a suitable lintel in place at its head. The new wall is located directly over the original external wall to bedroom 3 below and thus loads are transferred directly to this load bearing framing and then the subfloor structure below.

View of 'pushed-out' side wall to bedroom 4.

- 9.3 The exterior area of the new wall is clad with weatherboards to match the existing exterior cladding to the original dwelling while internally it is clad with plasterboard.

- 9.4 We are satisfied on reasonable grounds that the new wall framing and means of support to this framing is sound and is of sufficient structural strength to cope with the relatively small loads imposed on the structure.

- 9.5 The relocation of the side wall to bedroom 4 appears to have been carried out in an acceptable manner with no visible signs of weakness, with no adverse impact on the structural integrity of the original dwelling, and the exterior envelope remain acceptable weathertight. Therefore, we can confirm that in our professional opinion the works as a whole can be considered sound from a construction and/or structural point of view.

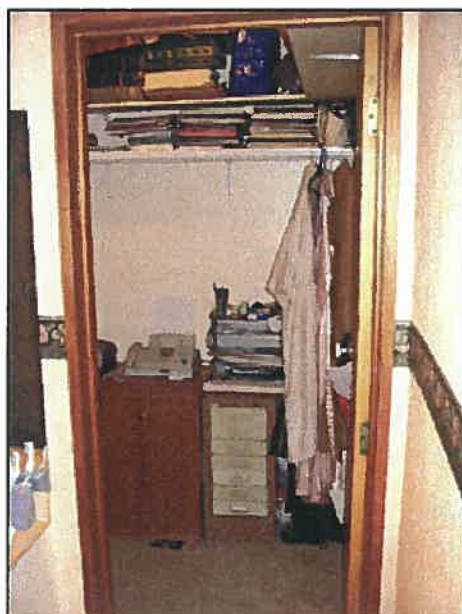
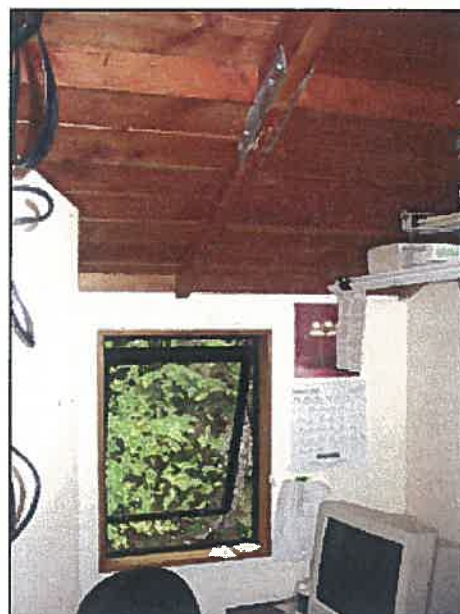
- 10.4 The internal side walls to the study are located above corresponding original internal walls which form part of the bathroom/WC spaces located below at the rear of the dwelling. The study also contains the Hot Water Cylinder within an enclosed cupboard space created in the rear left-hand corner of the room.

Views of new study area.

- 10.5 We are satisfied on reasonable grounds that the new wall framing to the study and means of support to this framing is sound and is of sufficient structural strength to cope with the relatively small loads imposed on the structure.
- 10.6 The creation of the new study appears to have been carried out in an acceptable manner with no visible signs of weakness, with no adverse impact on the structural integrity of the original dwelling, and the exterior envelope remain acceptable weathertight. Therefore, we can confirm that in our professional opinion the works as a whole can be considered sound from a construction and/or structural point of view.

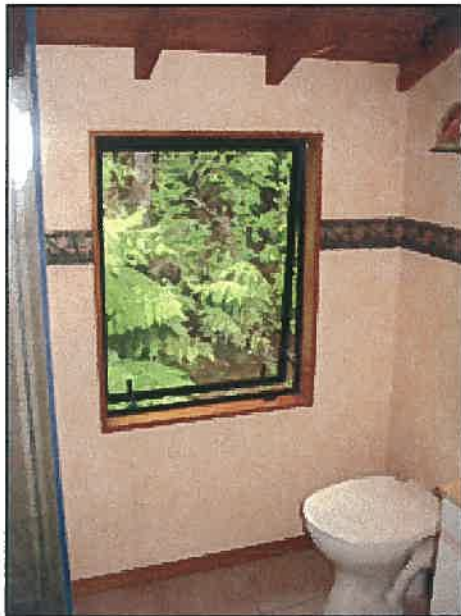
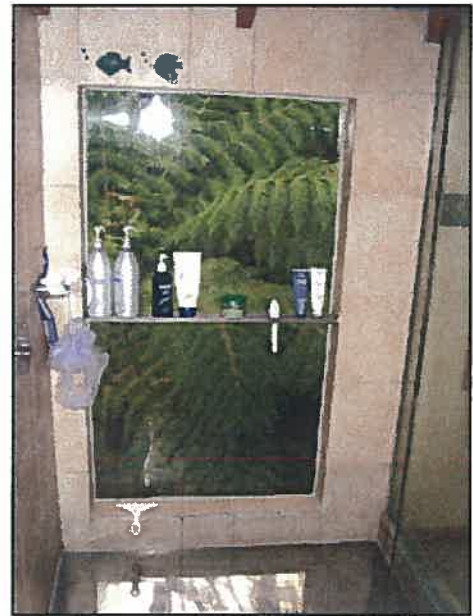
- 11.4 The installation of the bathroom fixtures and fittings has had no adverse impact on the structural integrity of the original building envelope and all plumbing fittings and pipework appears to be free from leaks and working acceptably. The wastes from the bathroom fittings have been routed to discharge into the existing gully trap located at the rear of the dwelling or have direct connections to the foulwater system as appropriate.
- 11.5 All plumbing and electrical installation work would appear to have been carried out in a competent manner and appears sound. While the bathroom joinery installation work appears to have been carried out in an acceptable manner, in accordance with prevailing methods and trade practices applicable to the period in which the work was carried out, with no obvious/serious defects or signs of weakness.

Views of en-suite including window in shower stall.

- 11.6 We are satisfied on reasonable grounds that the new wall framing to the reconfigured en-suite and means of support to this framing is sound and is of sufficient structural strength to cope with the relatively small loads imposed on the structure.
- 11.7 The creation of the reconfigured en-suite appears to have been carried out in an acceptable manner with no visible signs of weakness, with no adverse impact on the structural integrity of the original dwelling, and the exterior envelope remain acceptable weathertight. Therefore, we can confirm that in our professional opinion the works as a whole can be considered sound from a construction and/or structural point of view.

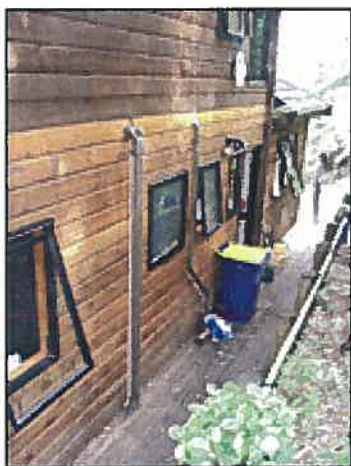
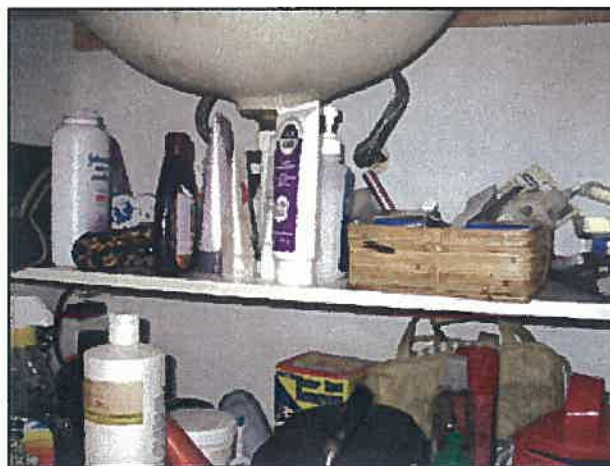
13.1 All plumbing & drainage work carried out in connection with the works appears sound and is working acceptably. There is no evidence of water leaks and the plumbing & drainage arrangements are satisfactory.

Views of plumbing and drainage to upper floor.

13.2 The downpipes which serve the guttering to the outer edge of the raised rear roof plane has been connected to the existing stormwater drainage pipework located within the subfloor area of the dwelling.

13.3 The wastes from the bathroom fittings have been routed to discharge into the existing gully trap located at the rear of the dwelling or have direct connections to the foulwater system as appropriate.
