Guardian Housing Services Ltd

June 2021

RE: SAFE AND SANITARY REPORT ON THE DECK LOCATED AT 27 DANUBE LANE.

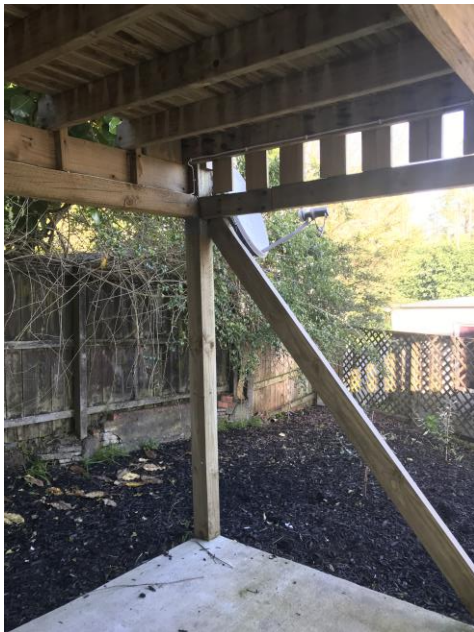
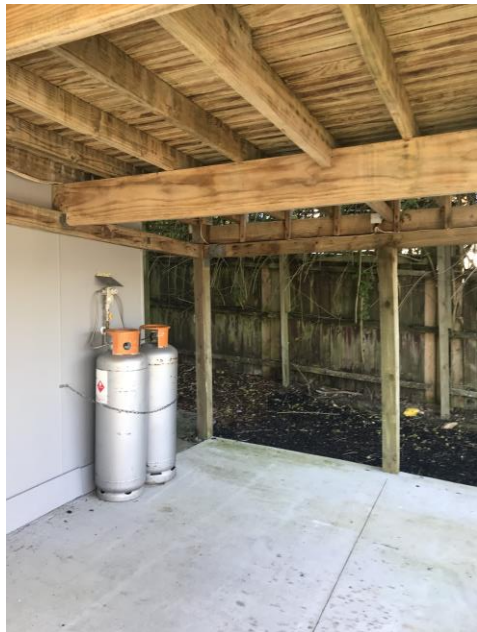
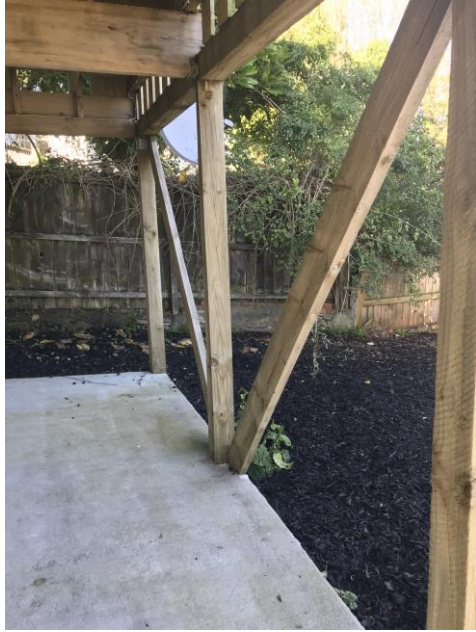
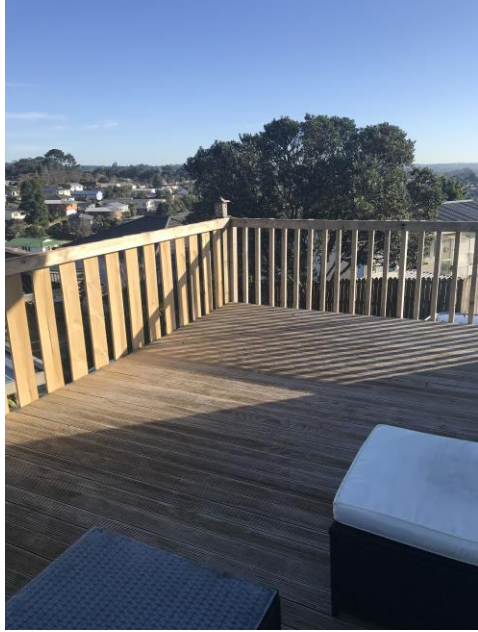
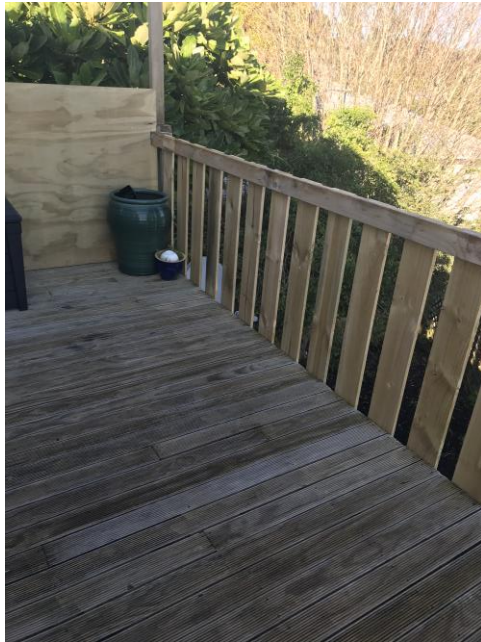
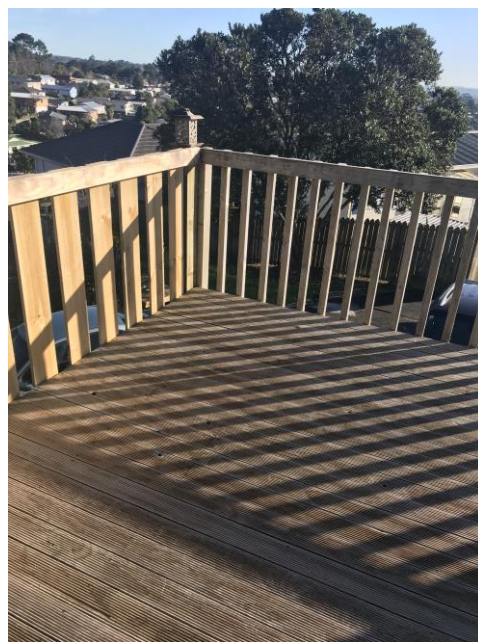
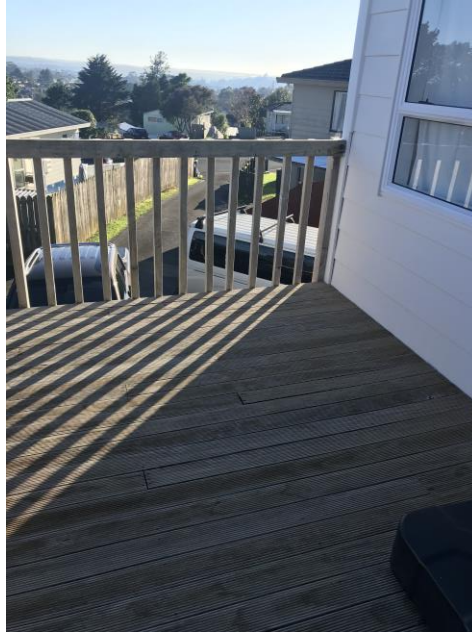
- 3.1 The dwelling is a single level home located on a sloping section. Located at the end of the dwelling is the dining and lounge areas. A large timber framed deck has been erected off these rooms.
- 3.2 This deck has been substantially constructed at the time and appears to have had a few alterations made over the time. The structure is supported on 125x125 timber piles which are well braced to resist lateral movement.

- 3.3 The deck surface is of treated pine decking timber on treated joists and bearers. All the structural members appear to be within the allowable spans and spacings as allowed for under NZS3604.

- 3.4 A timber barrier that meets the 1.000 meter height requirement has been provided on two elevations and a plywood screen on the third. This has been constructed generally in accordance with the performance requirements of clause F4, Safety from Falling, NZ Building Code.

- 4.1 These works appear to have been constructed in an acceptable manner with no visible signs of weakness or problems, which would have an adverse impact on the structural integrity of the property.

- 4.2 We note that some of the galvanized metal brackets (joist hangers) are showing signs of corrosion, as part of the maintenance requirements we recommend that these be treated with an anti-corrosion paint and then over painted. We also note some decay to the tops of the posts, this should be monitored and replaced when necessary.
