# Home Inspection Report

1/2b Matipo Road, Te Atatu Peninsula, Auckland

Inspection prepared for: Philippa Wintle  
Date of Inspection: 11/8/2021 Time: 12:00 PM  
Age of Home: 1980's Size: 90m<sup>2</sup>  
Weather: Fine

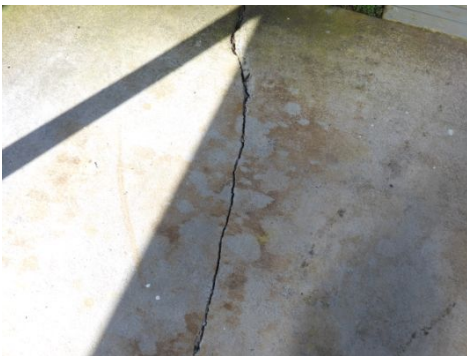
Cracked concrete

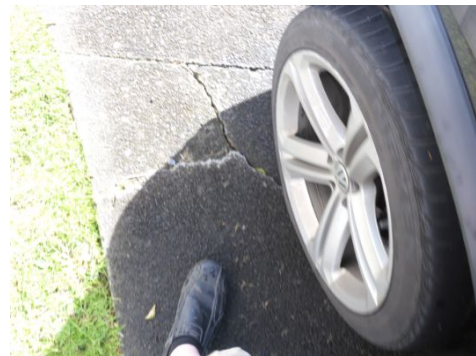
Cracked concrete

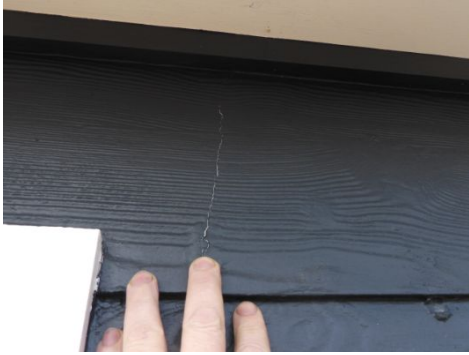
- X • Good condition however some areas of cracked cladding are visible, recommend sealing these areas to ensure weathertightness

Cracked cladding

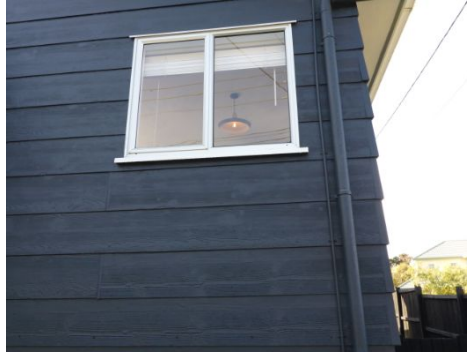
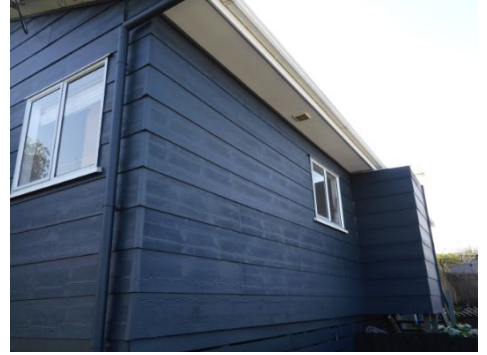
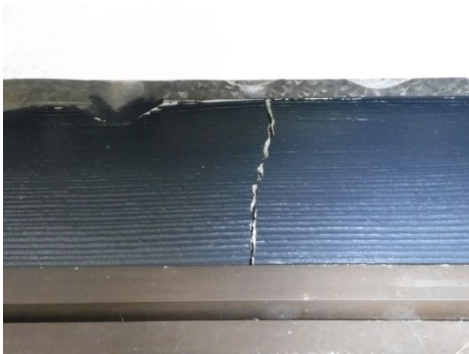
Cracked cladding

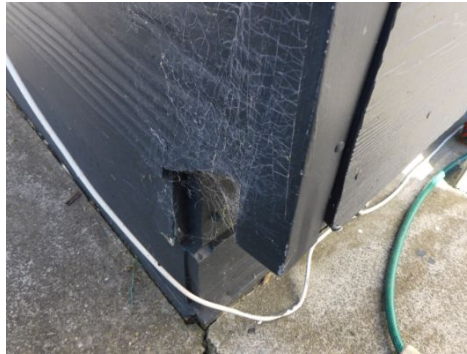
Minor damage

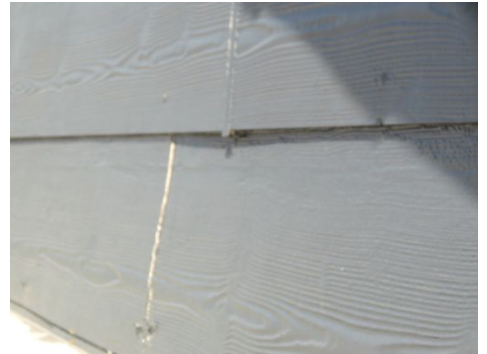
Cracked cladding

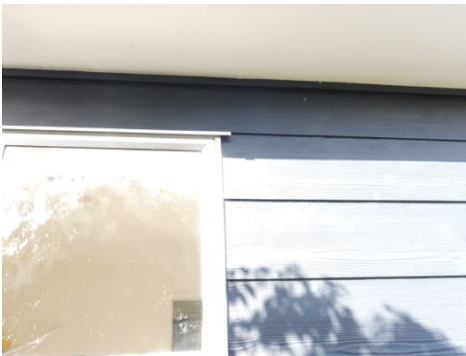
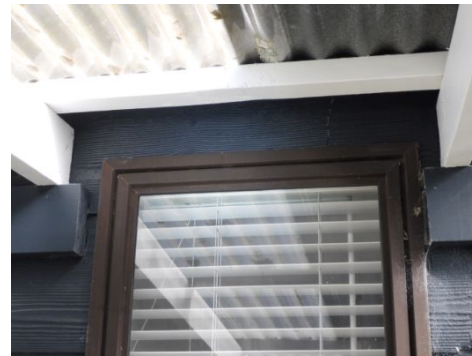
- Present in most areas
- The flashing is missing above the window beneath the carport, while this area is well protected from the elements sealants should be added to prevent moisture and insects entering the wall cavity

Sealants recommended

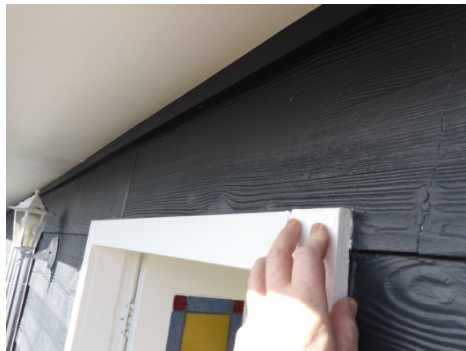
- Not present above the front door, this appears to be well sealed and protected from the elements by the eave, recommend ensuring the sealants remain in good condition

Missing head flashing

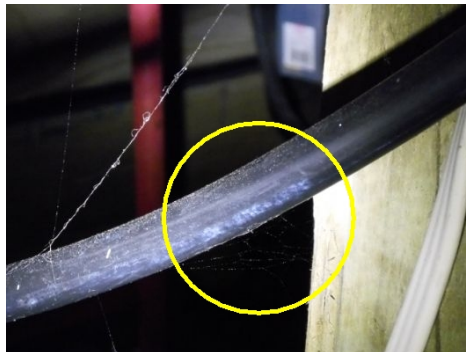
- X
- P.V.C
  - Copper
  - Polybutylene
  - Dux Quest water supply pipe is present, this is a type of black plastic piping used in houses in the 1970's and 1980's, it is known as a defective product prone to failure and it may affect the homes insurance. While much of this water supply pipe has been upgraded replacing the remaining Dux Quest is recommended to prevent future issues

Dux Quest

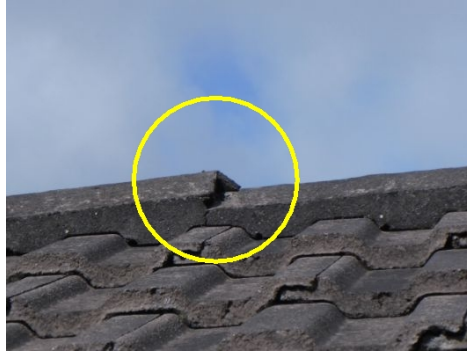
- A small amount of mortar is cracked
- No cracked tiles apparent
- No apparent erosion can be seen at the time of inspection

Cracked mortar present

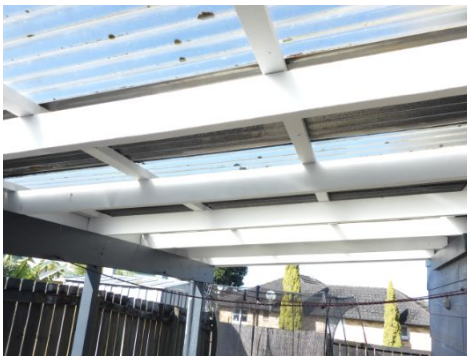
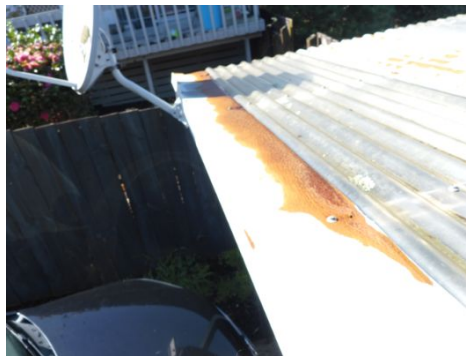
- General deterioration present

Surface corrosion present

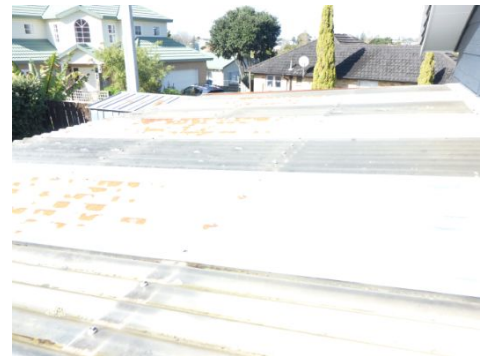
Surface corrosion present
