PRE-PURCHASE BUILDING REPORT

Property Address	36 Eastglen Road, Glen Eden		
Client	Jesse Staines		
Date of Inspection	13th September 2022	Time	8:30 am
Inspector	Rob Sodeau Peer reviewed by LBP 133644		
LBP Number	Peer reviewed by LBP 133644		
Inspection Type	Pre-Purchase Report		
People Present	Owner, Inspector		
House Occupied	Yes

CERTIFICATE OF INSPECTION IN ACCORDANCE WITH NZS 4306:2005

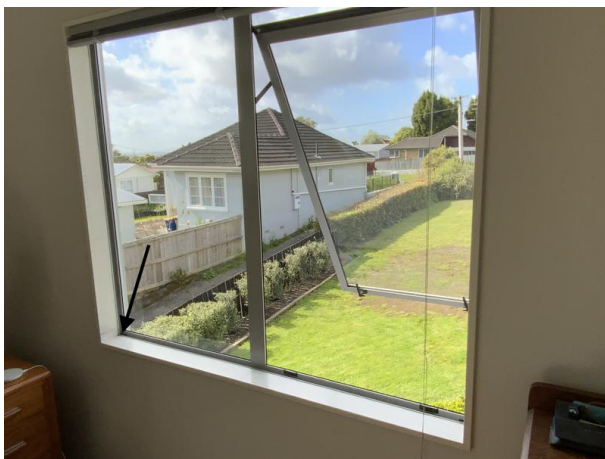
Photo 24

Bedroom one joinery with one joinery, installation of security stays is recommended

Recommended that security stays are installed on any second-story opening windows with a sill height lower than 900mm to reduce fall hazards.

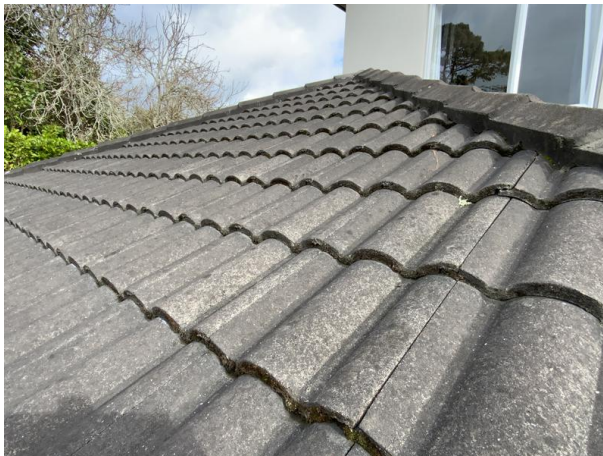
Photo 28

Sample photo of the roof above the carriage at the front of the property, moss treatment and tile sealing is recommended

There were visible areas on the roofing with moss and lichen growing over the surface. It is recommended to treat the surface as part of general maintenance. Upkeep of maintenance of masonry tiles by way of cleaning and sealing. General upkeep of the roofing system to maintain weathertightness.

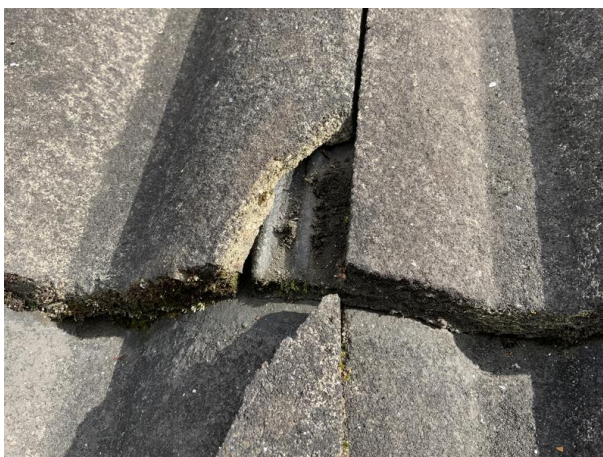
Photo 29

Photo shows cracked tile above the garage, further investigation for repair or replacement by a roof specialist is recommended

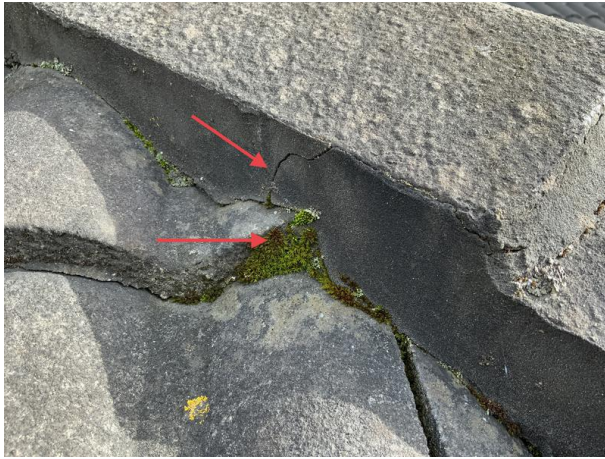
Photo 30

Sample photo of minor crack in the cement fixing and moss growing, moss treatment recommended, monitor and maintain the pointing as required.

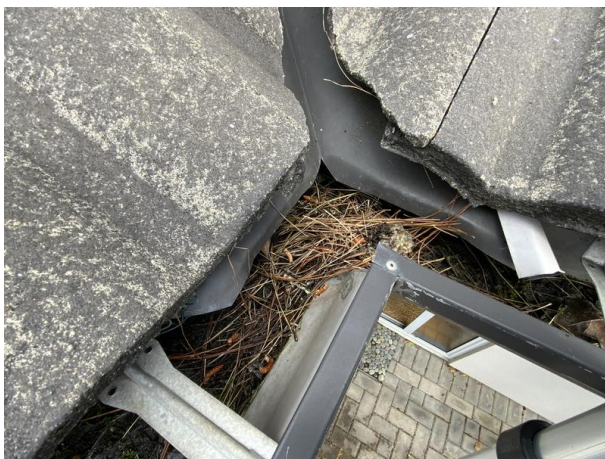
Photo 32

Sample photo of debris in the gutters, cleaning recommended

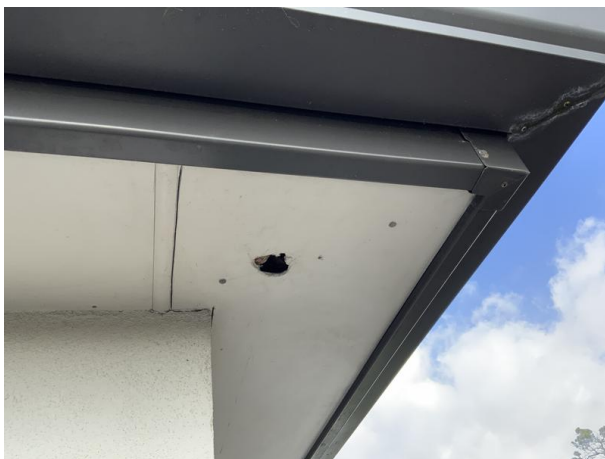
Photo 35

Photo showing a hole in the soffit at the back of the property, maintenance recommended

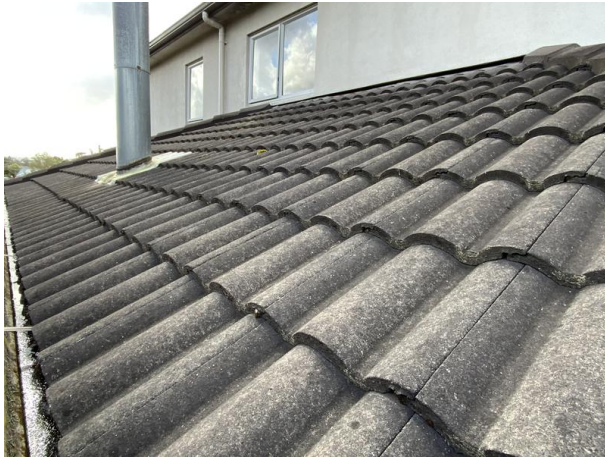
Photo 36

Sample photo of the roof at the back of the house, moss treatment recommended

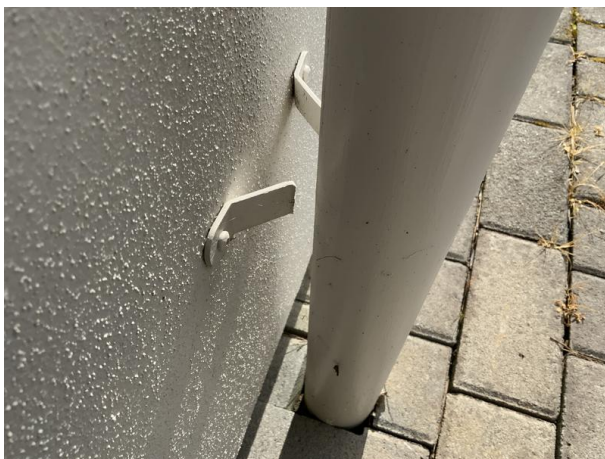
Photo 38

Sample photo of broken down pipe clip, recommend this is replaced

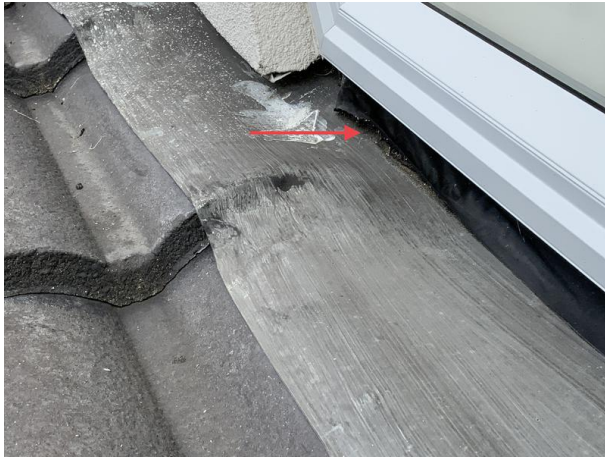
Photo 39

Photo shows flashing tape lifting outside bedroom two, maintenance recommended

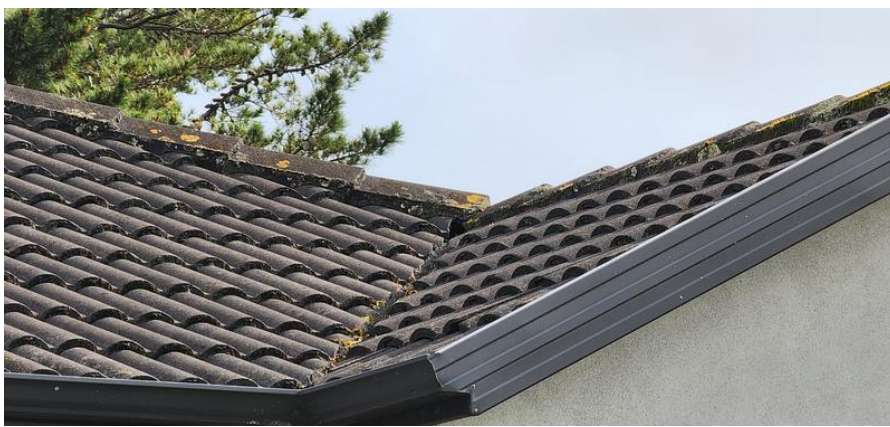
Photo 40

Sample photo of the upper level roof valley, sealing and moss treatment by a roof specialist is recommended

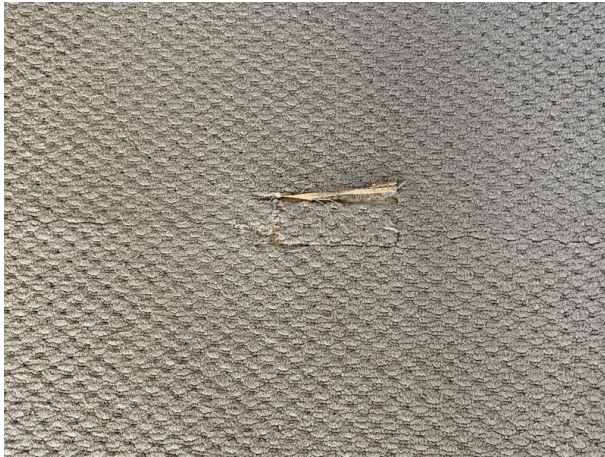
Photo 61

Defects - Damaged carpet.

Damaged carpet, maintenance recommended

It is recommended the carpet is repaired.

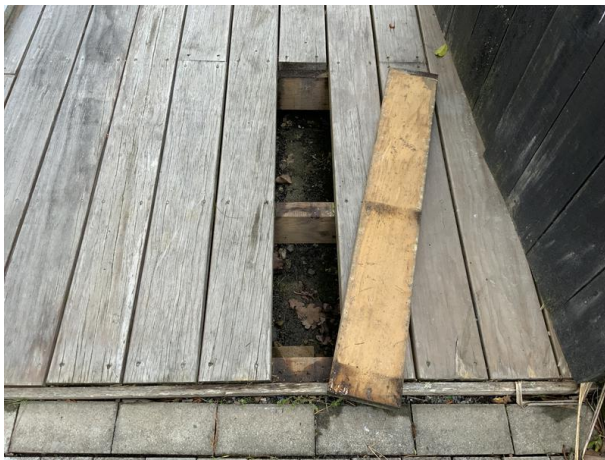
Photo 80

Deck timber not secured in place by the gate, recommend this is nailed down

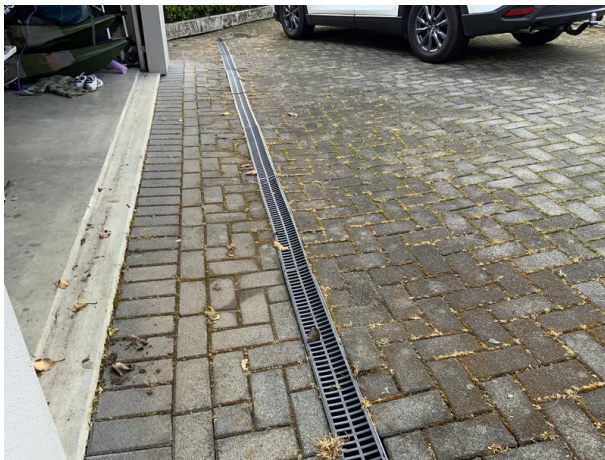
Photo 86

Drain strip in front of the garage, ensure this is kept clear

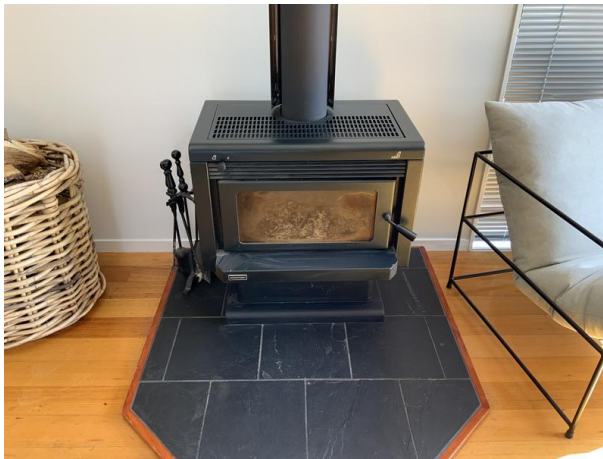
Photo 87

Fireplace, not tested

Check with territorial authority for solid fuel burners compliance. Have a heating specialist investigate and report on the firebox condition. It is recommended to have the flue cleaned and checked annually.
