Home Inspection Report

16 Panzic Place, Glen Eden, Auckland

Inspection prepared for: Boaz Shulruf
Date of Inspection: 19/6/2023 Time: 11:30 AM
Age of Home: 1980s Size: 88m2
Weather: Fine

Inspector: Duane Turner
Phone: 027 376 4806 / 09 8118 017
Email: duane.turner@abuyerschoice.com

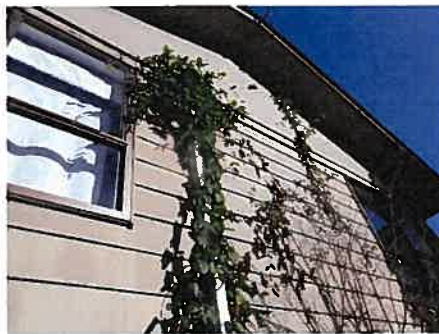
X • The vegetation growing on the home should be removed to prevent damage

Remove from the home

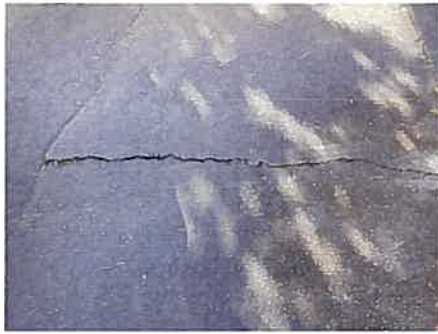
Cracked concrete present

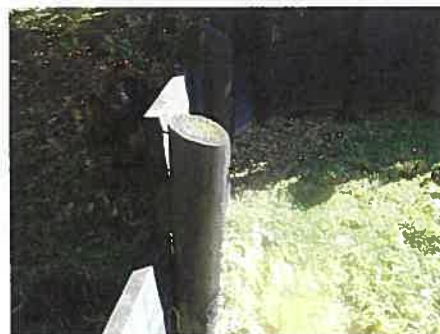
Some damage present

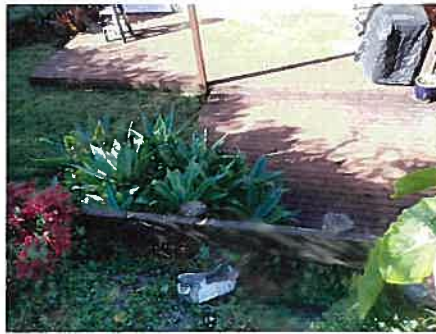
• Some areas are higher than 1 meter and no barrier has been installed presenting a fall hazard

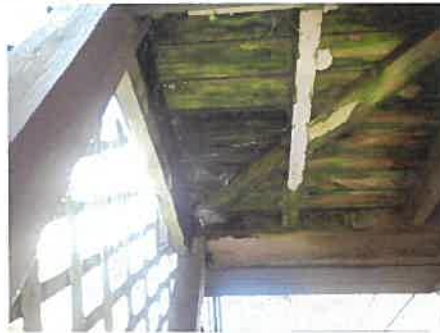
General deterioration

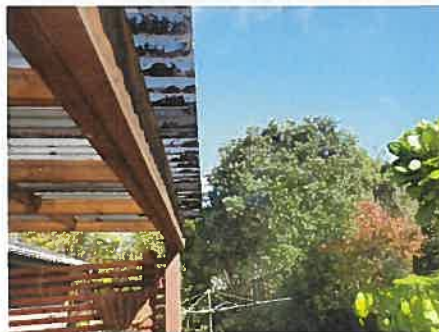
- Appears well constructed and in good condition however no guttering is present

No guttering present

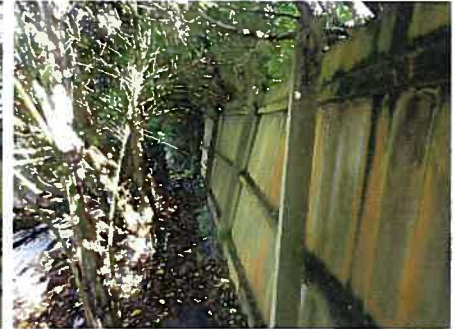
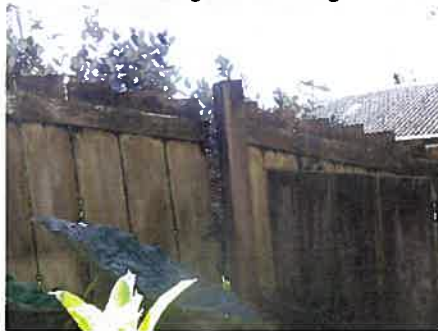
- Areas of damage present requiring repairs or replacement

Damaged fencing

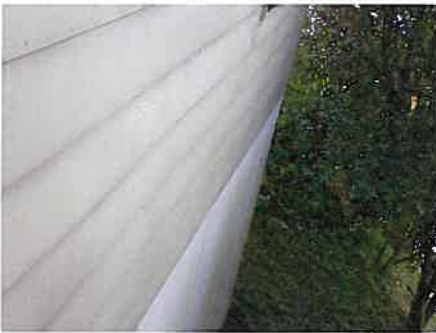
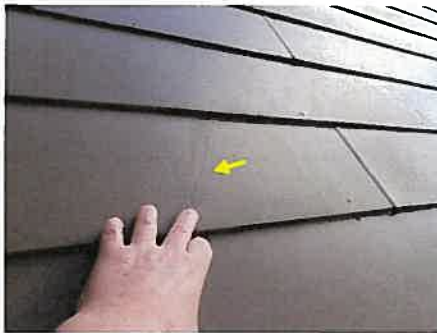
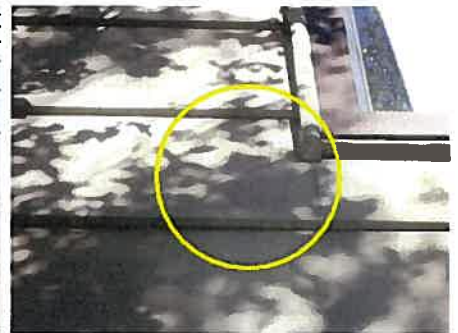
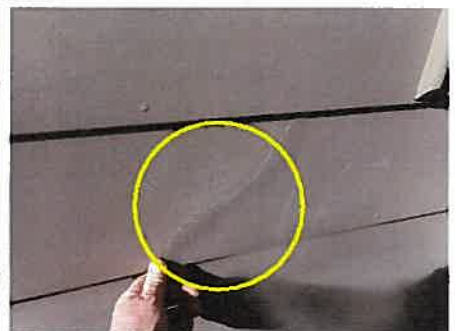
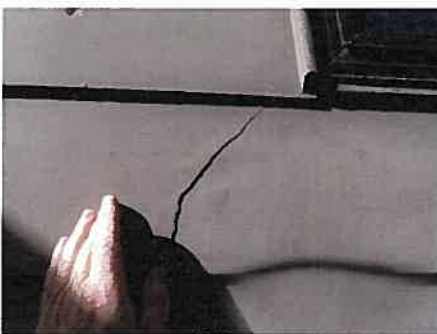
• Areas of cracking and damage present, repairs recommended

Cracked fiber cement

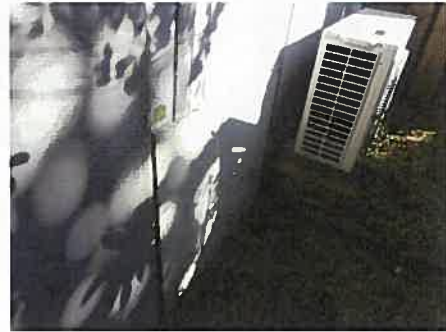
Damage to the access door

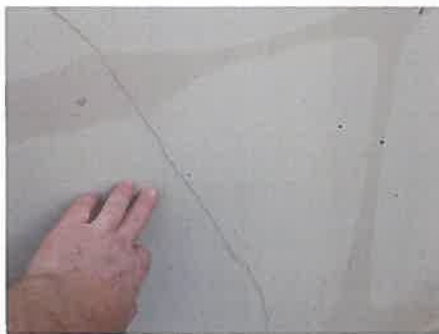
Some cracking present

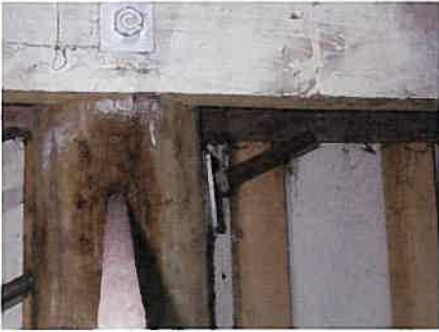
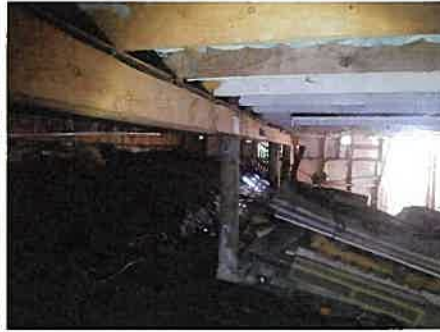
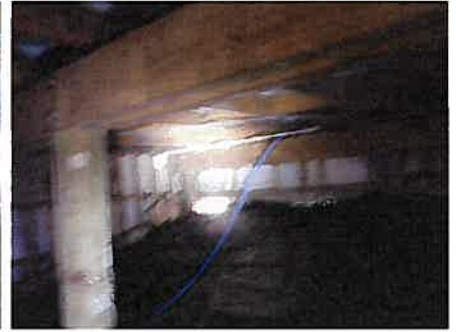
- Appears satisfactory for the age and type of structure however the metal cross bracing is quite loose, recommend tightening these braces for maximum effect

Recommend tightening

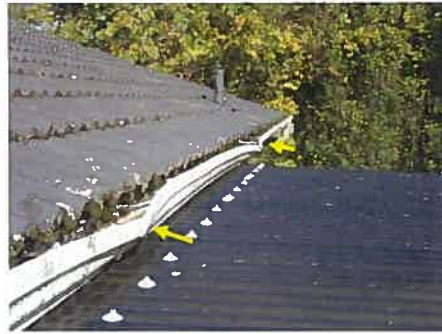
- Damage present in some places, the guttering will require repairs or replacement

Damaged guttering

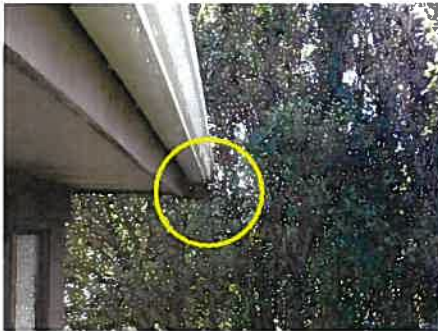
- M D NI • General damage and deterioration present

Rot present

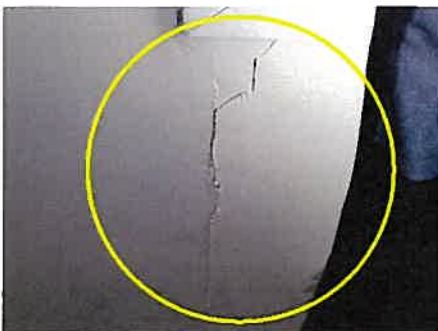
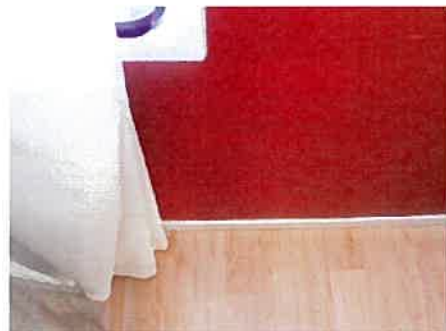
- M D NI • Cracks and damage present requiring repairs

Damaged wall lining

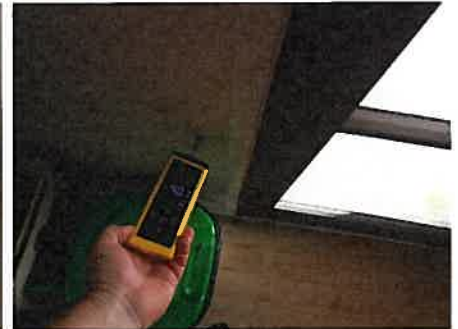
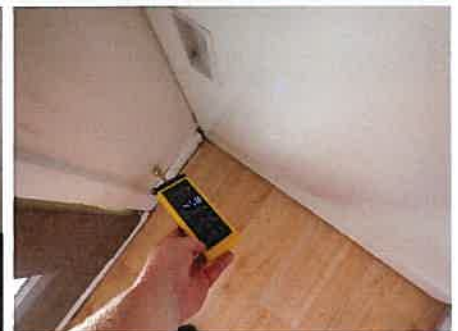
M D NI • Several readings were taken and all were within the acceptable range and indicate the room to be DRY however mould growth behind the laundry tub should be controlled

Mould growth

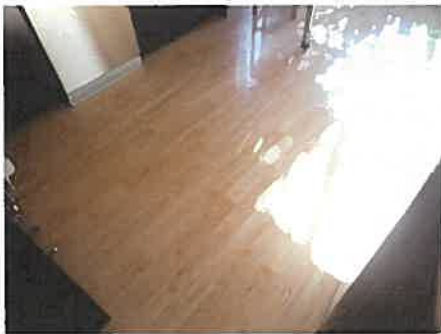
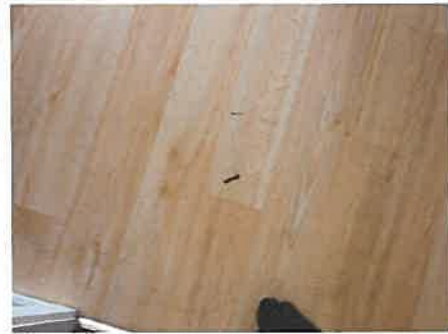
Some damage present

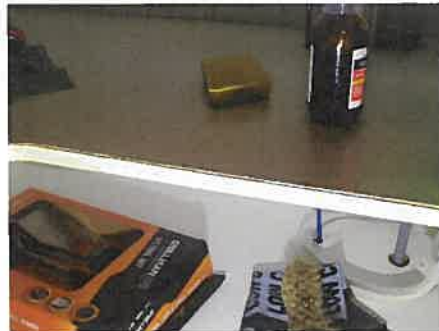
- Laminate type and composite materials
- Swelling present from moisture exposure

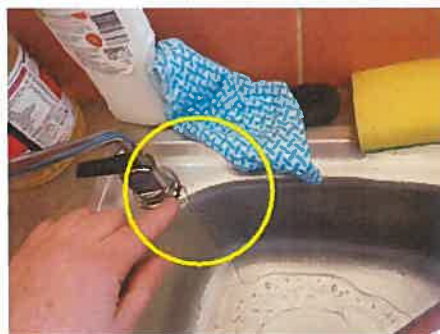
- There is a leak from the base of the filtered water tap

Leakage noted

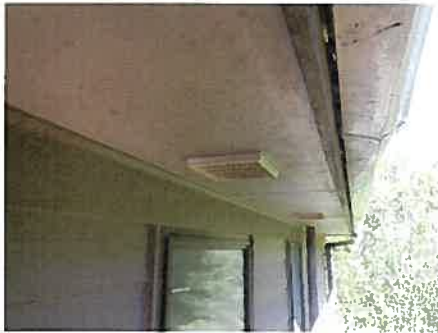
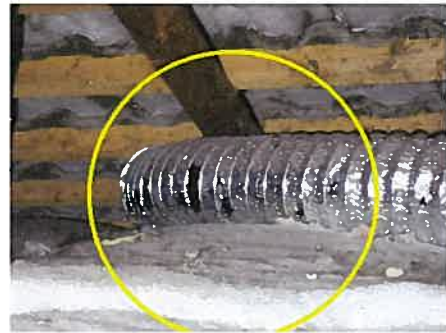
• Venting to the exterior of the home however the ducting has become damaged requiring repairs

Damaged ducting

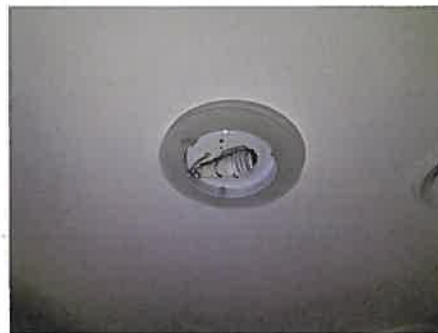
Missing light cover

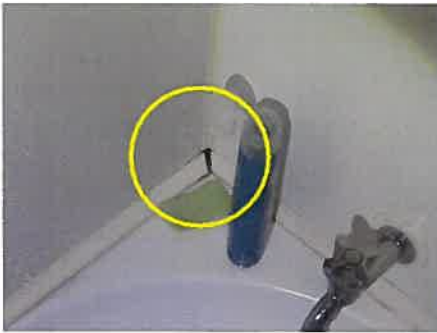
• Several readings were taken and some were within the higher range and indicate the room to be WET around the bath, this is due to the poorly sealed bath lining and has resulted in the floor beneath being effected by moisture, recommend ensuring the bath/shower lining is well sealed to prevent further issues

Poorly sealed

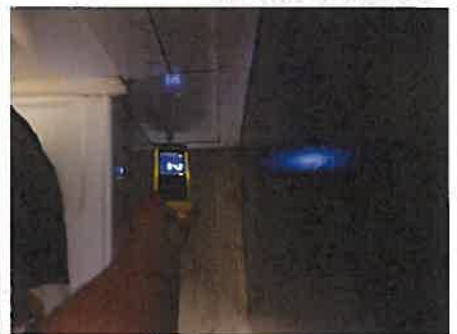
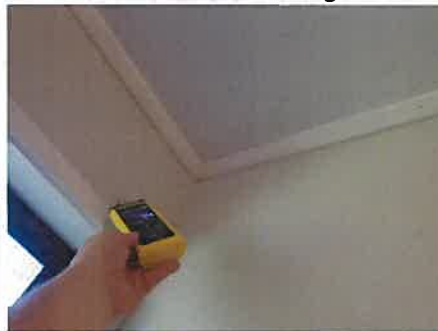
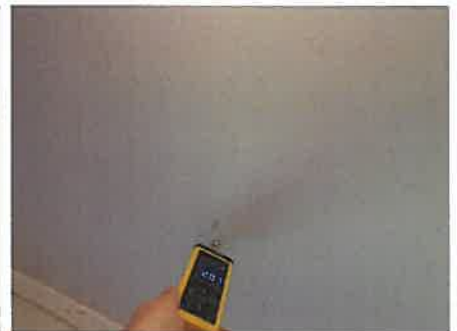
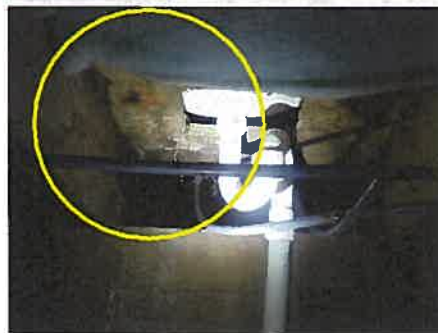
Elevated reading

Moisture effected floor
