Pre-purchase HOUSE inspections

RECOMMENDATIONS REPORT

Inspection 8991
Customer Carl Calitz c/o Tech Studio
Property Address 82 Warner Park Avenue, Laingholm
Date 12/12/2024

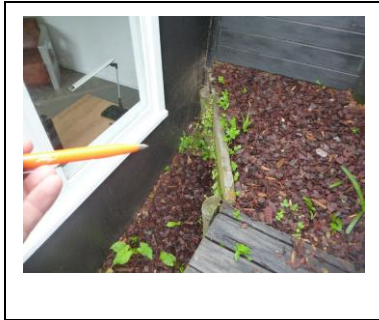
Note: Recommend keeping cladding clear of the ground level to prevent water soakage as seen on lower east wall of office. Refer to notes under "Walls".

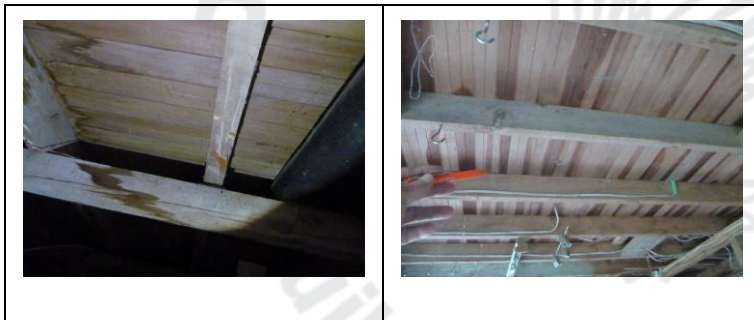
Access located on west side of house. Foundation walls are timber posts on concrete blocks and concrete blocks. Piles are timber posts on concrete blocks. Sub-floor bracing and fixings, damp proof courses, bearers and floor joists all appear to be in good condition other than notes below. Floor is T&G flooring with no insulation. Note:

- 1 Recommend insulation be installed.
- 2 We were unable to access all of basement area due to lowness to ground.
- 3 Refer to notes under "Floors" due to uneven flooring found and notes under "Windows".
- 4 Due to number of uneven surfaces in house recommend foundation specialist carries out inspection with recommendations. Further investigation required.

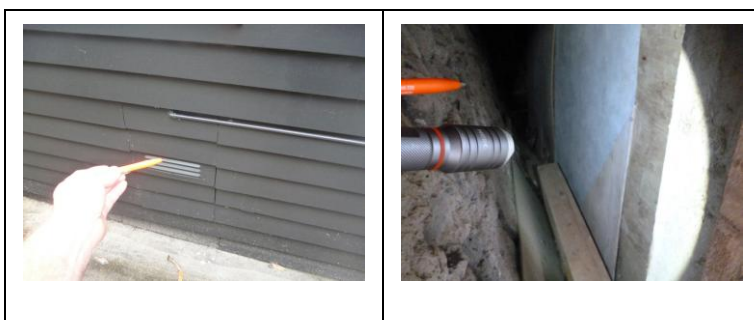
- 1 Recommend weatherboard soakers are installed to seal upper north cladding below kitchen window.
- 2 Patchwork cladding used to patch back of office wall on north side, against rock retaining wall.

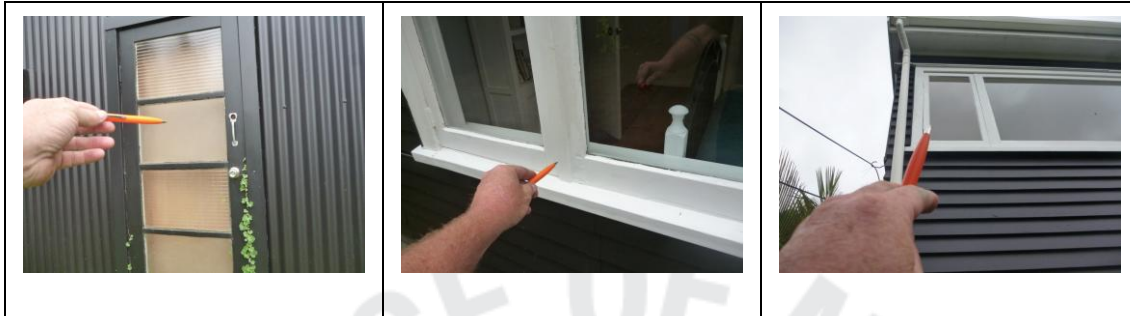
- 1 South side timber door to garage does not open.
- 2 Remedial builders bog work has been undertaken to several timber windows.

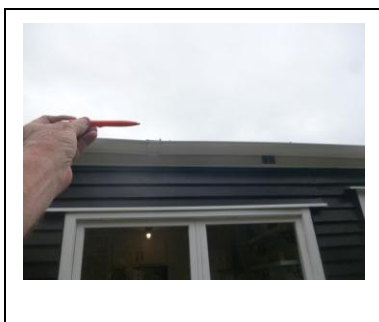
Note: Spouting parted from bracket on upper east side of house, lots of silicone used to seal handmade spouting and downpipes on upper south side of house.

PVC spouting all appears in good / fair condition. Recommend cleaning spouting on a regular basis and make any necessary repairs as required to extend the life of the product.

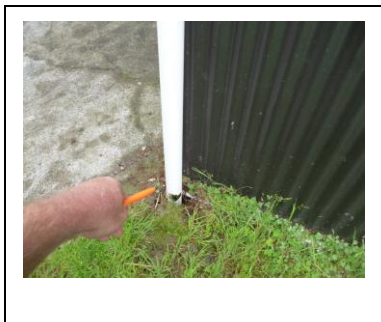
Note: Damage to downpipe on south-west corner of house due to impact.

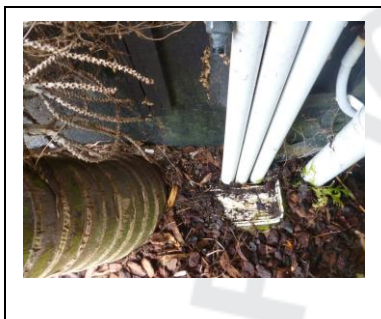
Note: Recommend clearing all bark away from grills of gully traps.

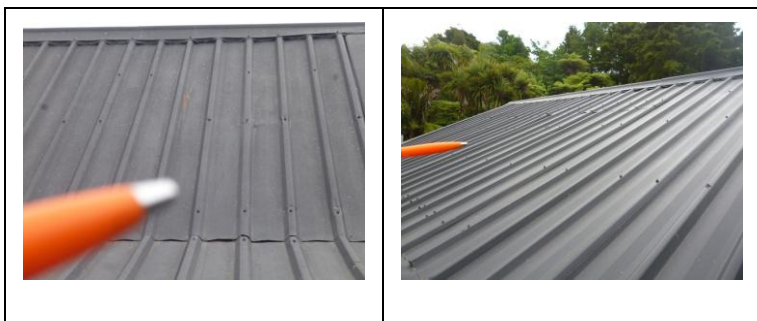
- 1 Recommend a professional roof company check and carry out all repairs to ensure watertight or replace as necessary due to minor rust sighted on north side of roof and sheet laps.
- 2 Refer to notes under "Inside Ceiling Space".

Recommend yearly checks to clean and carry out any necessary maintenance which may be required to ensure watertight. We inspected roof area from spouting line only. Note:

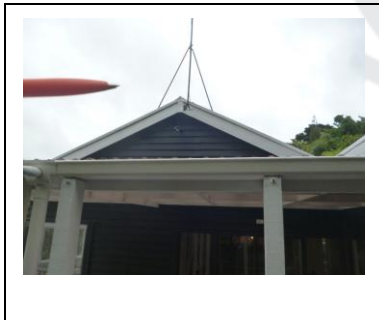
Note: Broken bulb on top east side of gable.

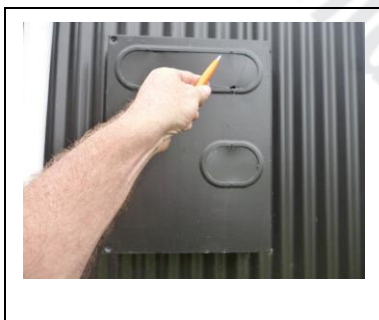
Note: Viewing screen broken.

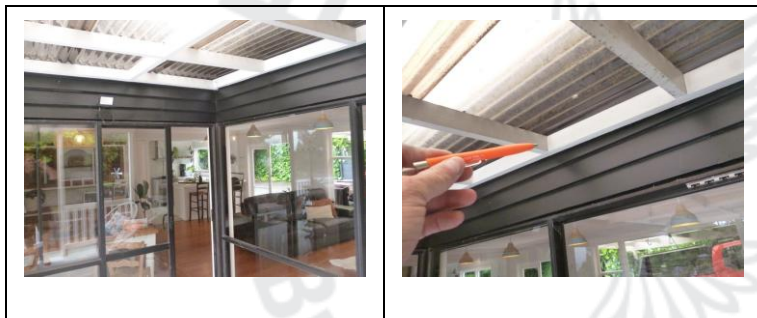
Attached wooden structures located on north and south sides of dwelling. Appropriate and incorrect mechanical fixings with clear light roof. Appears in fair condition at time of inspection. Note:

1 Stringer of pergola, direct fixed to dwelling requires 12 mm watertight spacers at connection points to ensure watertight.

2 No side flashings used on south pergola or cladding flashing used on north pergola.

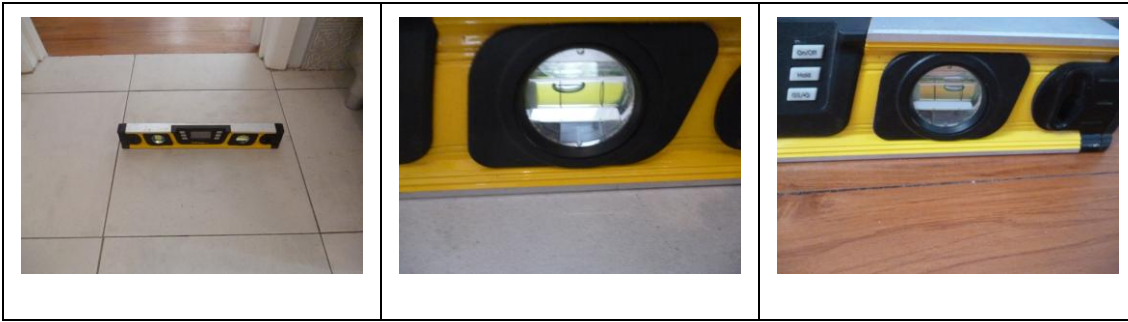
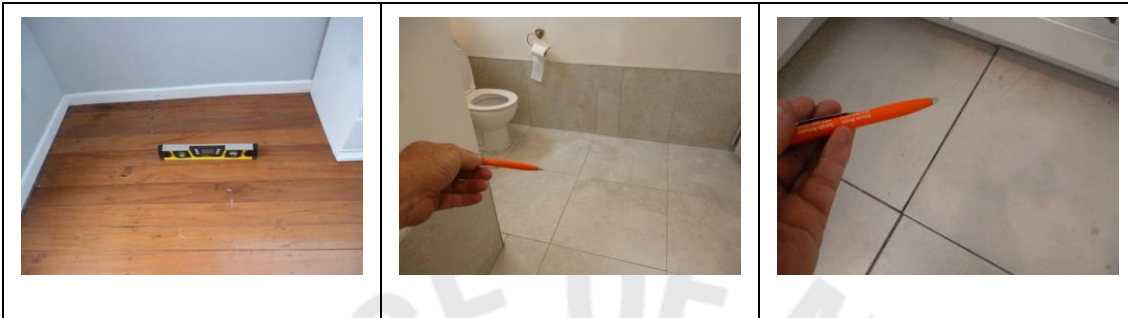
1 Areas throughout house where flooring and floor coverings are out of level due to substrate movement. Refer to notes under "Basement".

2 Cracked tile in kitchen.

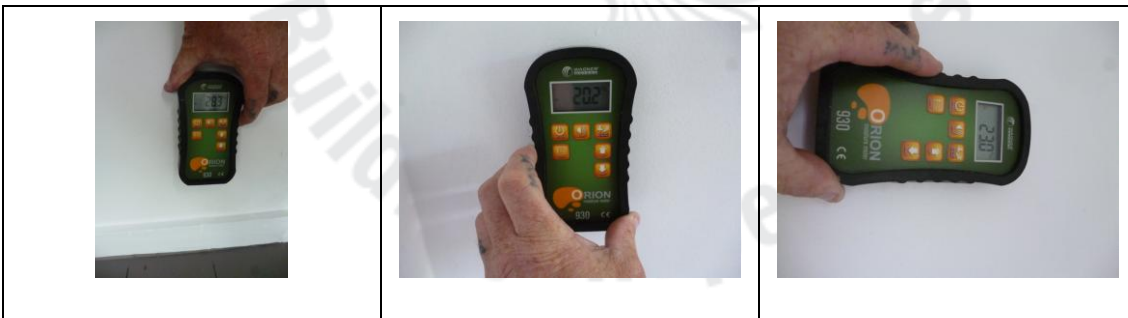
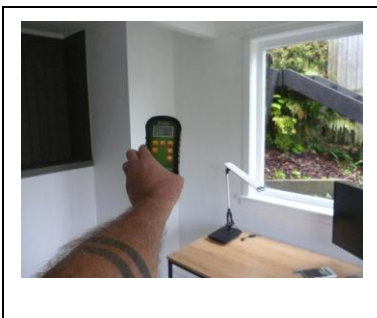
- 1 Lived-in damage and marks and different paint levels throughout house.
- 2 High and elevated moisture readings recorded in north-east corner of office due to contact with ground and retaining walls in this area. Further investigation required.

28.3 high

20.2 elevated

23.0 elevated

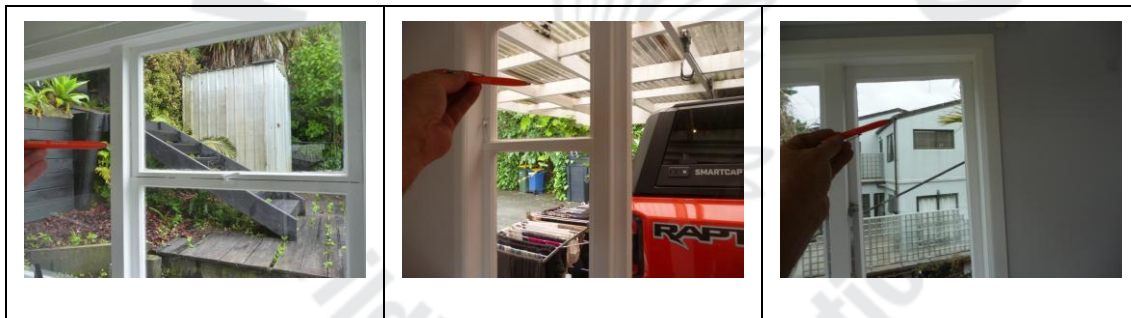
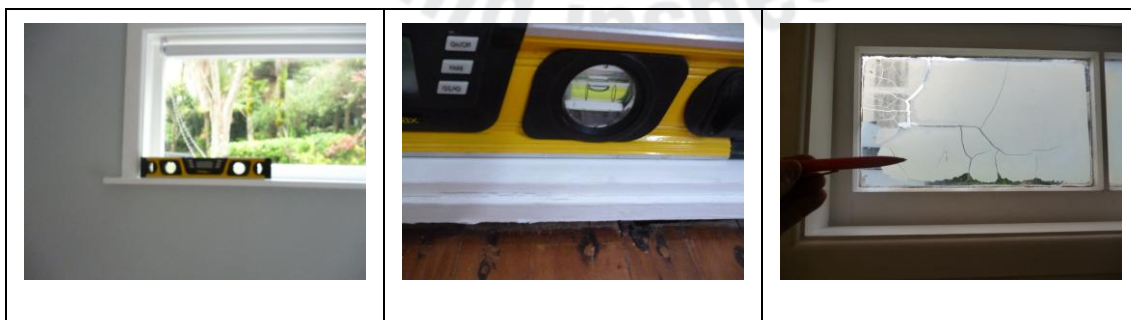
- 1 Office window and lounge north side window painted shut.
- 2 Recommend maintenance to all windows so open and function 100%.
- 3 Windows and doors in areas are out of level. Refer to notes under "Basement" and "Floors".
- 4 Film on bathroom west window cracking due to shrinkage.

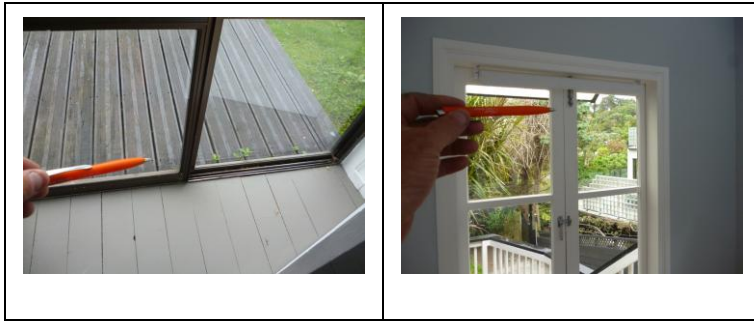
- 1 Office ranch slider requires roller maintenance required to slide correctly.
- 2 Recommend maintenance to all exterior doors so function 100%.

Front door is painted timber. Doors to the exterior are aluminium and timber with glass panels. Interior doors are painted with good hardware and found in good / fair condition at the time of inspection. Recommend due to number of doors requiring maintenance a LPB builder carry out all necessary repairs.

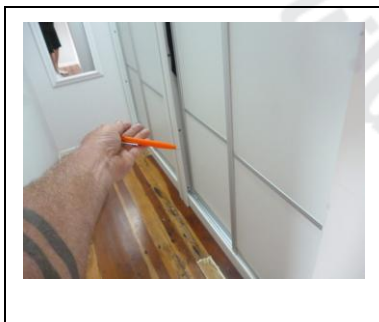
- 1 No doors to bedroom two wardrobe.
- 2 Master bedroom wardrobe doors R/H/S do not slide freely.

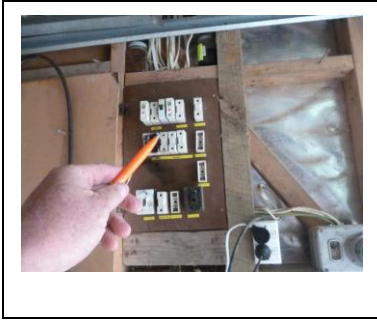
Located in garage. Circuit breakers and old-style fuses.

Note: Recommend upgrading old style fuses to circuit breakers.

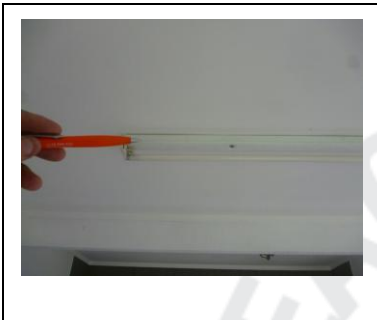
Fittings all appear to be in good condition. No damaged switches. Light bulbs all working at the time of inspection other than office missing fluorescence tube.

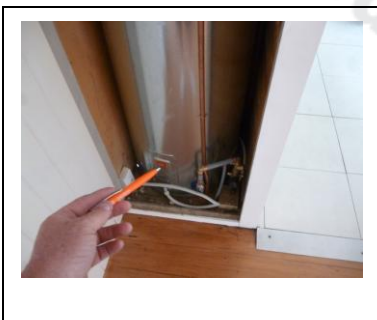
Located in hall cupboard; Rheem 180 lt. Date 2024. Mains pressure system. Appears to be in good condition at time of inspection.

Note: Regulations state all HWC installed after 1996 have Seismic Restraints (two when 180 lt. (100mm from top and bottom of cylinder).

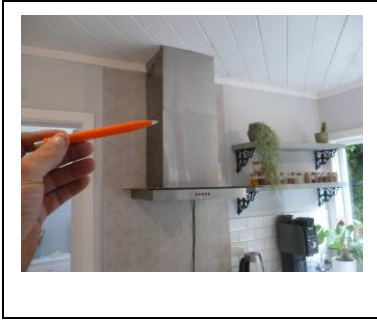
- 1 Refer to notes under "Floors".
- 2 Extractor hood out of level and not vented outside correctly.

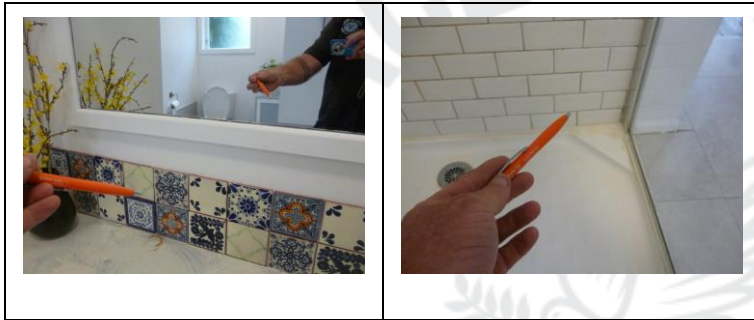
- 1 Recommend installing an exhaust fan or shower dome.
- 2 Vanity bottom drawer not closing fully.
- 3 No grout to vanity tiles.
- 4 Heavy silicone used to bottom of shower tray.

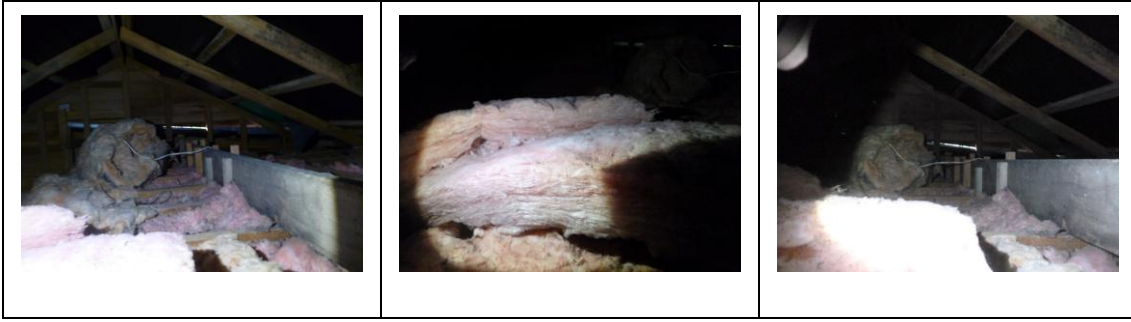
- 1 Batts in piles in areas of roof space.
- 2 Daylight seen in ceiling space on west side gable, cladding to flashing intersection. Possibly missing flashing. Further investigation required.

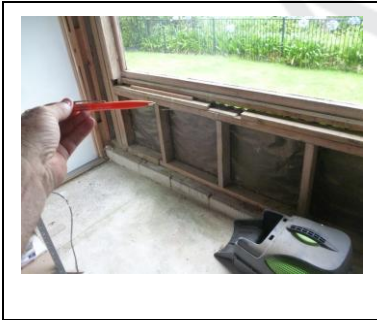
Note: Garage area not fully lined or framed.

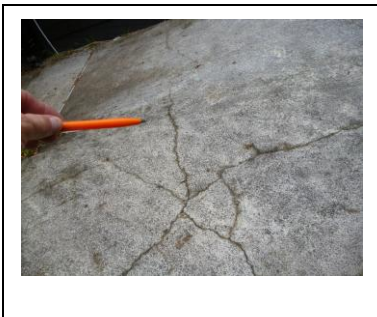
Note: Cracking noticed in driveway due to minor substrate movement.

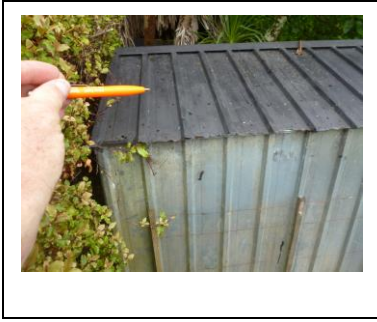
Note: rust to areas of shed.

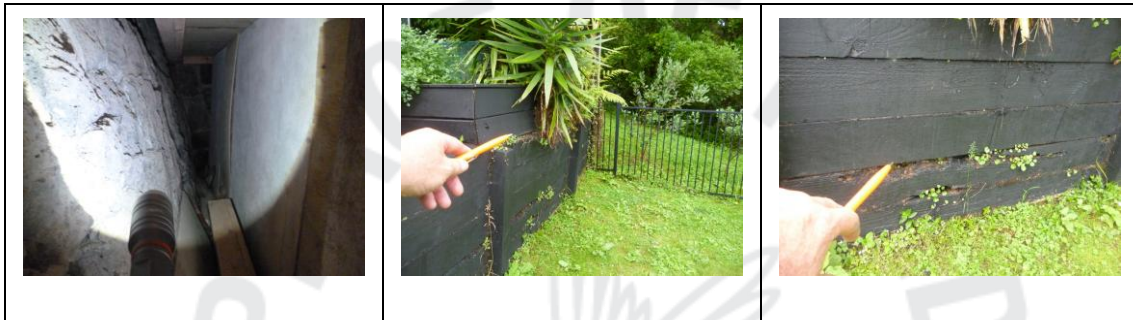
- 1 Unable to view all areas of retaining walls due to location and construction in front of areas.
- 2 Lower south side timber retaining wall out of level and rot to areas of retaining boards.
