## **GEOTECHNICAL PRE-SALE APPRAISAL**

**321A HUIA ROAD  
TITIRANGI**

**Reference:** GM140

**Prepared:** 25<sup>th</sup> February 2020

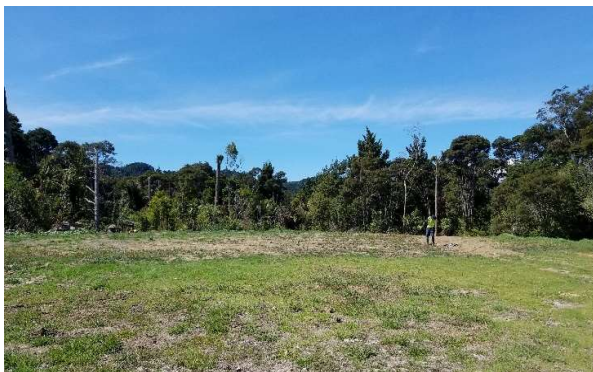
**Photograph 1:**

- A non-engineered fill area is located within the middle of the eastern half of the site forming a levelled platform area. The non-engineered fill is not suitable to support building loads. The site slopes steeply away from the north eastern side of the fill platform. During our walk over inspection we observed no obvious indications of current instability at this part of the site, however, the sloping and/or filled ground should be subject to more detailed specific site investigation and design. In ground retention and/or piled foundations are likely to be required.

Looking northeast toward the existing non-engineered fill platform area.

Any residential development of the property, particularly within the filled platform area or sloping land, must be preceded by further detailed geotechnical site investigation, stability analysis and reporting. This work would assess the specific nature of the site sub soils at depth, determine current site stability conditions and provide design parameters and recommendations for slope stability improvement, dwelling foundations, retaining walls and the satisfactory development of the property in relation to a specific development proposal.

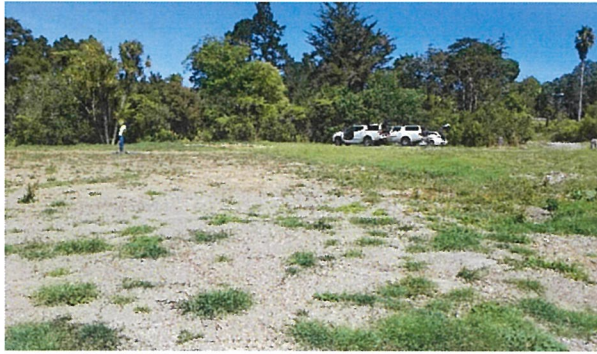
**Photograph 2:**

Looking south toward the gravel driveway and the non-engineered fill platform area from the northwest side of the platform.

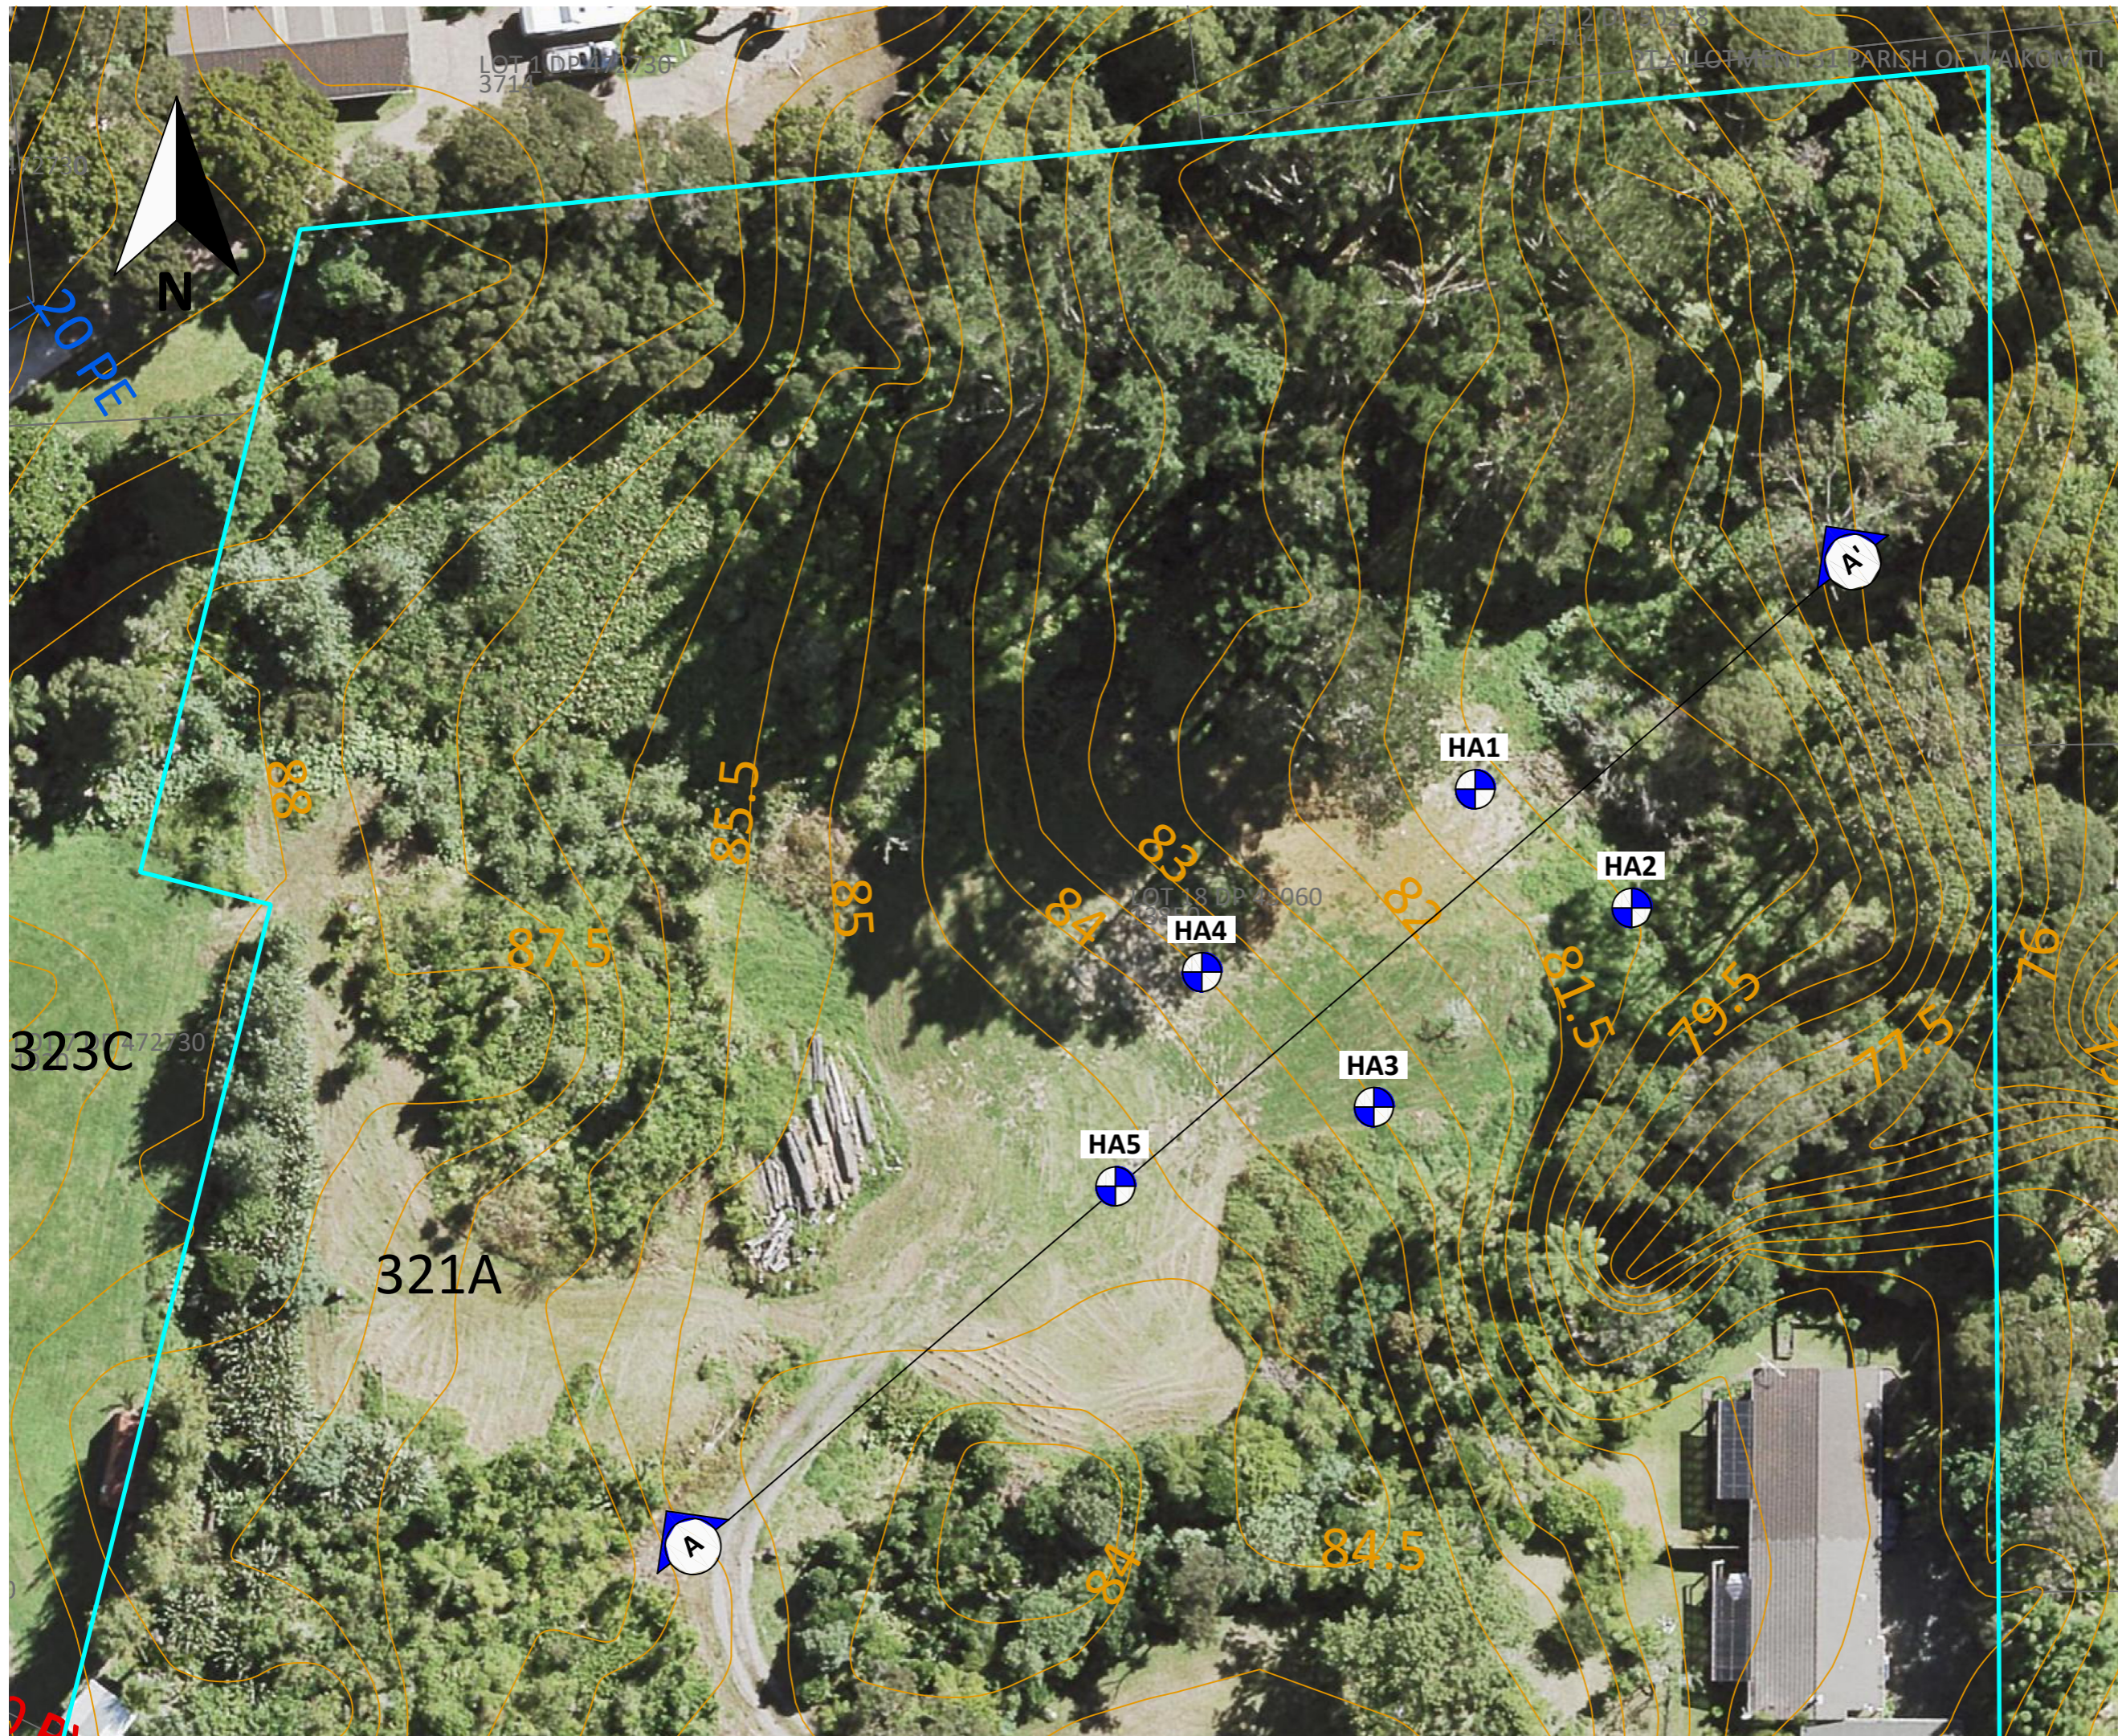
**TITLE:** SITE PLAN

The approximate locations of the boreholes are shown on our attached site plan drawing number GM140/1. The borehole logs are also attached. The soil descriptions given on the logs are in general accordance with the New Zealand Geotechnical Society's "Field Description of Soil and Rock." The undrained shear strength values given on the logs are 'Shear Vane Strengths', factored in accordance with the New Zealand Geotechnical Society Guidelines, not direct readings from the shear vane dial. The groundwater levels were measured following drilling and are indicated on the borehole logs.

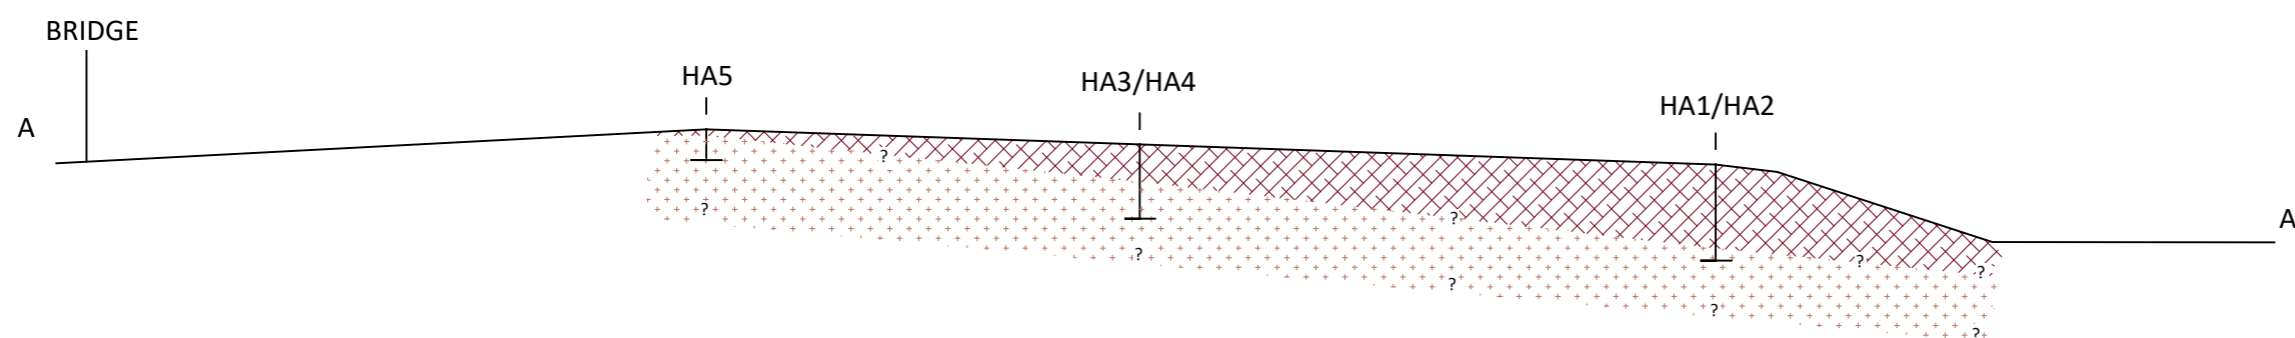
TITLE:  
CROSS SECTION A-A'

The cross section is also attached as drawing number GM140/2 it is preliminary and issued for information only and should not be used for design or construction purposes.
