## Oncore Healthy Homes Assessment - 2023

23 Jan 2023 / Ironbridge Property Management

1 Titchener Street, New Lynn, Auckland.

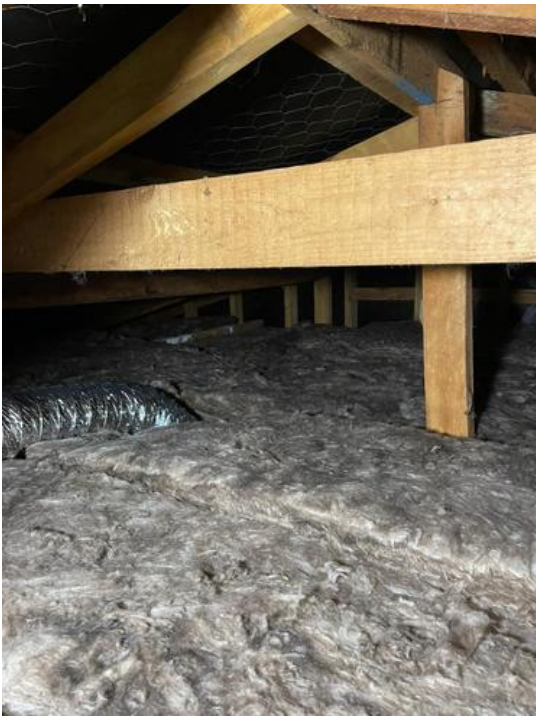
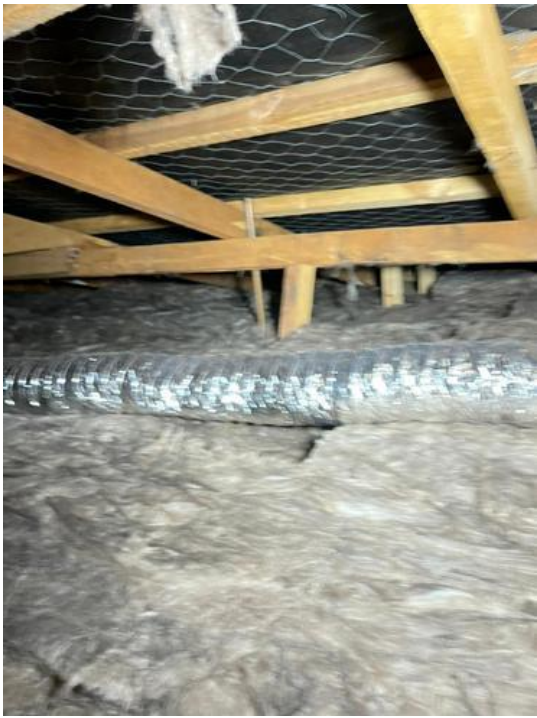
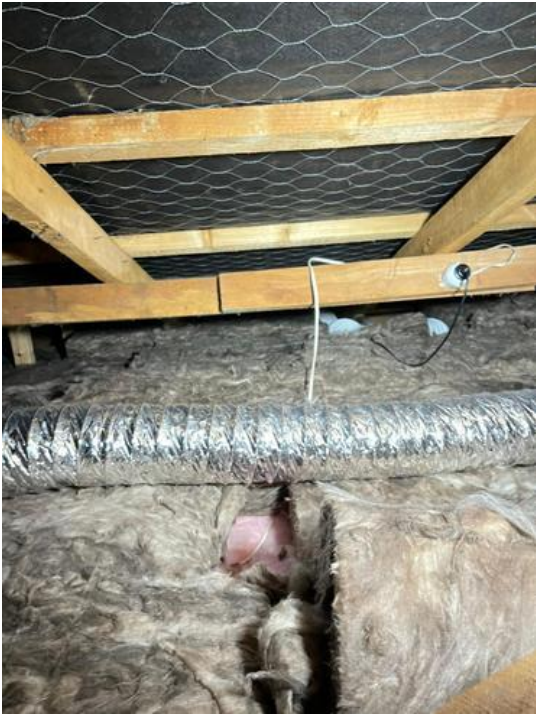
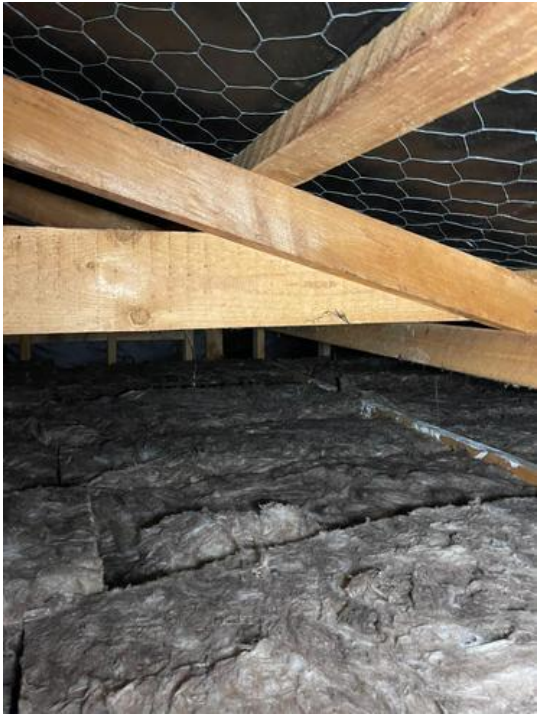
R-value/Thickness in mm:

R 2.6

Glasswool fibre

Yes

The ceiling insulation is at least 120mm thick and/or does have an R-value of at least 2.9 (climate zone 1&2) or 3.3 (climate zone 3) and it is also in reasonable condition. See attached photo(s).

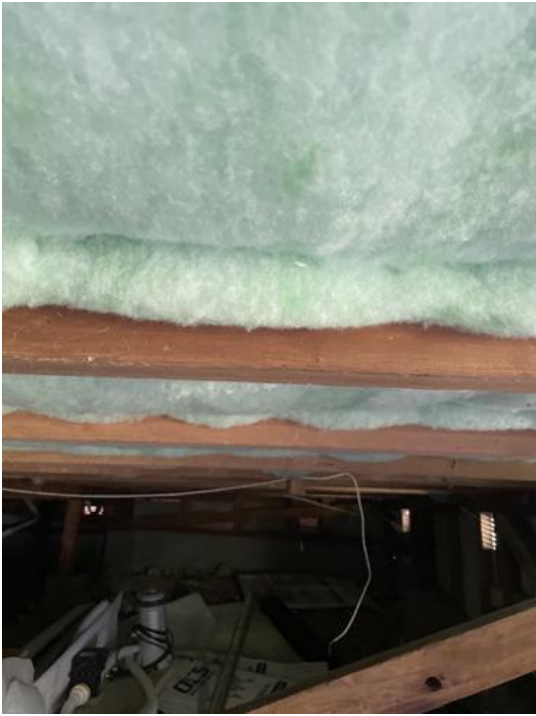
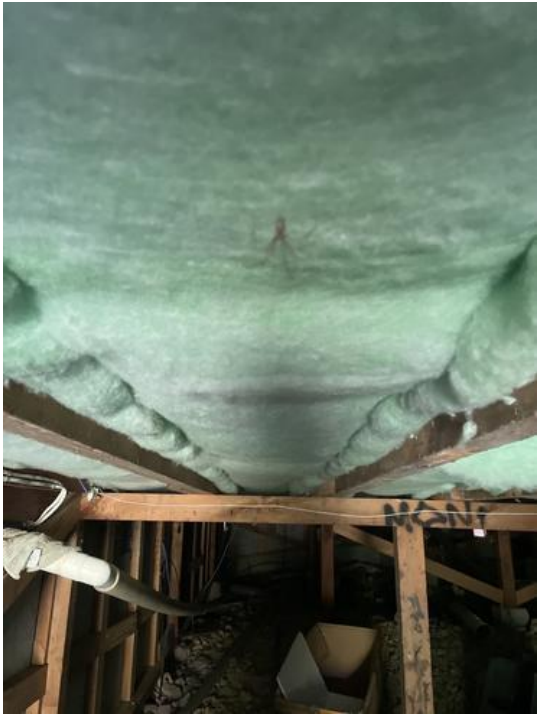
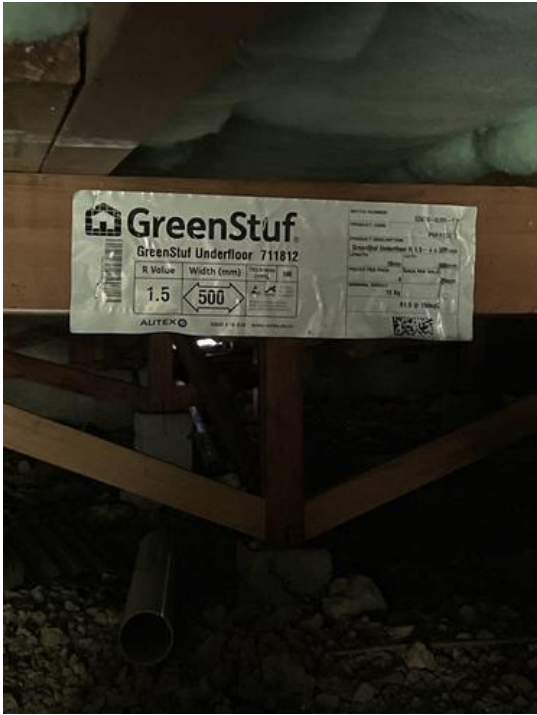
R1.5

Greenstuf Earthwool

Yes

The underfloor insulation has an R-Value of 1.3 or more and is in reasonable condition. See attached photo(s).

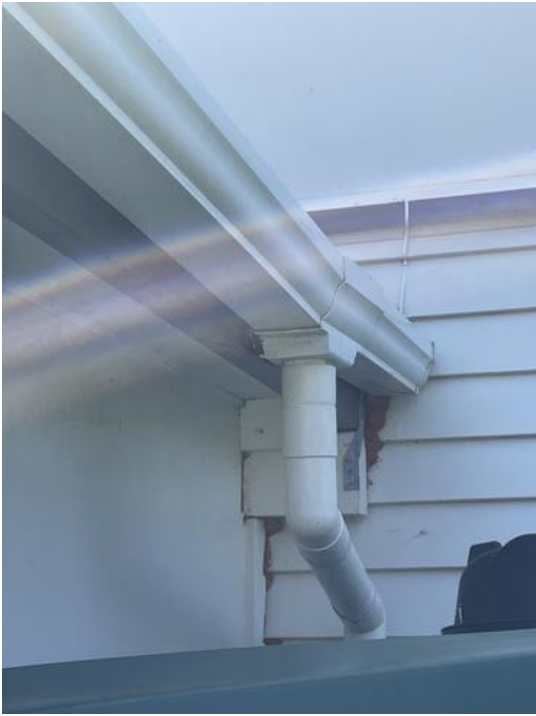
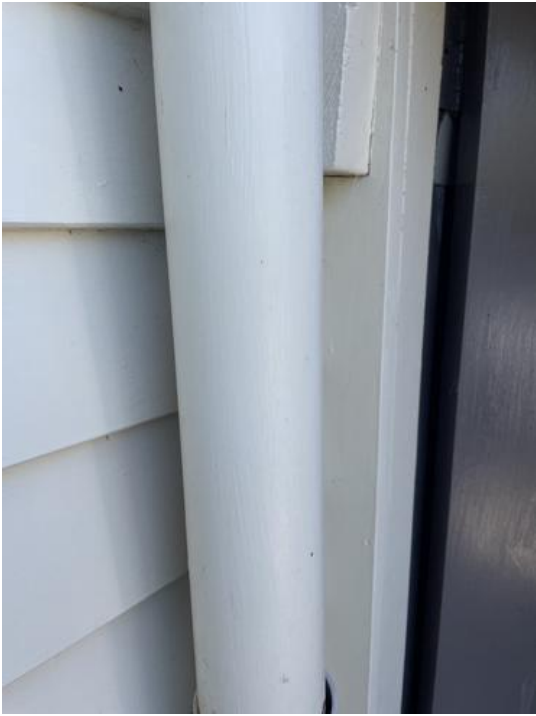
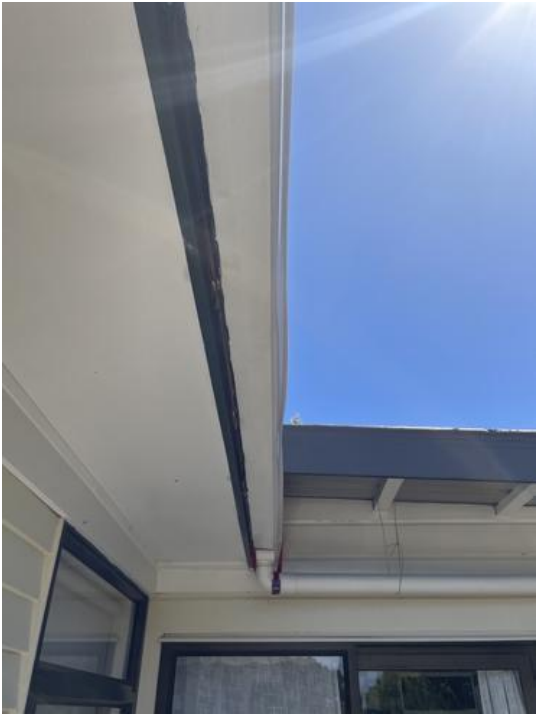
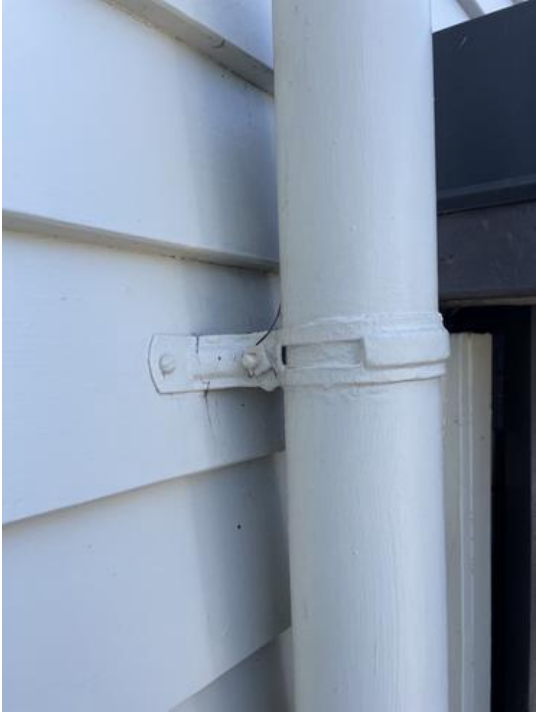
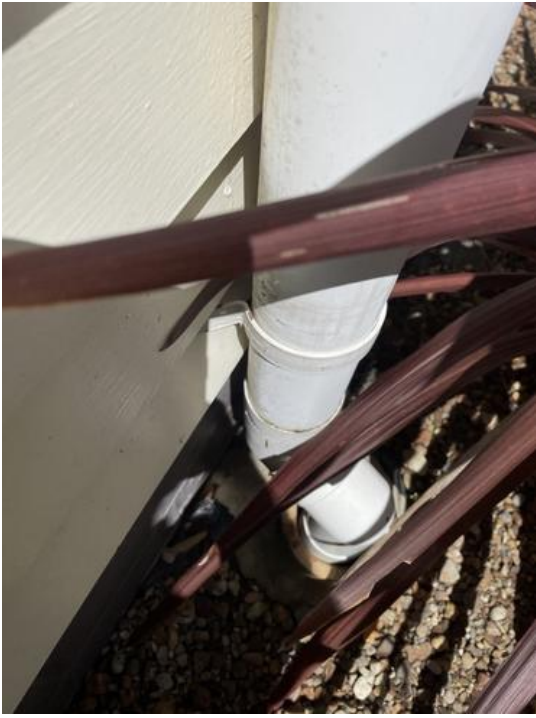
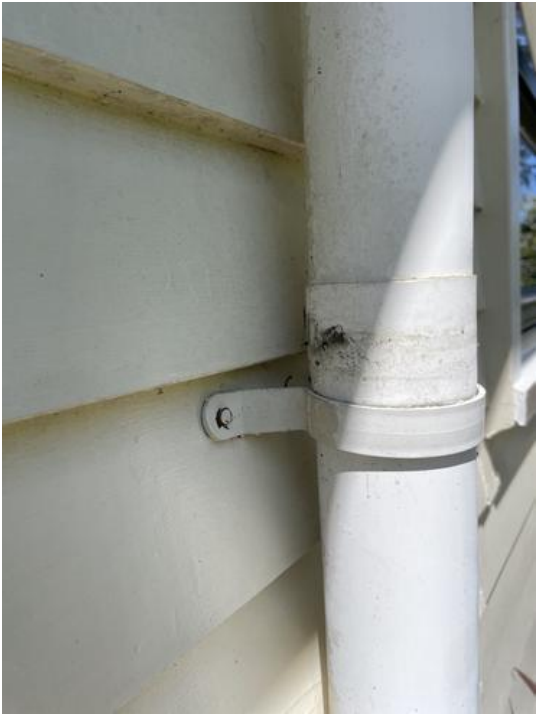
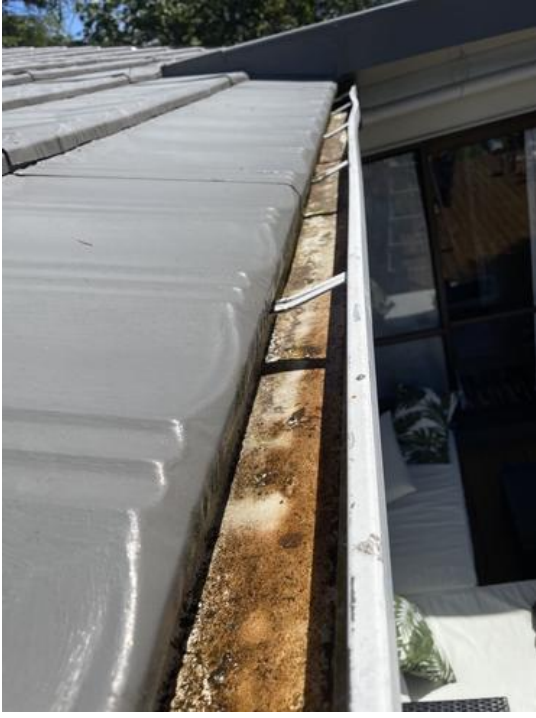
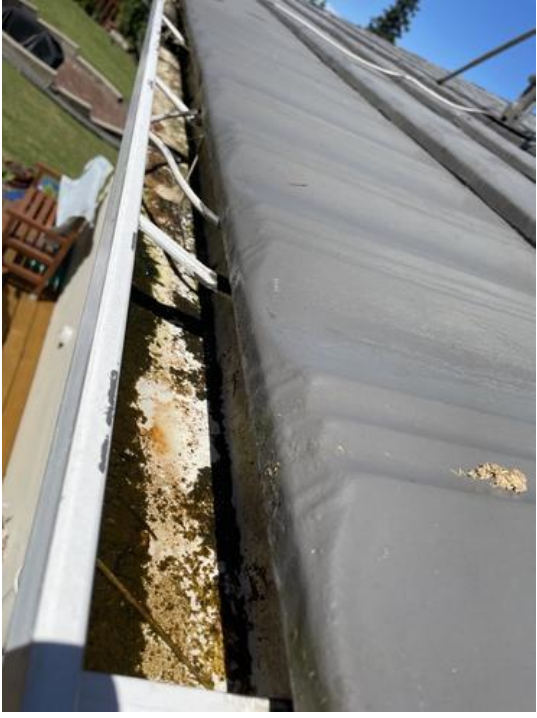
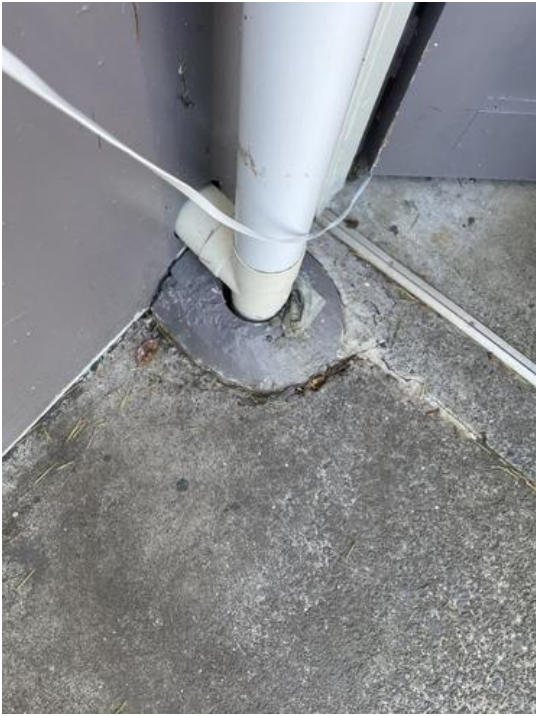
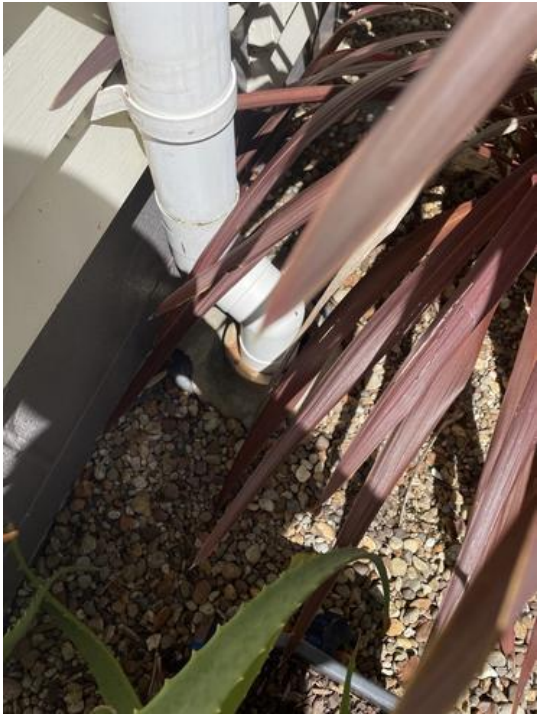
All gutters, down pipes and drains are sufficient for the removal of all storm, surface and ground water. They are all in good working order. See attached photos(s).

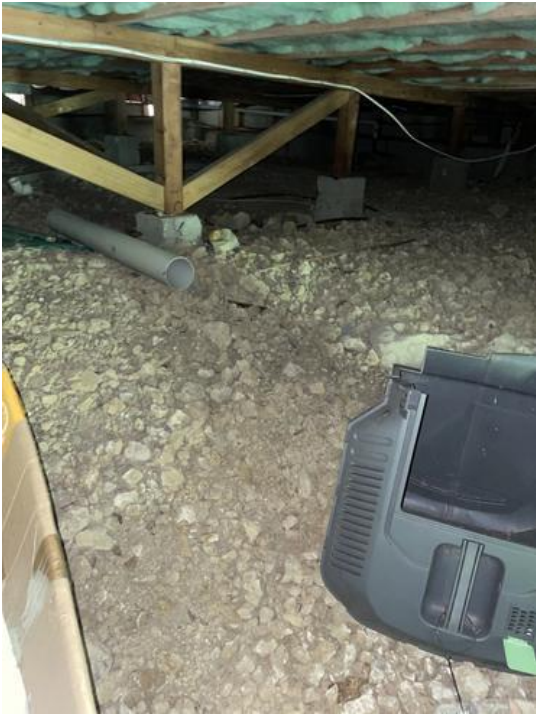
Photo 31

There is an existing polythene ground moisture barrier that is free from significant damage (rips/holes/tears). See attached photo(s).

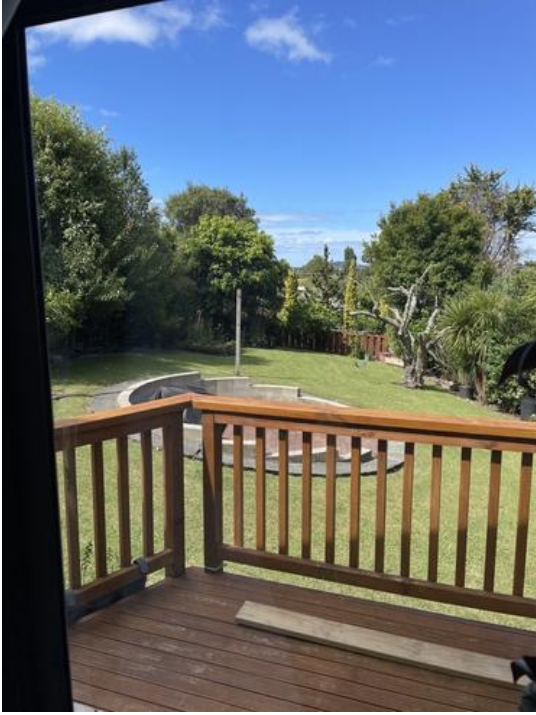
Photo 62

Is the room free of any unreasonable gaps or holes in walls, ceilings, windows, floors and doors that are not necessary and which cause noticeable draughts?

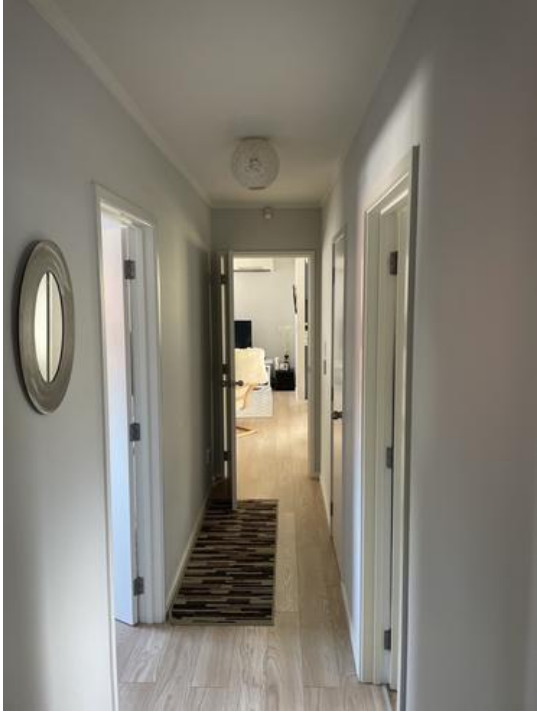
Photo 65

Is the area free of any unreasonable gaps or holes in walls, ceilings, windows, floors and doors that are not necessary and which cause noticeable draughts?

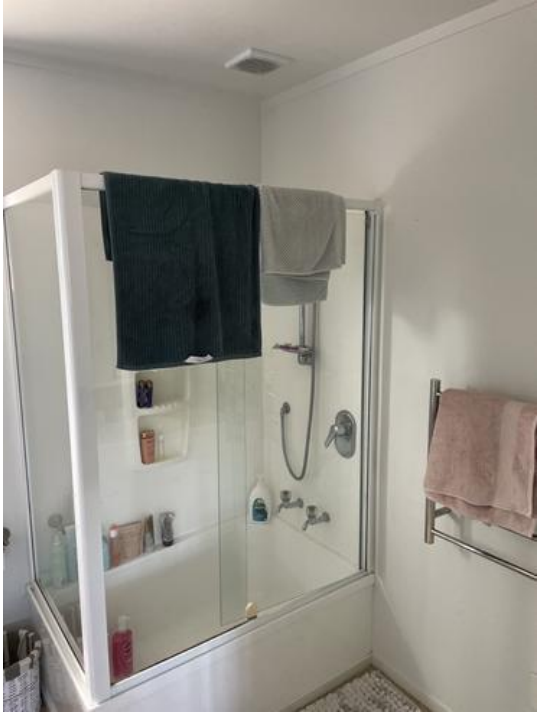
Photo 67

Is the room free of any unreasonable gaps or holes in walls, ceilings, windows, floors and doors that are not necessary and which cause noticeable draughts?

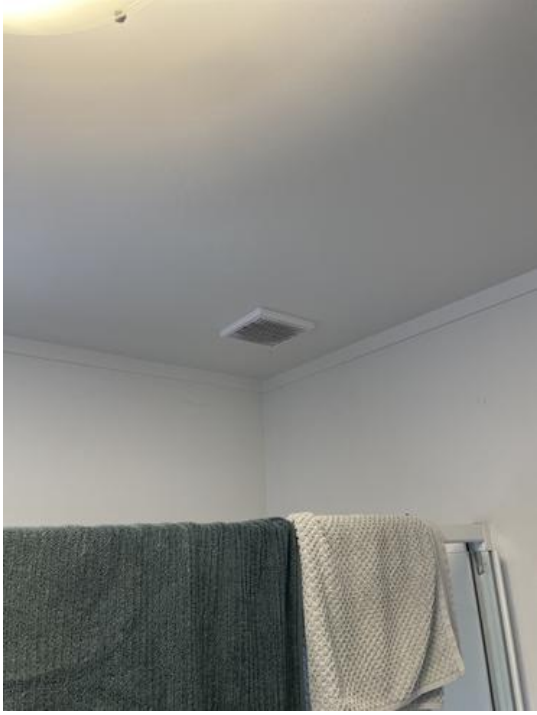
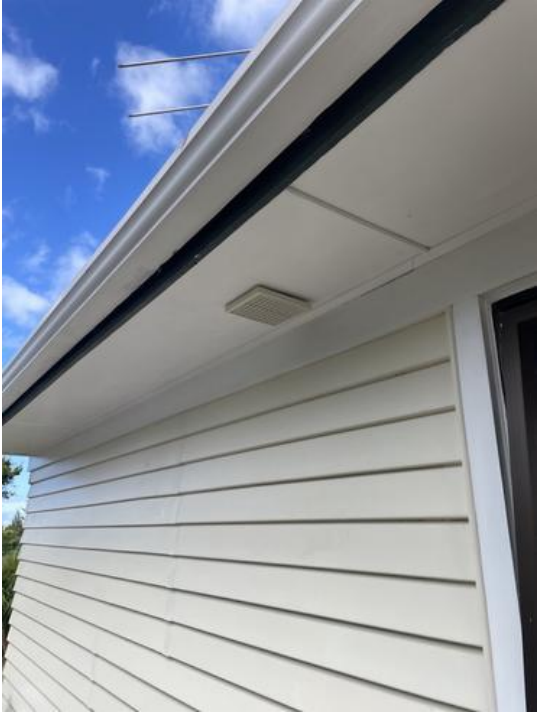
120mm diameter ducting

Yes

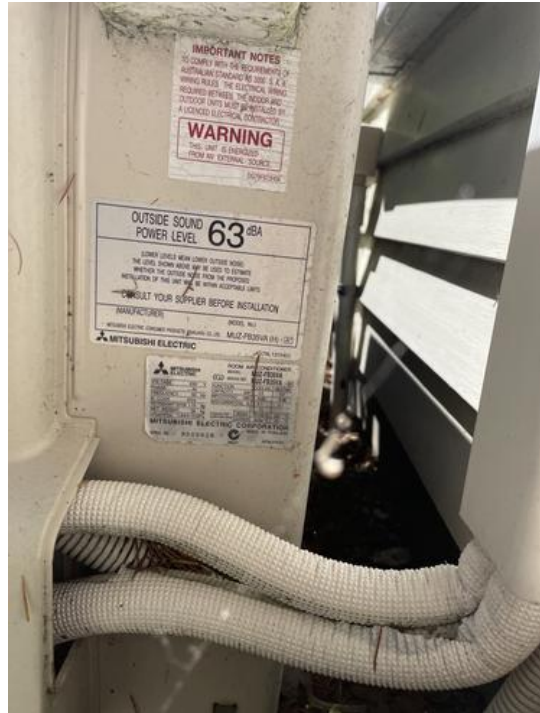
Photo 96

7.7kW

6.2kW

The main living room has an approved heating device (installed before 1 July 2019) with a heating capacity that is at least 80 per cent of the kW rating now needed. (See attached photo(s).

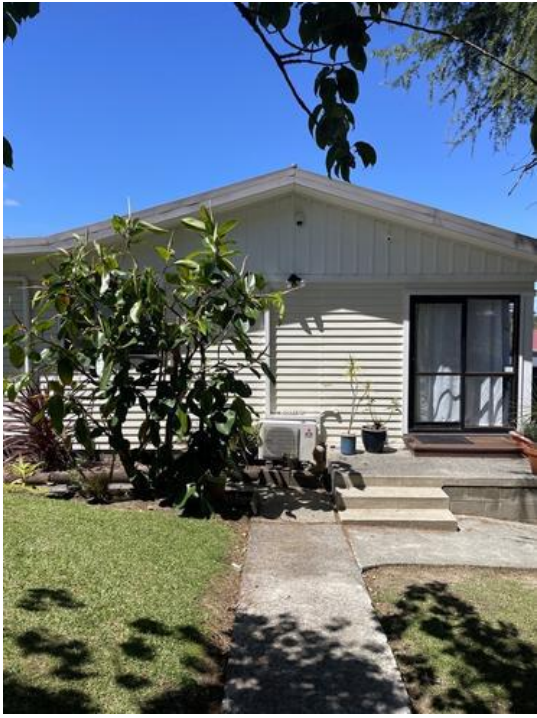
Photo 97

Is the external cladding free from damage?

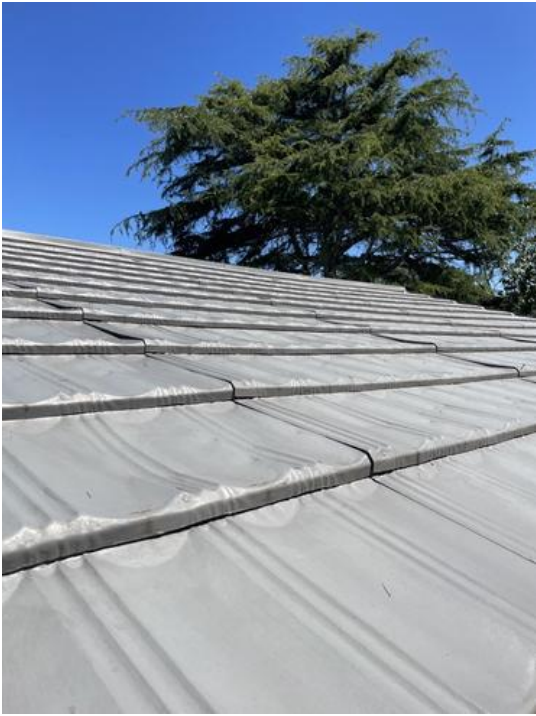
Photo 100

Is the roof cladding free from damage?

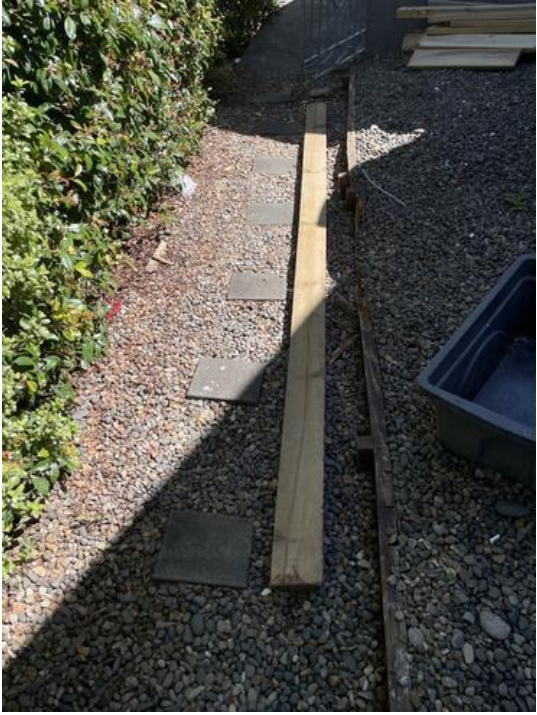
Photo 103

Are all external paths and driveway surfaces free of slippery conditions and moss free?

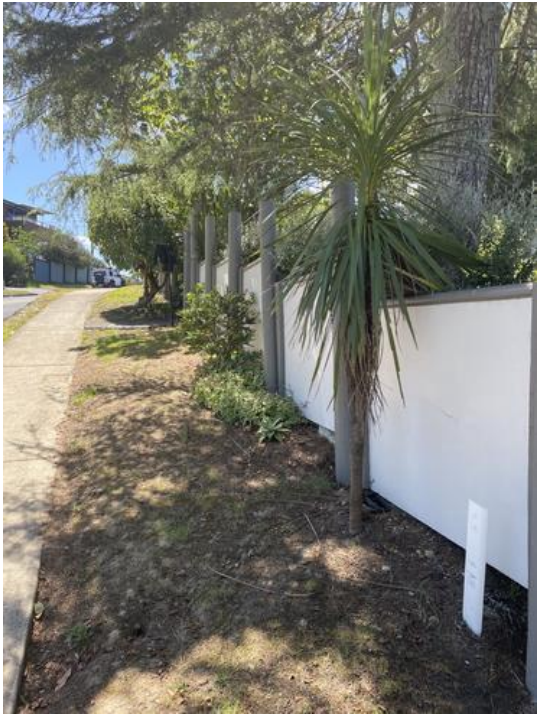
Photo 113

Is the fence in good condition?

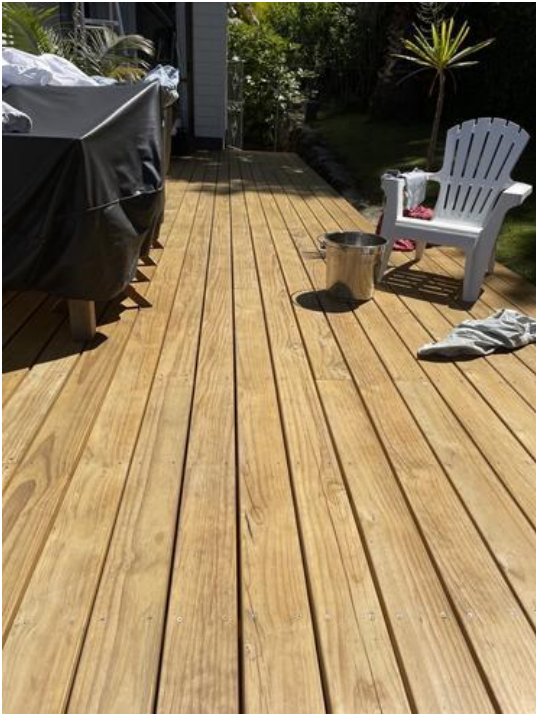
Photo 116

**Is the decking in good condition?**

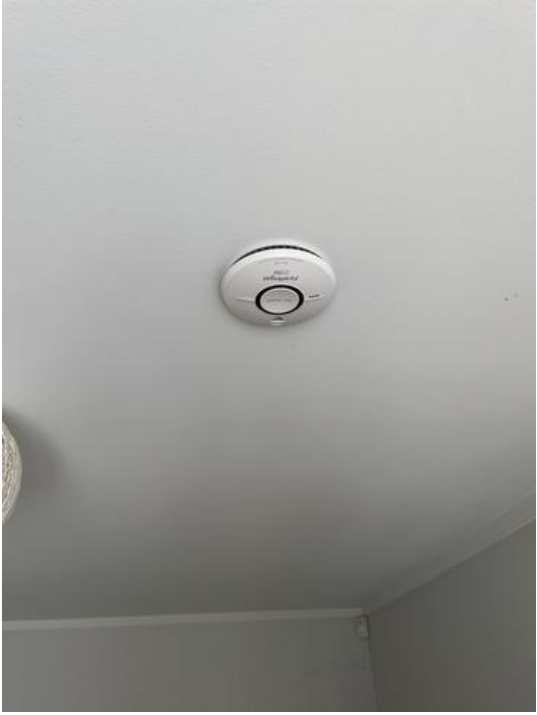
Photo 119

**Other general repair & maintenance notes/issues:**
