Moisture Inspection

115 Laingholm Drive, Laingholm,
Auckland, New Zealand

Moisture inspections undertaken on the 1st and 4th of September

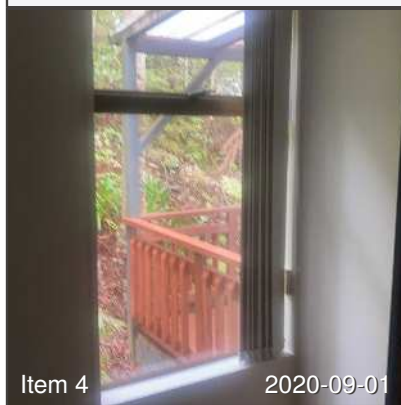
Item

This has been replaced and is new dry plasterboard

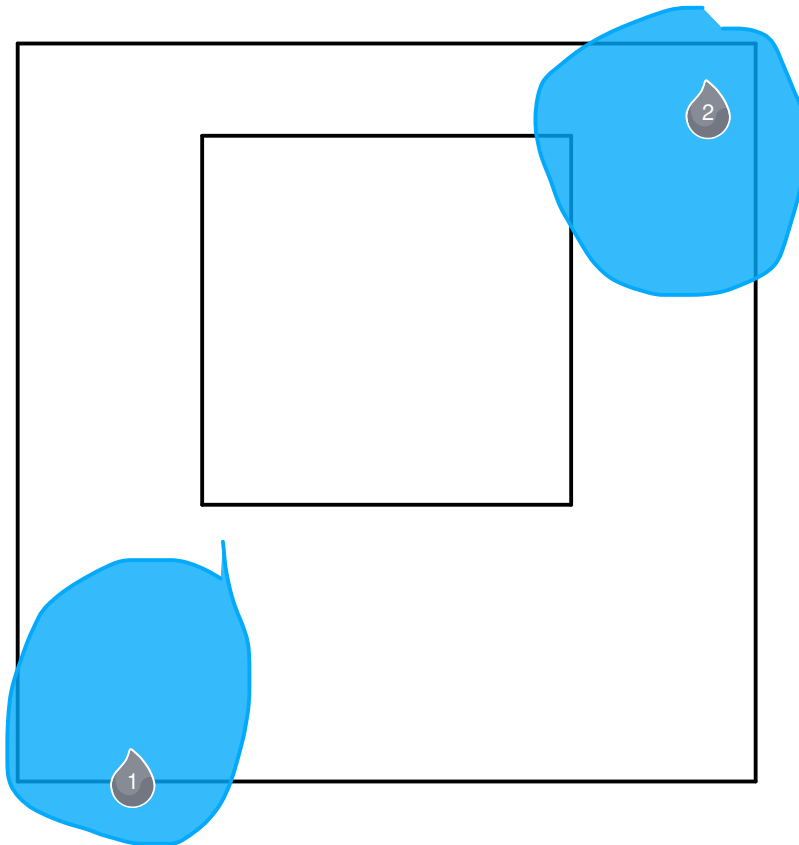
Affected Atmosphere: Bedroom 1

1: Wood Sill Plate
Delmhorst Wood 60%
 Dry Standard: 18%

Dry

#	Time	Meter	Moisture Content	Surface Temperature	Notes & Photos
1	Sep 1, 3:18 PM	Delmhorst Wood 60%	19.8%

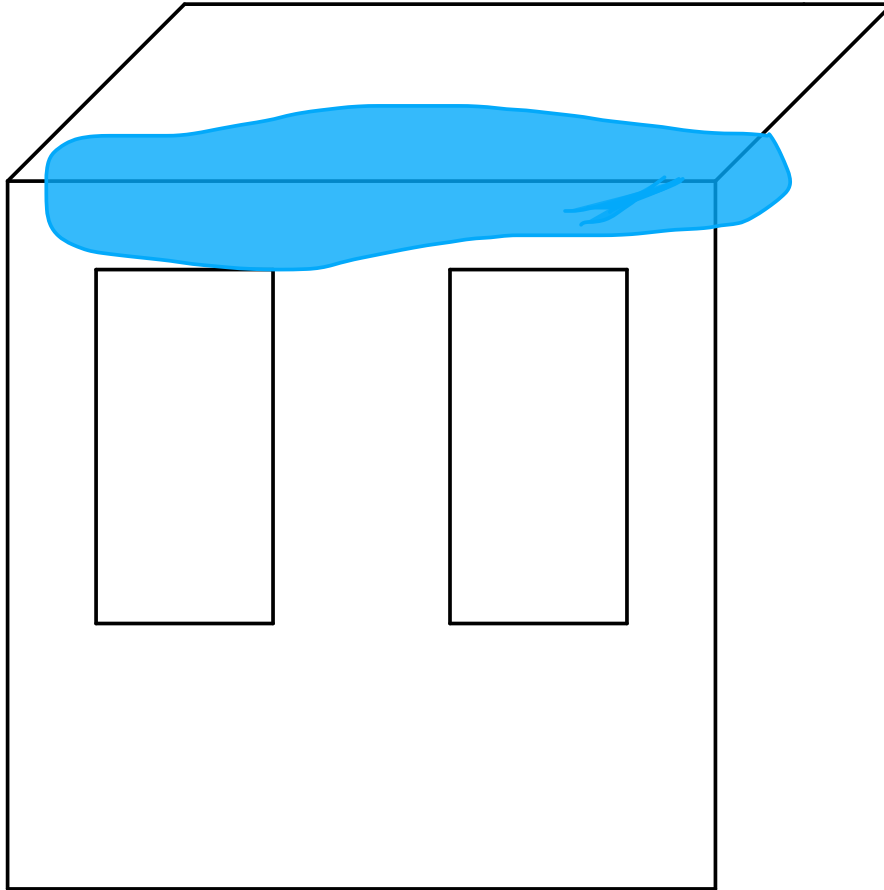
Affected Atmosphere: Bedroom 2

The average dry standard in this house is approximately 100 out of 300 in scan mode. Client confirmed the gib lining has been replaced and re-painted. Unable to scan due to wet paint.

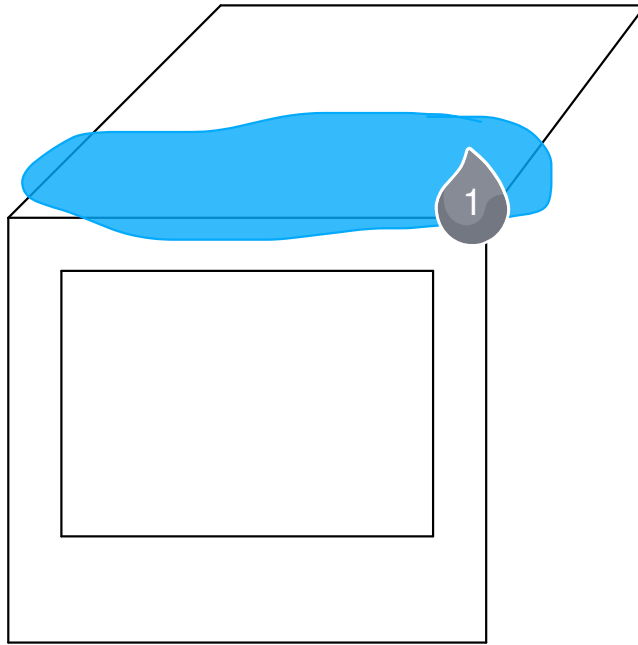
Affected Atmosphere: Bedroom 3

The average dry standard in this house is approximately 100 out of 300 in scan mode. The reading of 112 (recorded) was the highest reading observed when scanning numerous areas. Average 90. We will class this area as dry.

#	Time	Meter	Moisture Content	Surface Temperature	Notes & Photos
2	Sep 4, 1:19 PM	Delmhorst Scan 300	112		<p>Highest reading recorded. Average approx 90. This area is deemed dry</p>
