# Home Inspection Report

1/2b Matipo Road, Te Atatu Peninsula, Auckland

Inspection prepared for: Philippa Wintle  
Date of Inspection: 11/8/2021 Time: 12:00 PM  
Age of Home: 1980's Size: 90m<sup>2</sup>  
Weather: Fine

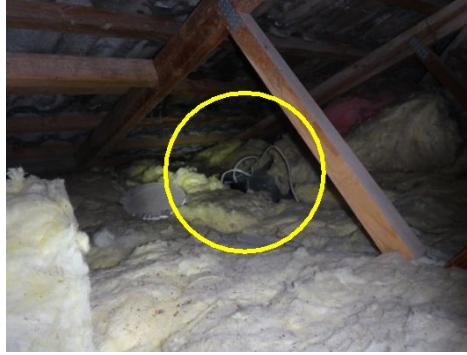
### 10. Ventilation Point of Discharge

M D NI  
X • Appears to be venting into roof space, this should be routed to the exterior of the home to prevent dampness in the roof space

Dose not appear to be ducted
