Home Inspection Report

16 Panzic Place, Glen Eden, Auckland

Inspection prepared for: Boaz Shulruf
Date of Inspection: 19/6/2023 Time: 11:30 AM
Age of Home: 1980s Size: 88m2
Weather: Fine

Inspector: Duane Turner
Phone: 027 376 4806 / 09 8118 017
Email: duane.turner@abuyerschoice.com

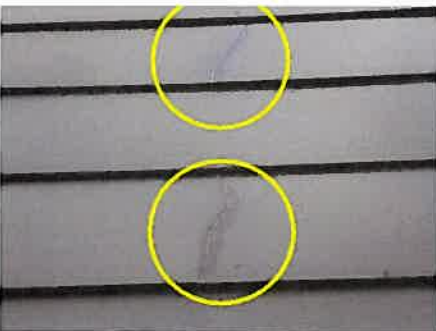
• Areas of cracking and damage present, repairs recommended

Cracked fiber cement

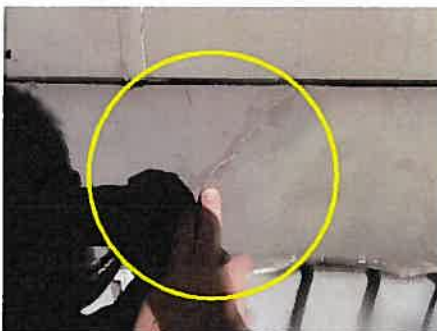
Cracked fiber cement
