Guardian Housing Services Ltd

Job Ref: 4126

5th March 2020

RE: SAFE AND SANITARY REPORT ON THE PLUMBING SYSTEM WITHIN THE LOWER LEVEL BATHROOM AT 122 WOODLANDS PARK ROAD.

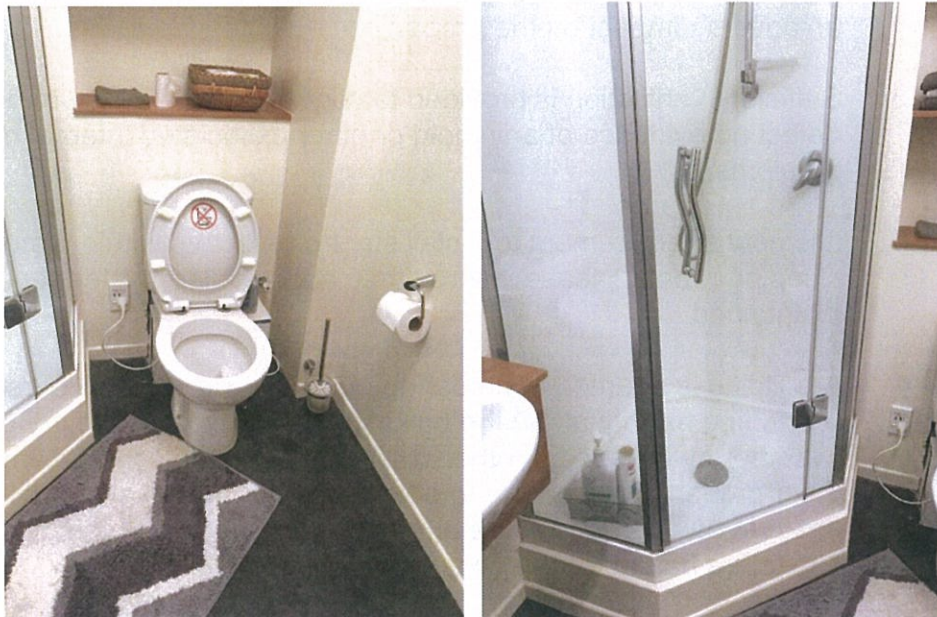
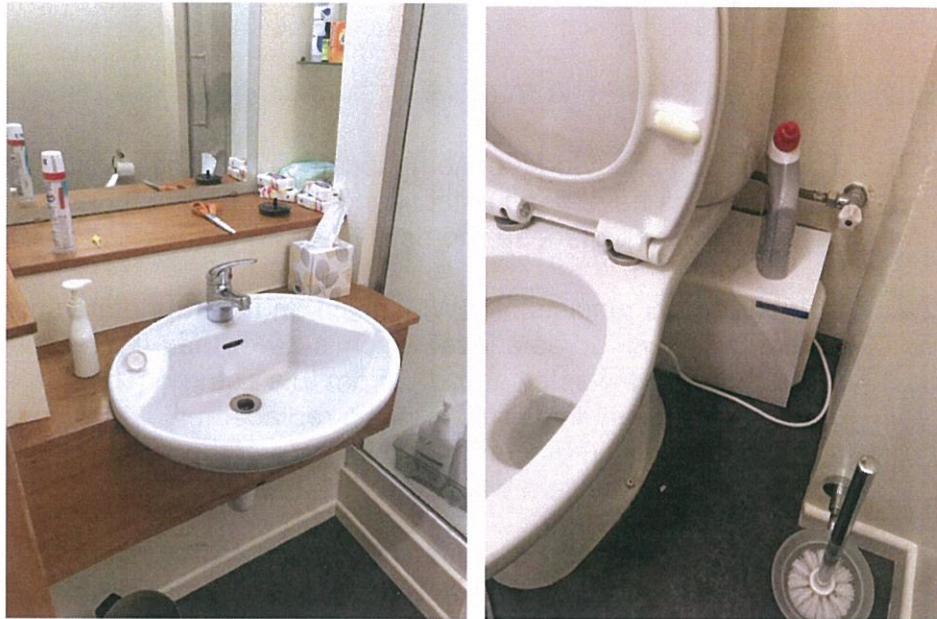
- 3.2 The bathroom consists of a WC, basin and a proprietary shower. The bathroom is located as a level which is lower than the sewer line. In order to discharge the wastewater etc. from this bathroom a "Sani Split" pump unit has been installed. This unit is a replacement as the former pump system had to be replaced due to the age of the system. The pump is active by a float system within the tank of the unit.

- 3.3 At the time of this visual only assessment we ran water from the shower and the basin and flushed the WC. Each of these fixtures activated the pump and disposed of the water.

- 3.4 The rest of the plumbing system appears to be adequate and functional as there were no signs of leakage or system failure.

- 4.1 This pump system appears to have been installed in an acceptable manner with no visible signs of weakness or problems, which would have an adverse impact on the property.
