# Home Inspection Report

1/2b Matipo Road, Te Atatu Peninsula, Auckland

Inspection prepared for: Philippa Wintle  
Date of Inspection: 11/8/2021 Time: 12:00 PM  
Age of Home: 1980's Size: 90m<sup>2</sup>  
Weather: Fine

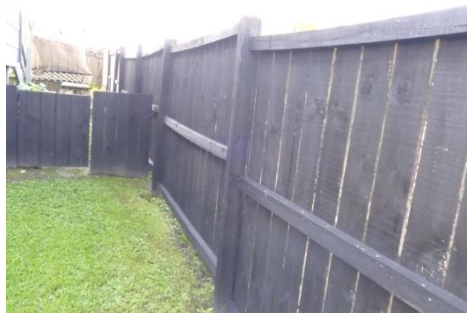
- Average condition

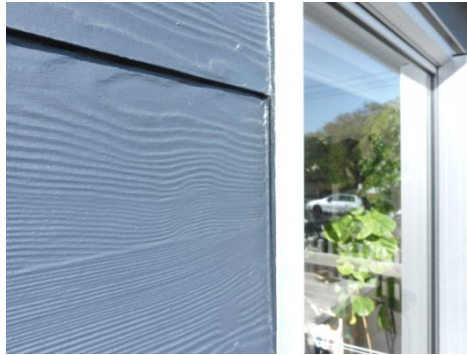
- Present in most areas
- The flashing is missing above the window beneath the carport, while this area is well protected from the elements sealants should be added to prevent moisture and insects entering the wall cavity

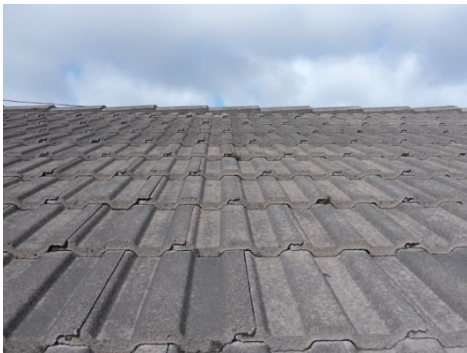
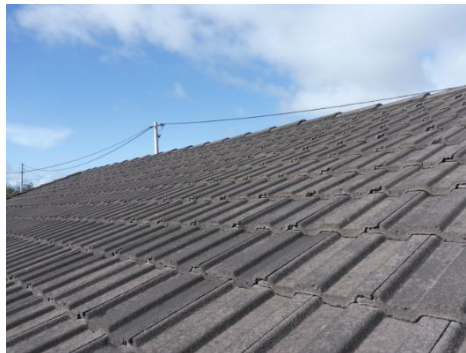
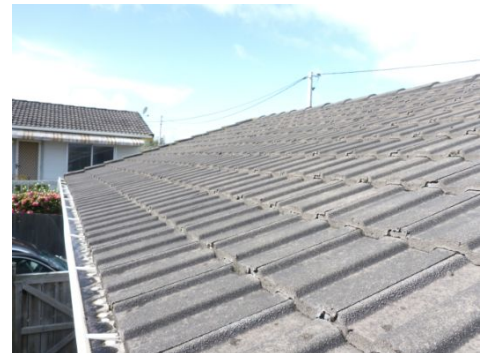
- No surface damage apparent

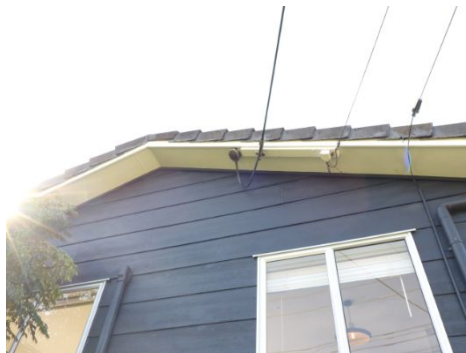
- >300mm

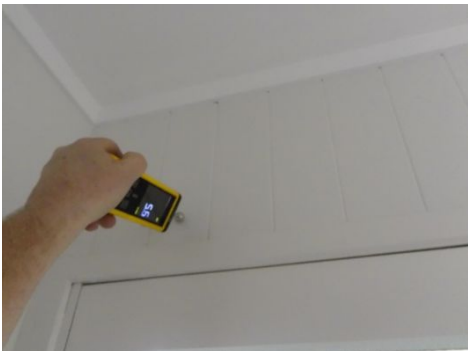
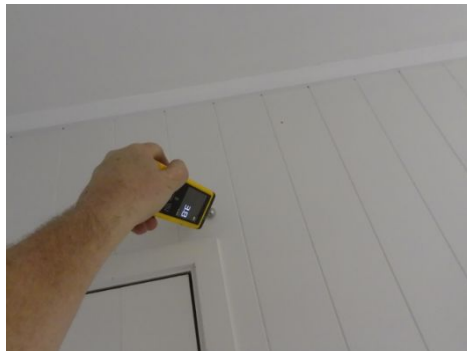
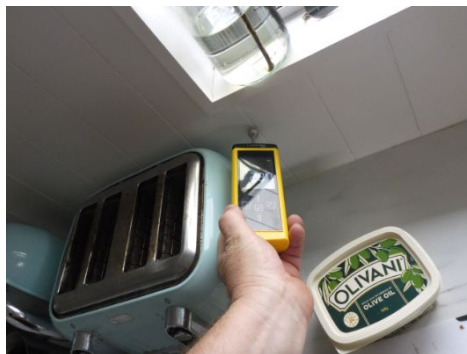
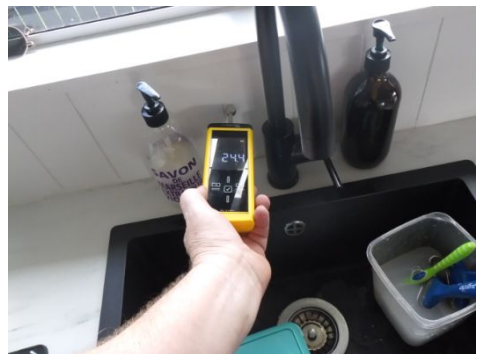
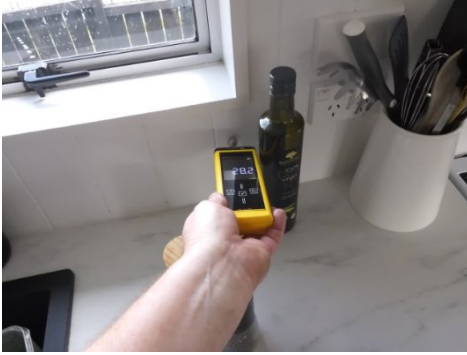
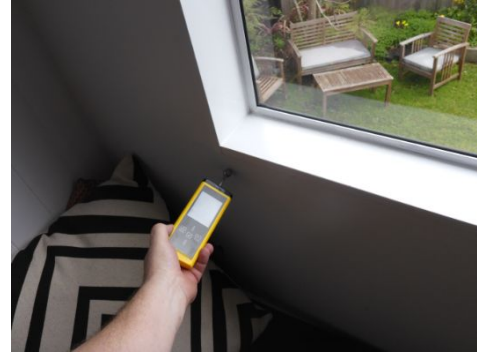
- Several readings were taken and all were within the acceptable range and indicate the room to be DRY.

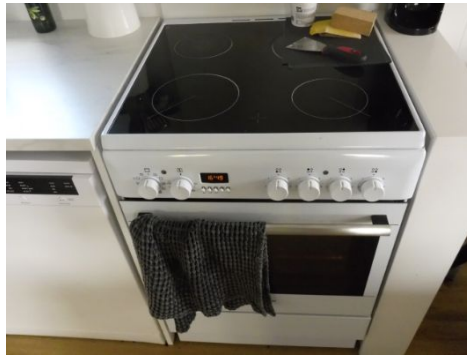
- Visually in good condition with functioning isolating switch, not tested for functionality

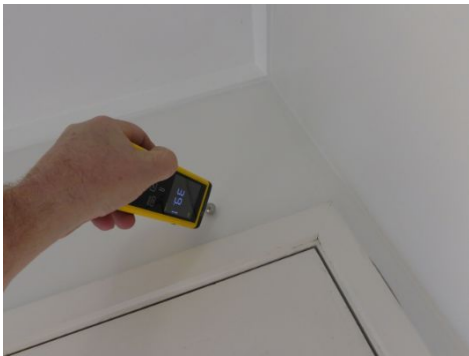
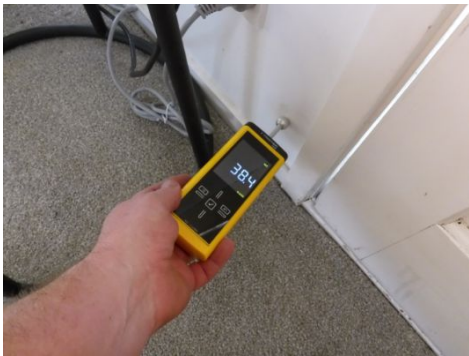
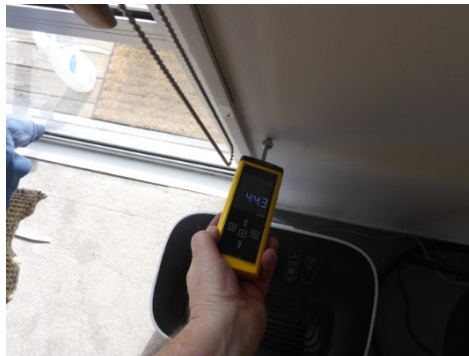
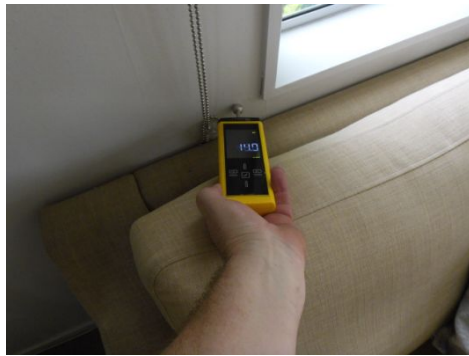
- Several readings were taken and all were within the acceptable range and indicate the room to be DRY.

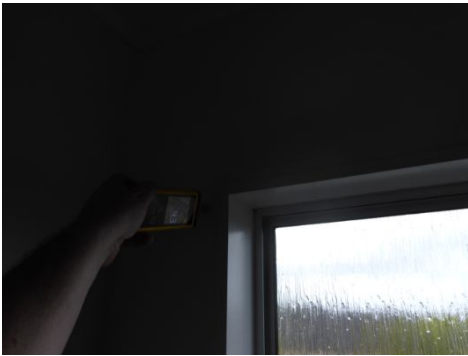
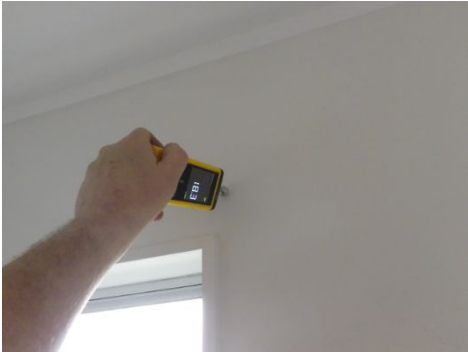
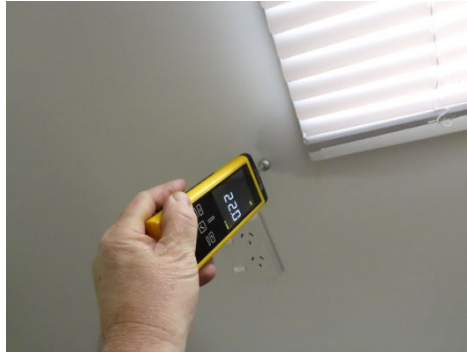
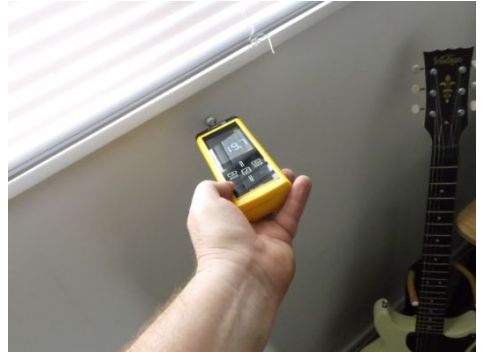
### 6. Moisture Readings

• Several readings were taken and all were within the acceptable range and indicate the room to be DRY.

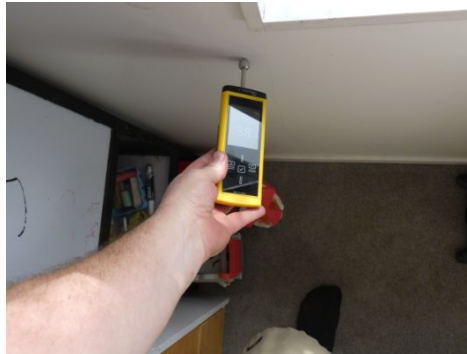
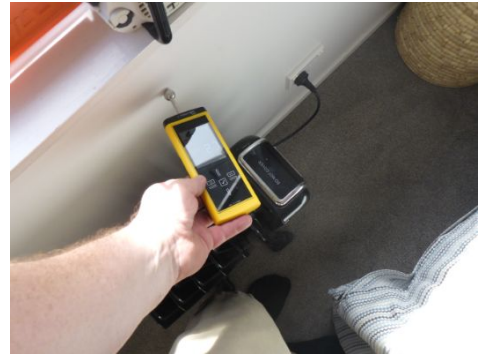
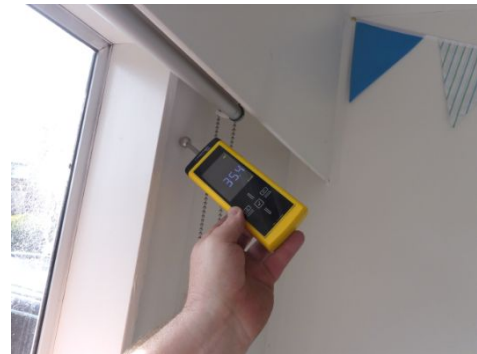
### 6. Moisture Readings

- Several readings were taken and all were within the acceptable range and indicate the room to be DRY.

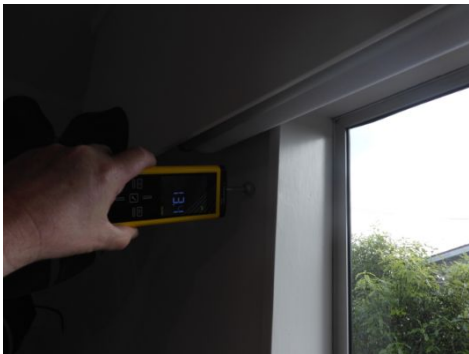
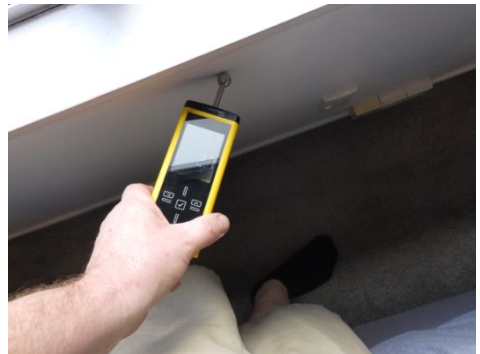
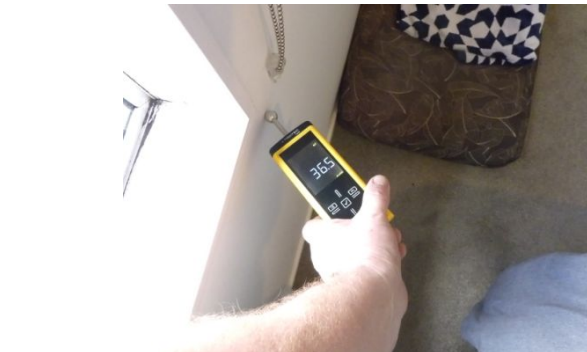
### 6. Moisture Readings

- Several readings were taken and all were within the acceptable range and indicate the room to be DRY.

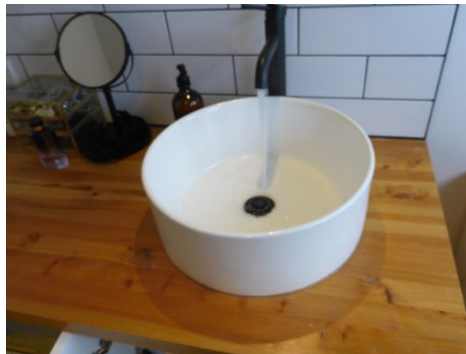
- Good condition

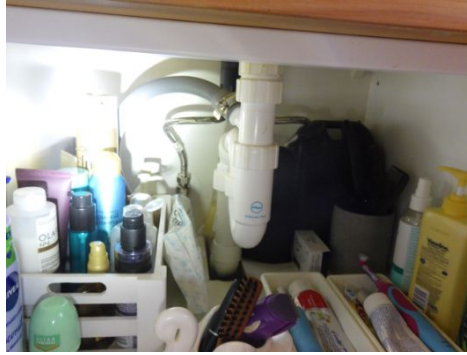
**6. Taps & Waste Traps**

- Operative

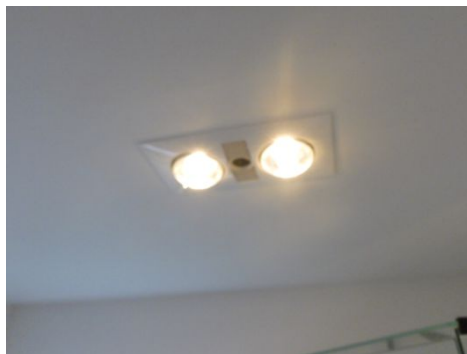
### 9. Ventilation System

M D NI • Mechanical

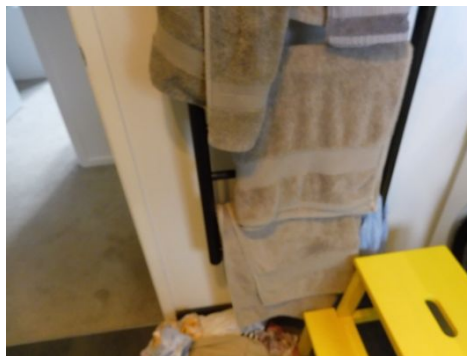
### 11. Heated towel rail

- Functional

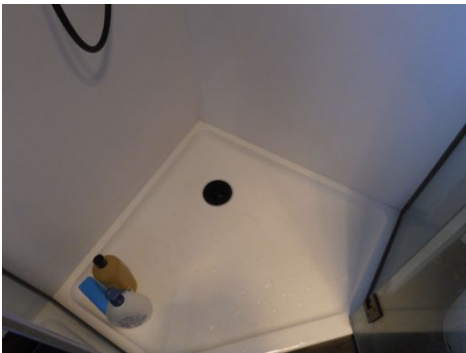
### 12. Shower/surround

- Plastic pan and surround

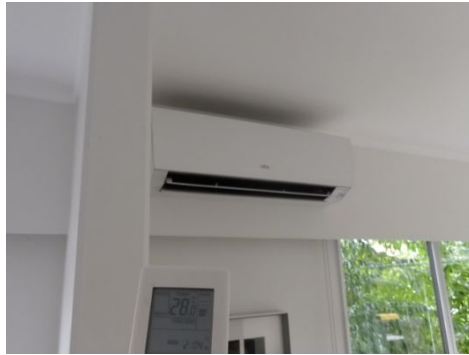
### 3. Condition

- M D NI • Appears to be in working condition

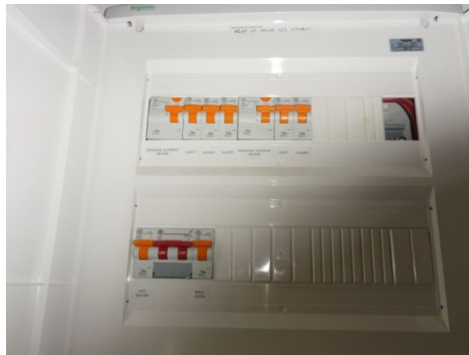
### 2. Condition

- Good condition

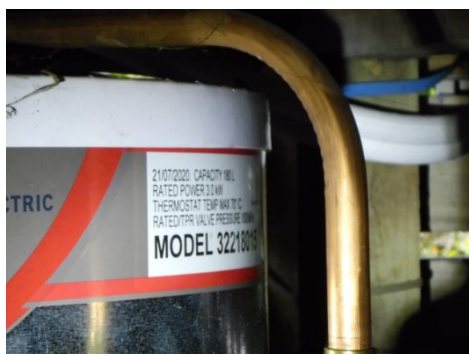
### 1. Type

- Hot water cylinder

180L Mains pressure

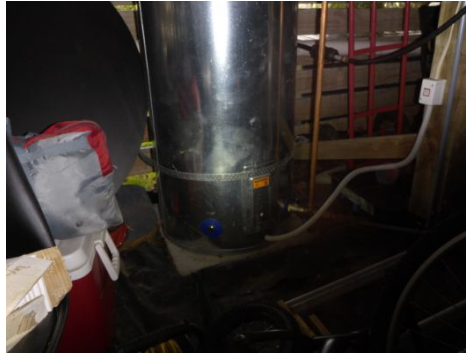
## 2. Location

- Crawl space
