PRE-PURCHASE BUILDING REPORT

Property Address	36 Eastglen Road, Glen Eden		
Client	Jesse Staines		
Date of Inspection	13th September 2022	Time	8:30 am
Inspector	Rob Sodeau Peer reviewed by LBP 133644		
LBP Number	Peer reviewed by LBP 133644		
Inspection Type	Pre-Purchase Report		
People Present	Owner, Inspector		
House Occupied	Yes

CERTIFICATE OF INSPECTION IN ACCORDANCE WITH NZS 4306:2005

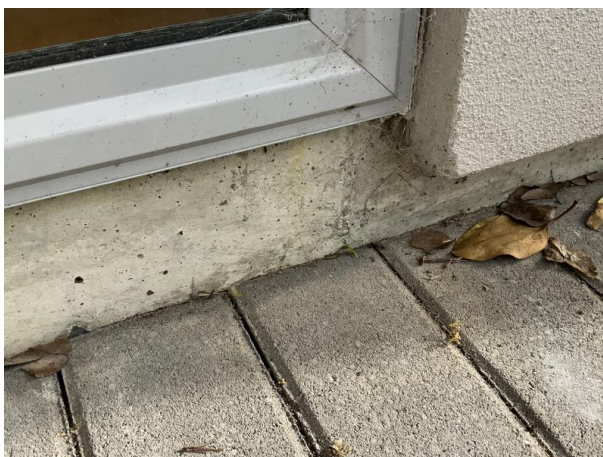
Photo 3

Sample photo of the foundation perimeter wall

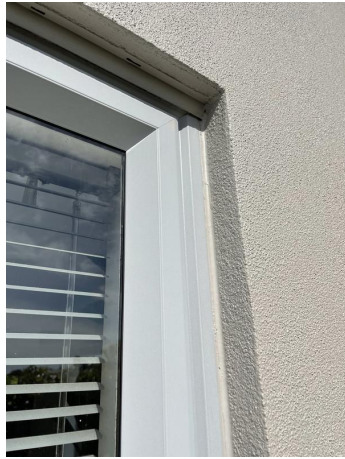
Photo 10

Sample photo of the joinery to cladding junction, ensure these areas are kept sealed and maintained

Ensure all cladding joinery, joins, soffit junctions and penetrations are kept sealed and maintained for continued weather tightness.

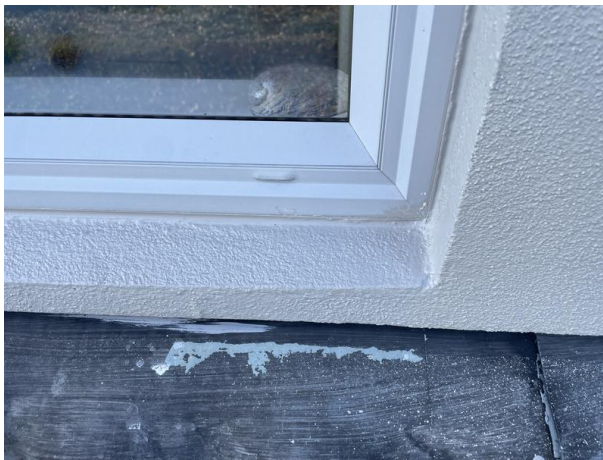
Photo 11

Sample photo of the joinery to cladding junction, ensure these areas are kept sealed and maintained

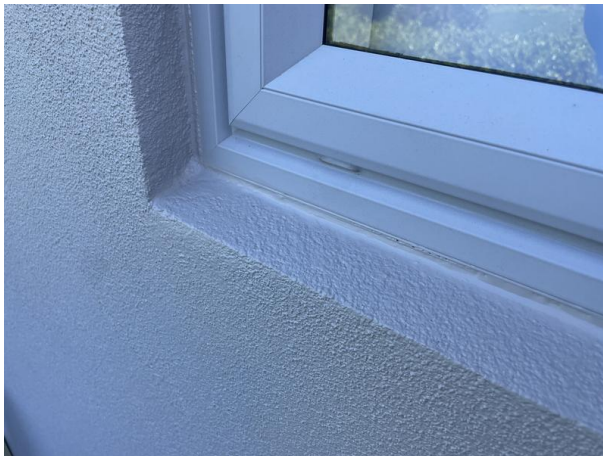
Photo 12

Sample photo of the joinery to cladding junction, ensure these areas are kept sealed and maintained

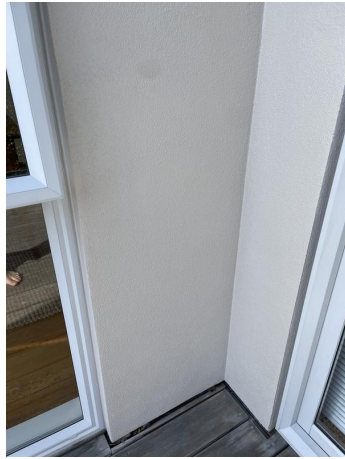
Photo 13

Sample photo of a cladding corner junction, ensure these areas are kept sealed and maintained

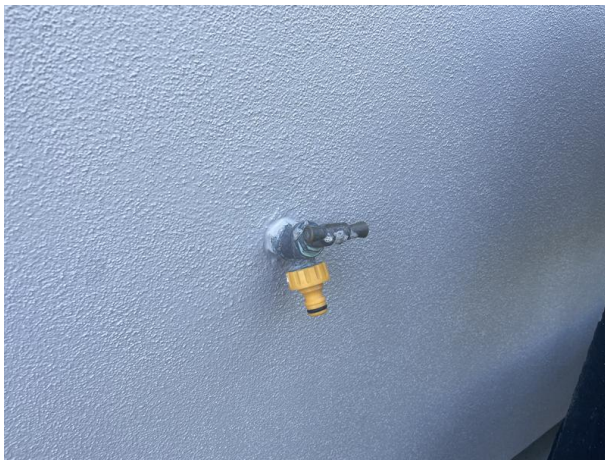
Photo 14

Sample photo of a cladding penetrations, ensure these areas are kept sealed and maintained

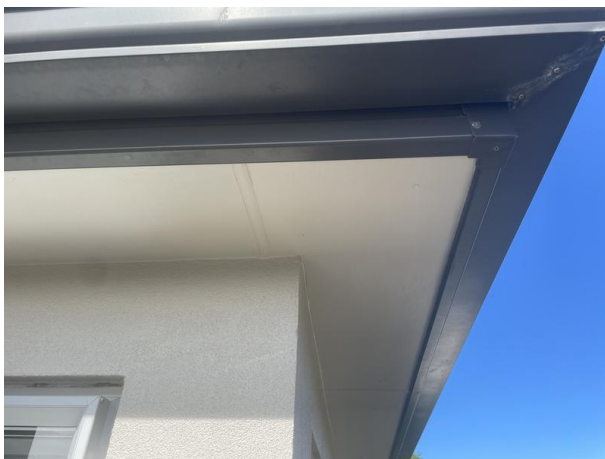
Photo 15

Sample photo of a cladding to soffit junction, ensure these areas are kept sealed and maintained

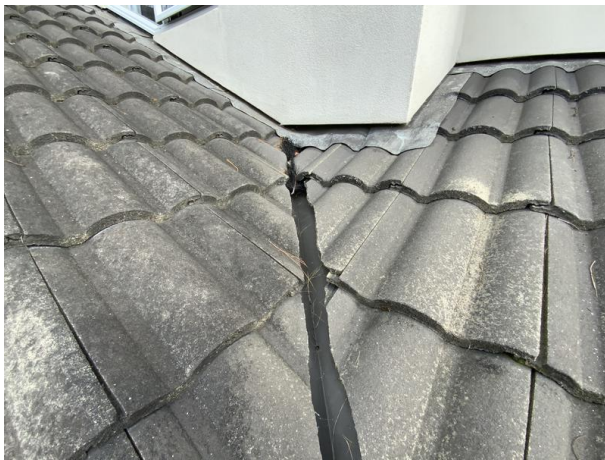
Photo 31

Sample photo of the roof valley, ensure this is maintained and kept clean

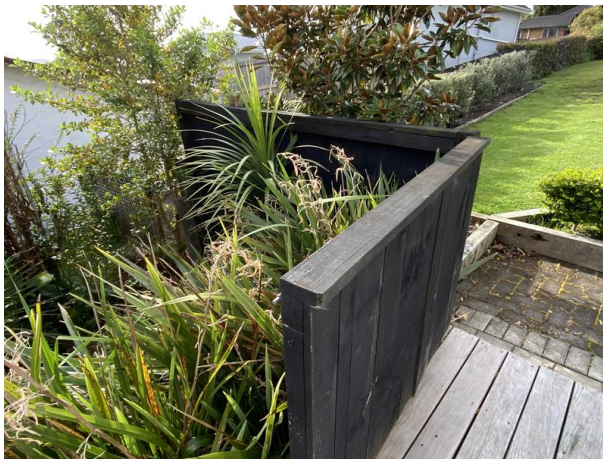
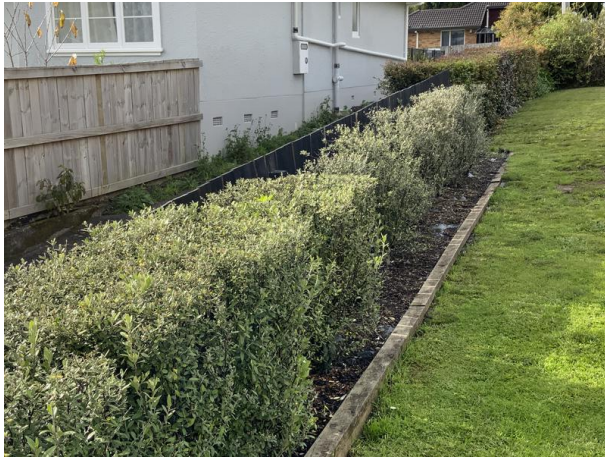
Moisture - Visible at the bottom of the wall.

General upkeep and maintenance, keep vegetation and soils clear of timbers as these timbers are only exterior treated and will rot if vegetation or soils are up against them. Some palings may need replacement.

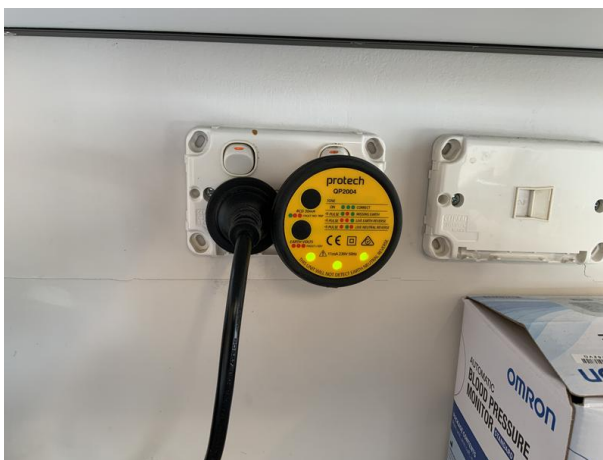
Photo 94

Sample photo of the electrical plug test, all tested plugs passed
