Home Inspection Report

16 Panzic Place, Glen Eden, Auckland

Inspection prepared for: Boaz Shulruf
Date of Inspection: 19/6/2023 Time: 11:30 AM
Age of Home: 1980s Size: 88m2
Weather: Fine

Inspector: Duane Turner
Phone: 027 376 4806 / 09 8118 017
Email: duane.turner@abuyerschoice.com

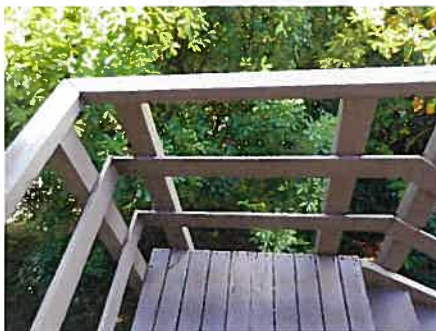
- M D NI
X • The design of the handrail while acceptable at the time of construction should now be considered a fall hazard for young children

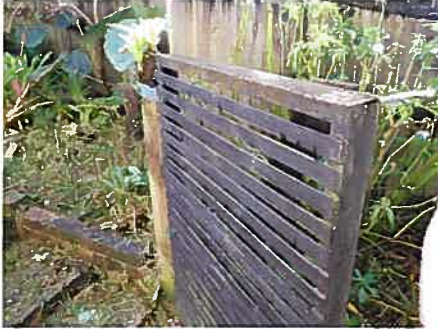
Average condition

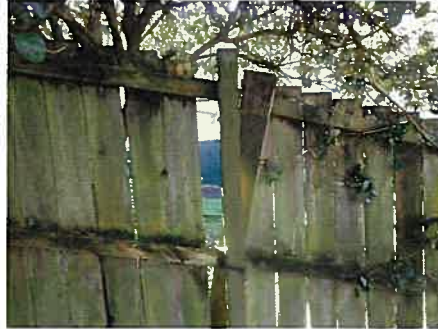
- Areas of damage present requiring repairs or replacement

Damaged fencing

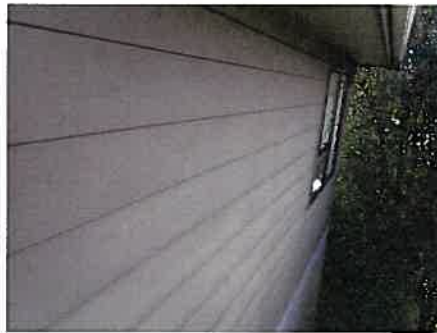
• Areas of cracking and damage present, repairs recommended

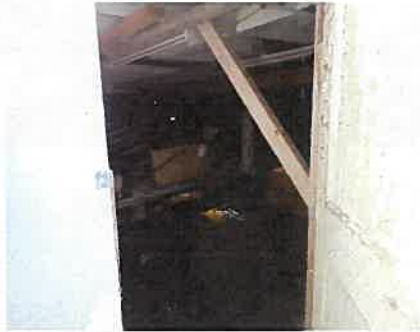
Damage to the access door

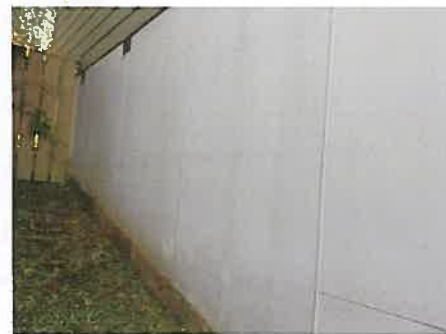
Some cracking present

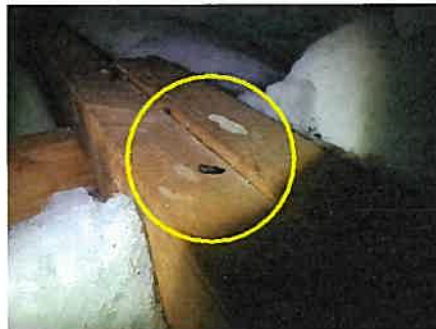
M D NI • Evidence of rodent activity, this should be kept in check to prevent damage
X

Rodent droppings

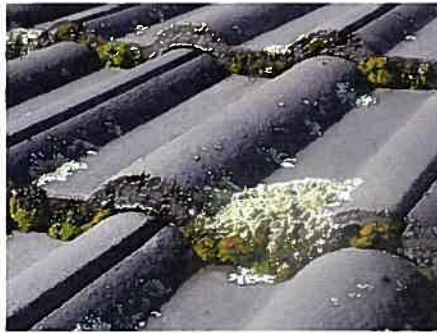
- There is a small amount of lichen/moss present on the roof
- The roof surface would benefit from being cleaned

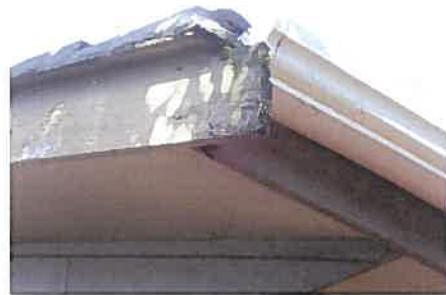
- M D NI • General damage and deterioration present

General deterioration

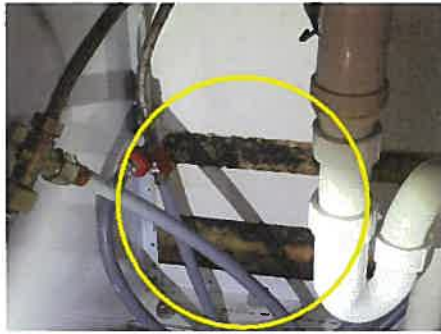
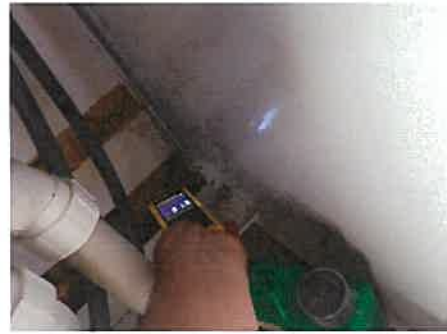
M D NI • Several readings were taken and all were within the acceptable range and indicate the room to be DRY however mould growth behind the laundry tub should be controlled

Mould growth

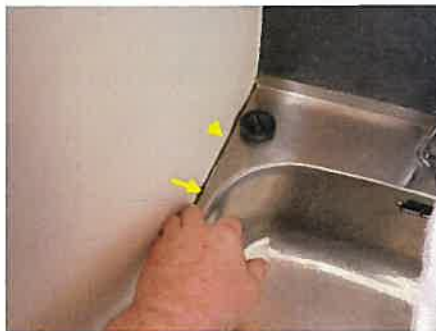
M D NI • Sealants should be added to prevent water damage
X

Sealants recommended

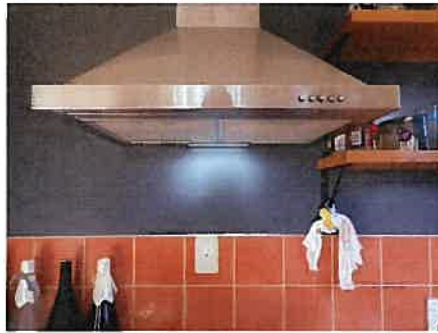
13. Air Extraction Point of Discharge

M D NI
X

• Venting to the exterior of the home however the ducting has become damaged requiring repairs

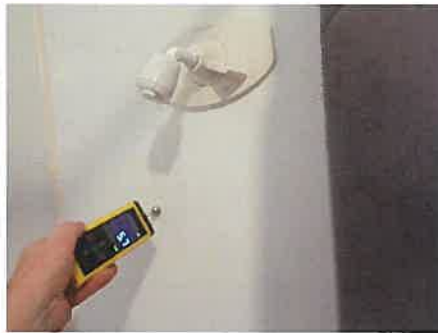
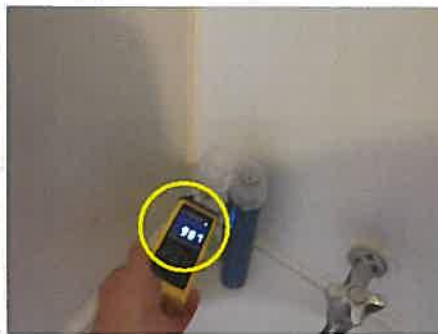
• Several readings were taken and some were within the higher range and indicate the room to be WET around the bath, this is due to the poorly sealed bath lining and has resulted in the floor beneath being effected by moisture, recommend ensuring the bath/shower lining is well sealed to prevent further issues

Poorly sealed

Elevated reading

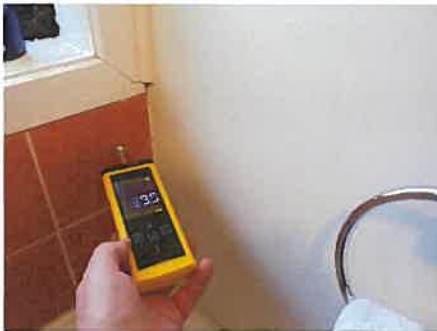
Moisture effected floor
